Docket No. 272 – Development and Management Plan Inspection

Norwalk Substation

Date: September 5, 2008

Location: Norwalk Substation - 50 New Canaan Avenue, Norwalk, CT

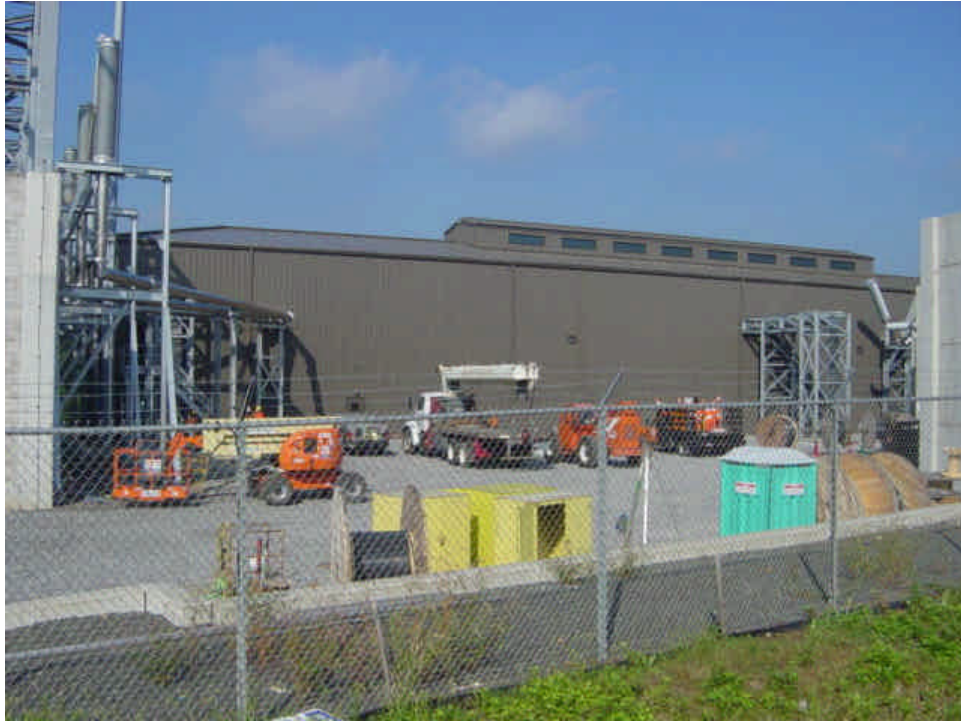
Electrical tie-in work continues inside the substation perimeter.

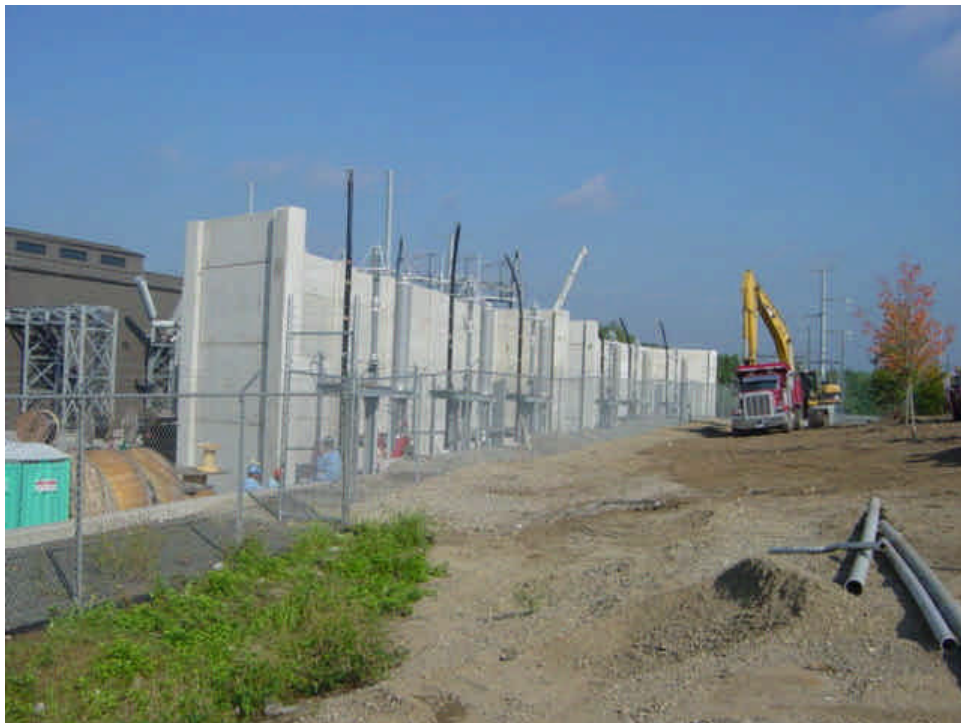
Electrical connection and tie-in work continues inside the substation perimeter.
