Docket No. 272 – Development and Management Plan Inspection

Norwalk Substation

Date: September 19, 2008

Location: Norwalk Substation - 50 New Canaan Avenue, Norwalk, CT

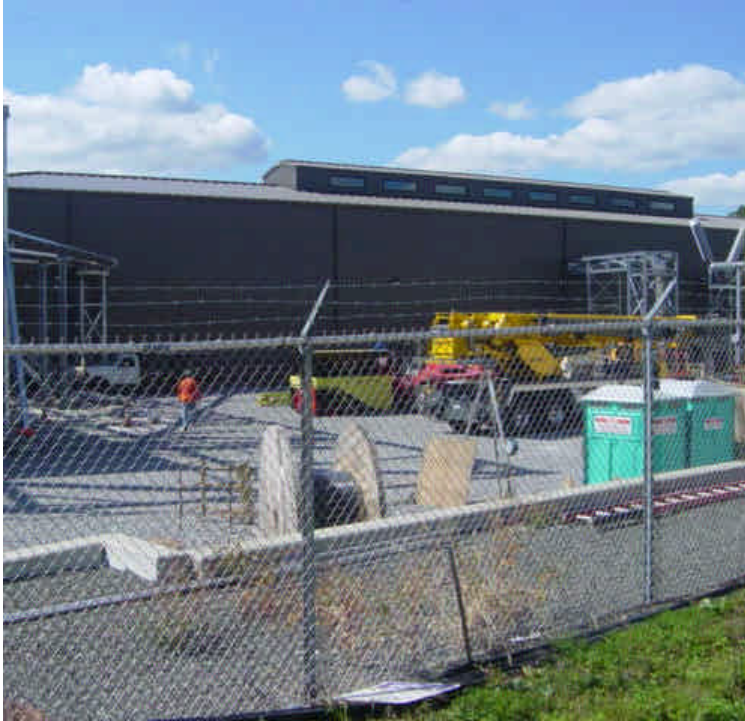
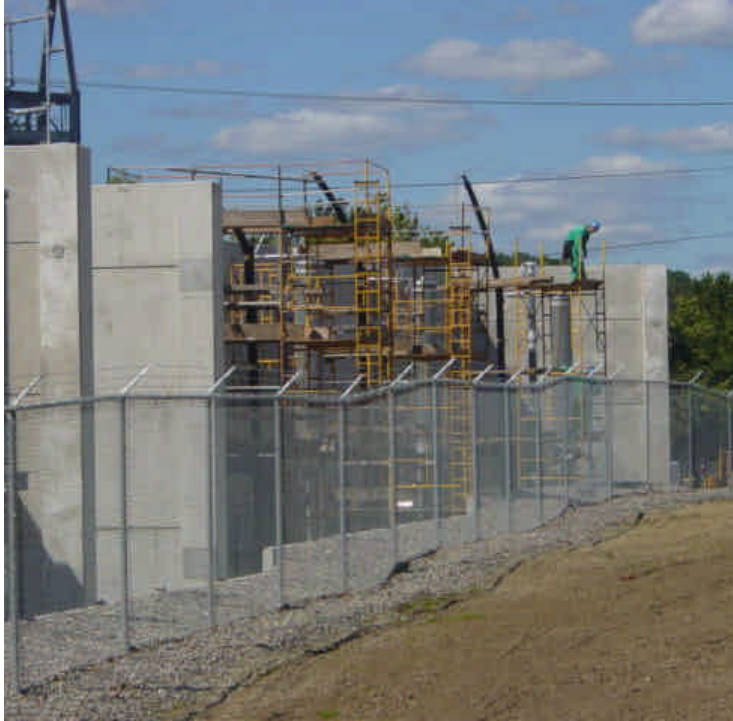
Electrical tie-in work continues inside the substation. New equipment continues to be installed.

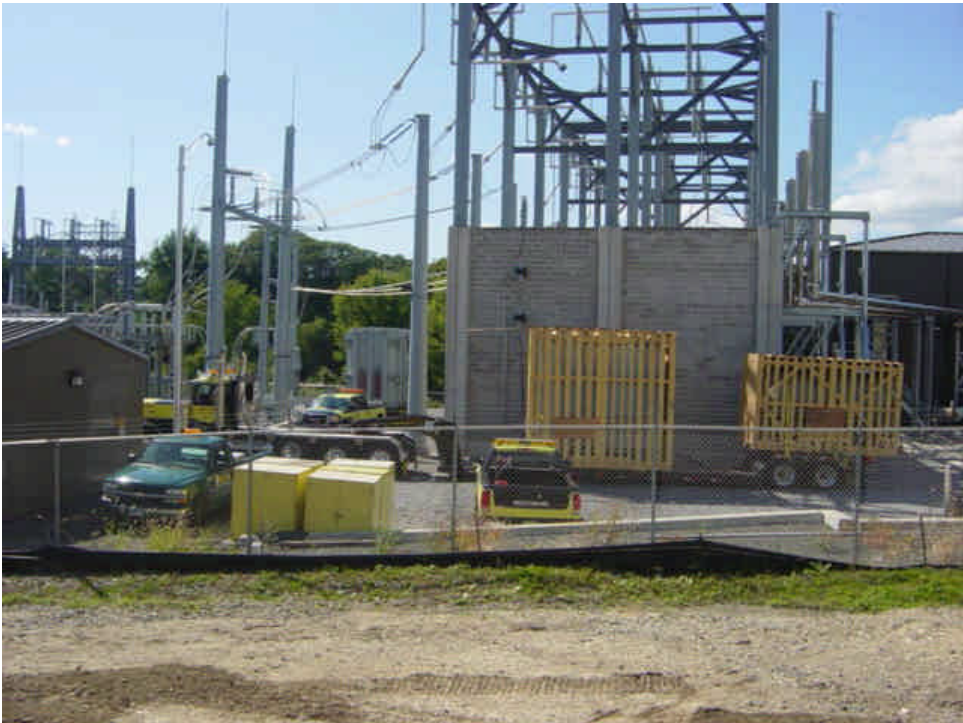
New electrical equipment was delivered to the Norwalk Substation.
