**Docket No. 272 – Development and Management Plan Inspection**

**Segment 1a Inspection**

**Date:** January 15, 2008

**Location:** Segment 1a – Scovill Rock Switching Station to Chestnut Junction, Oxbow Junction to Beseck Switching Station (excluding Royal Oak Bypass), and Black Pond Junction to Beseck Switching Station

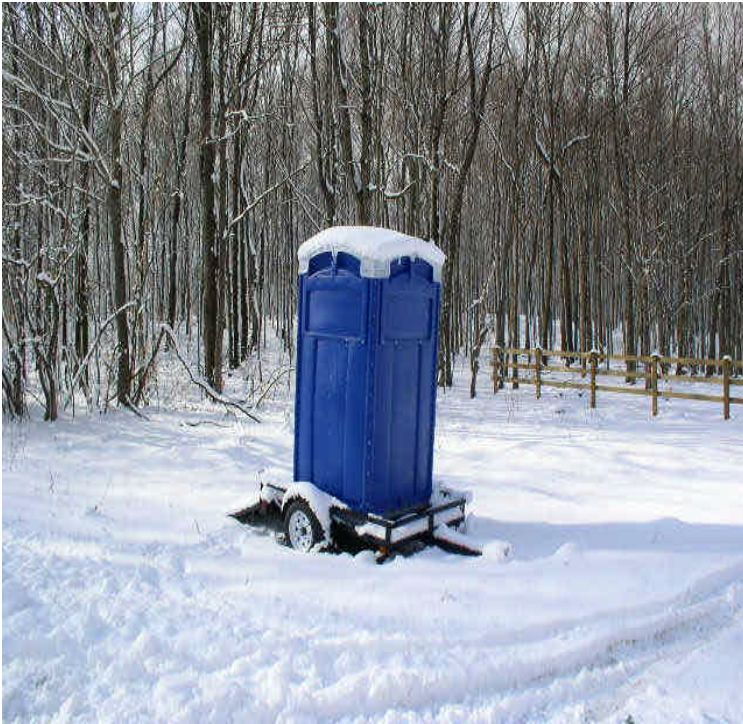
**Arbutus St: Sanitary facility has been placed upright. Confirm whether affected soils were cleaned up and removed prior to snow cover. If not, attention is still needed.**

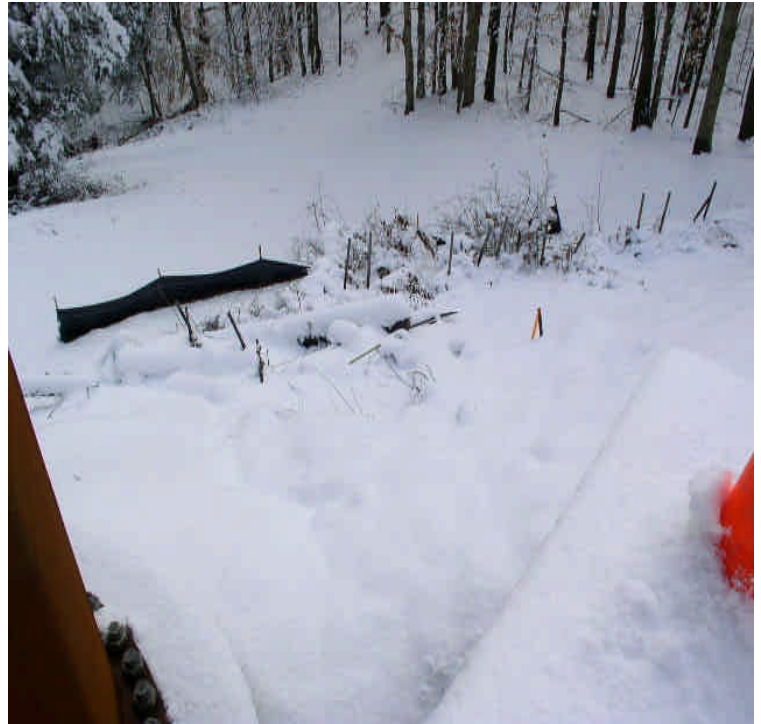
**Controls remain upgradient from Ball Brook at the end of the Black Walnut Dr. entrance access road.**

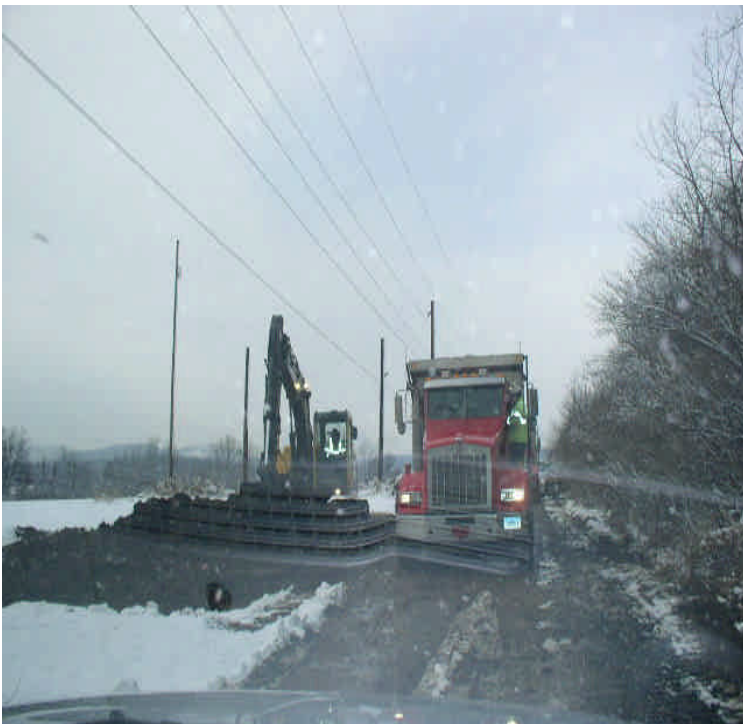
**Little Lane: Stockpile removal underway. Line pulling activities were also occurring.**

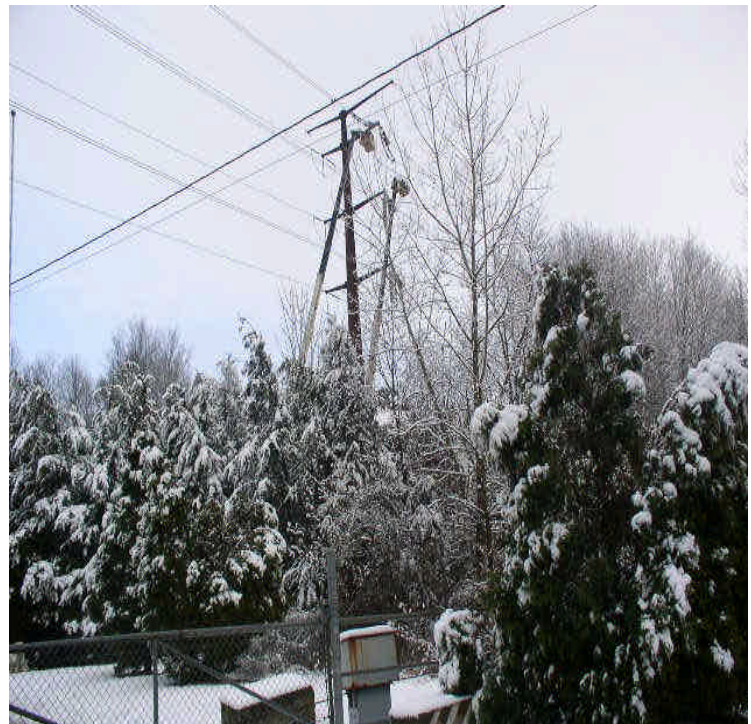
**Durham Rd: Line work was underway within the transfer station land**

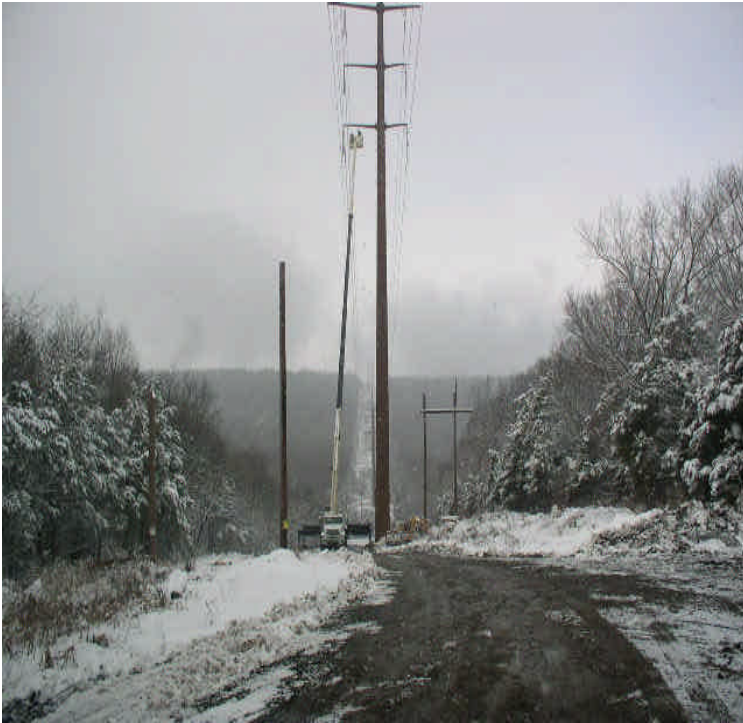
**Powder Hill Rd:** Line work underway between here and Little Lane.

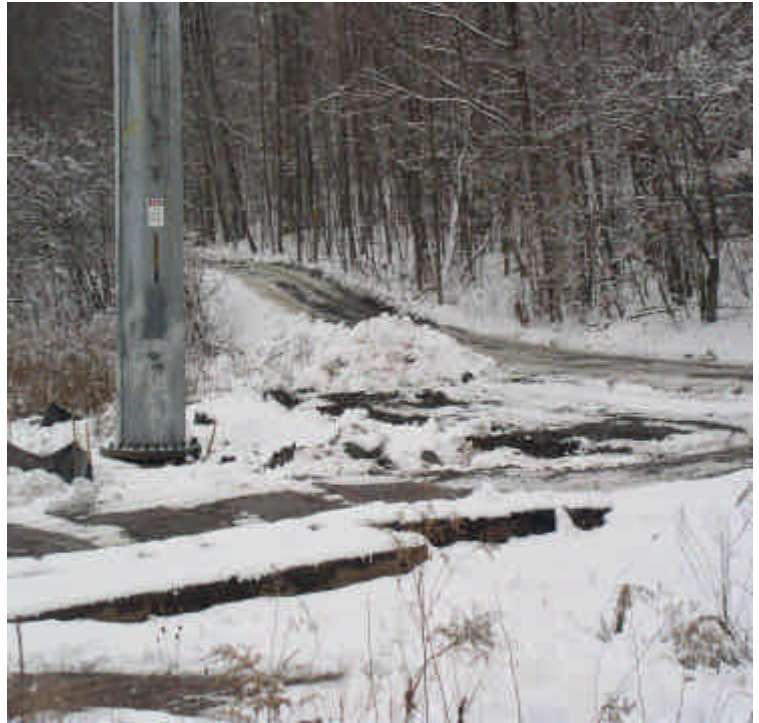
**High Hill Rd:** Provide controls in order to reduce sediment tracking on the timber mats as needed. Controls are still needed upgradient from wetlands in this section.

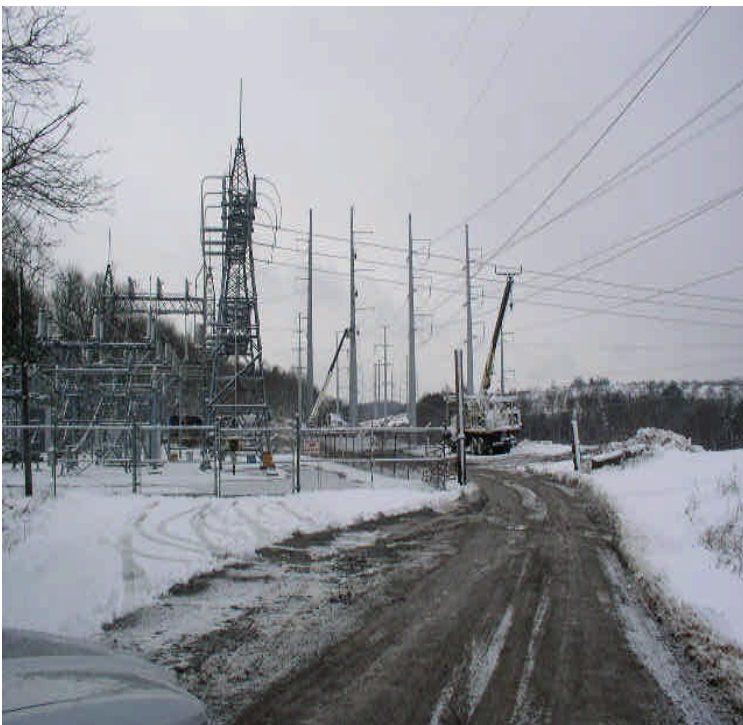
**E. Meriden SS:** Line work underway between here and Black Pond Jct.

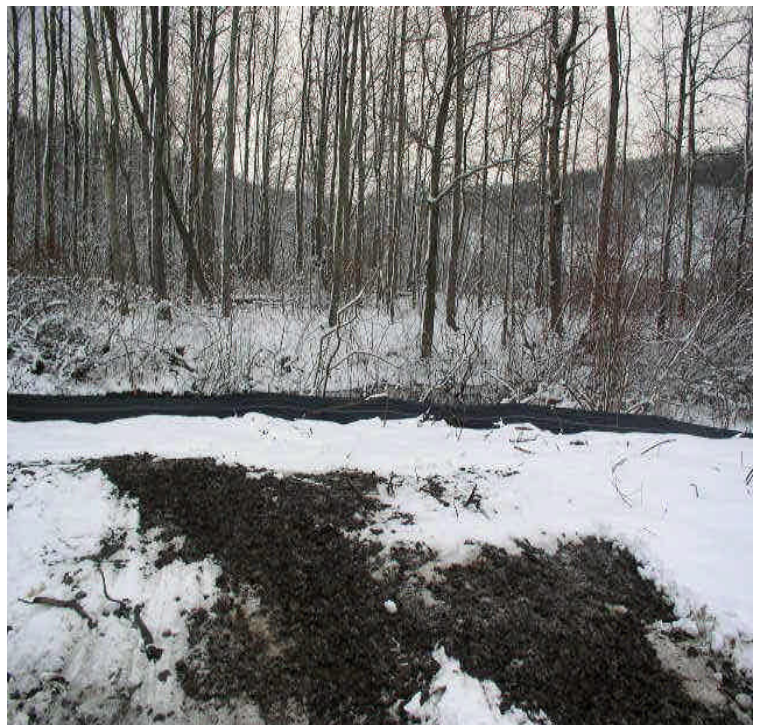
**South of East Main Street:** Snow and associated sediment have been removed from the wetlands and controls have been installed.
