Docket No. 272 – Development and Management Plan Inspection

Segment 1a Inspection

Date: January 28, 2008

Location: Segment 1a – Scovill Rock Switching Station to Chestnut Junction, Oxbow Junction to Beseck Switching Station (excluding Royal Oak Bypass), and Black Pond Junction to Beseck Switching Station

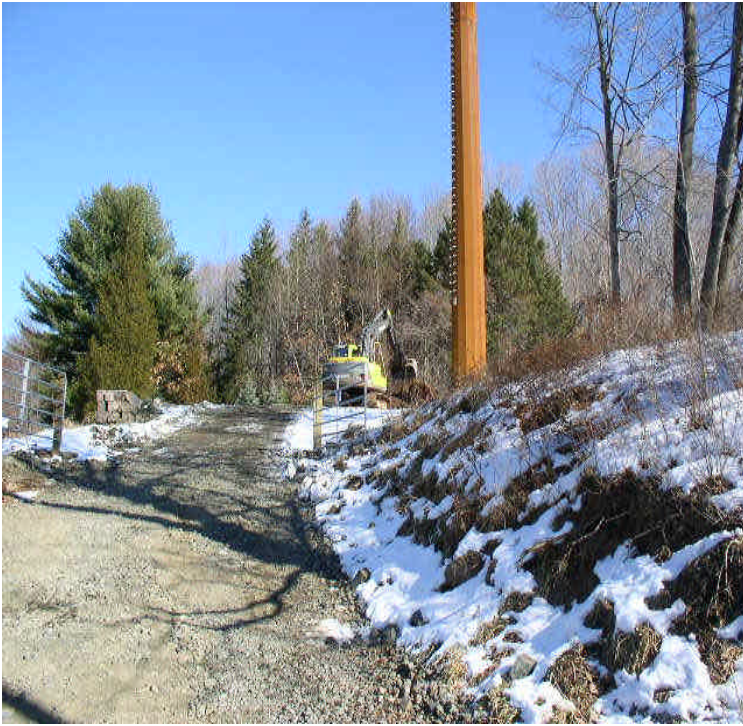
Foot Hills Rd: Minor grading and pad work was underway.

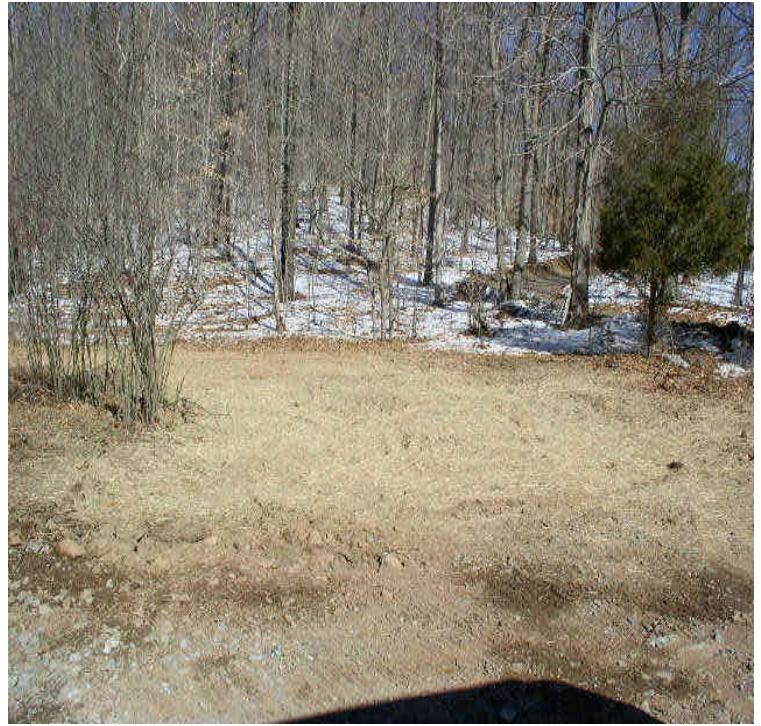
Johnson Ln: A small stockpile was removed and the area was mulched and seeded

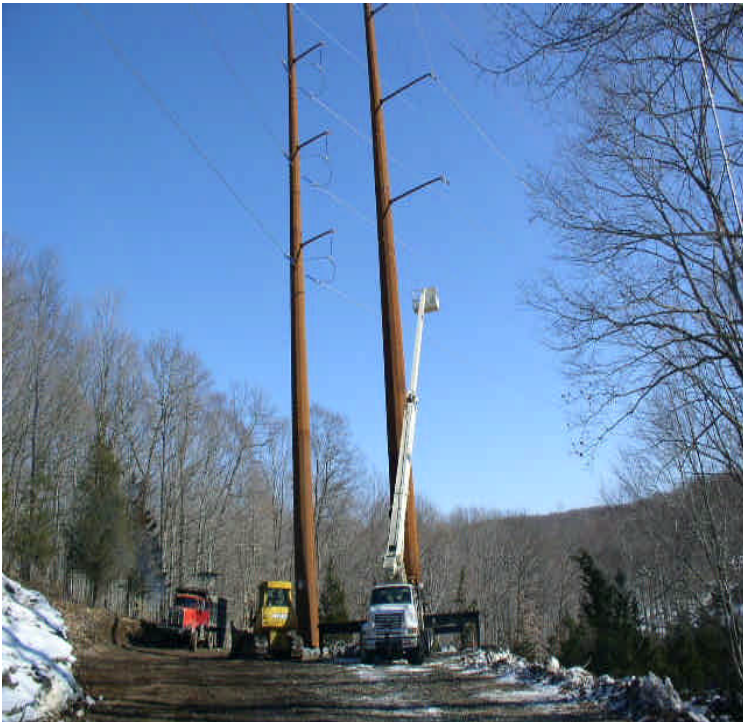
Black Walnut Dr: Minor pad work underway in preparation for line pulling activities.

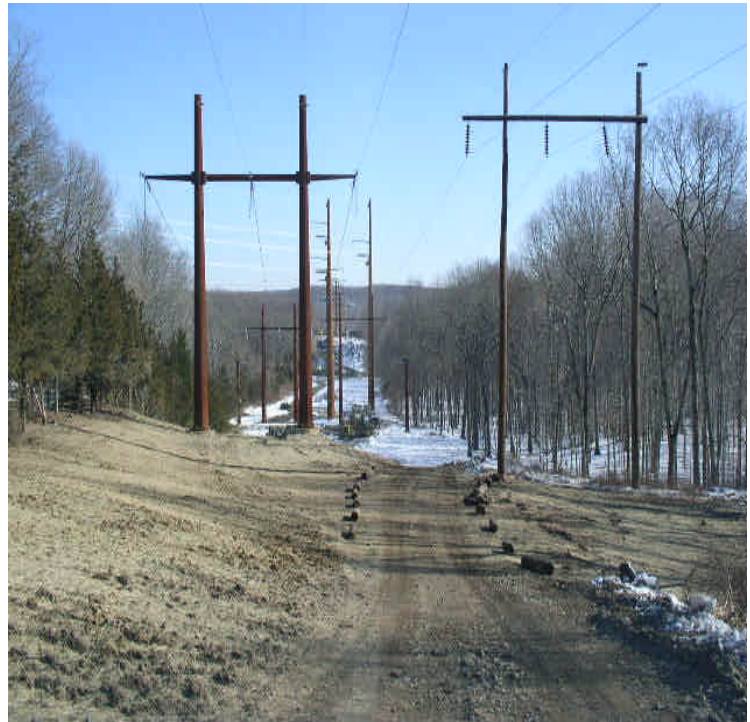
Black Walnut Dr: Final grading completed adjacent to the access road. Hay mulch and seed have been applied in reclaimed areas.

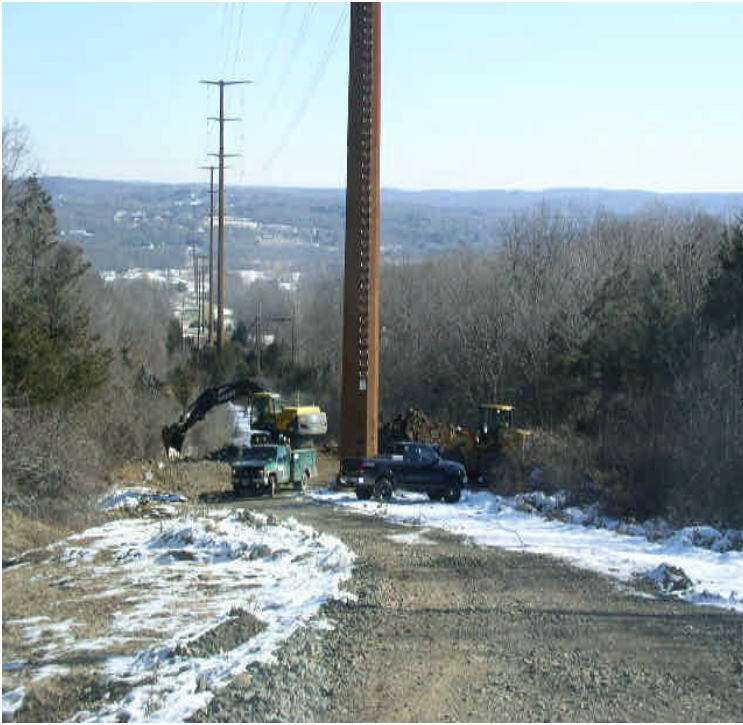
Powder Hill Rd: Minor pad work and restoration work underway east of the roadway.

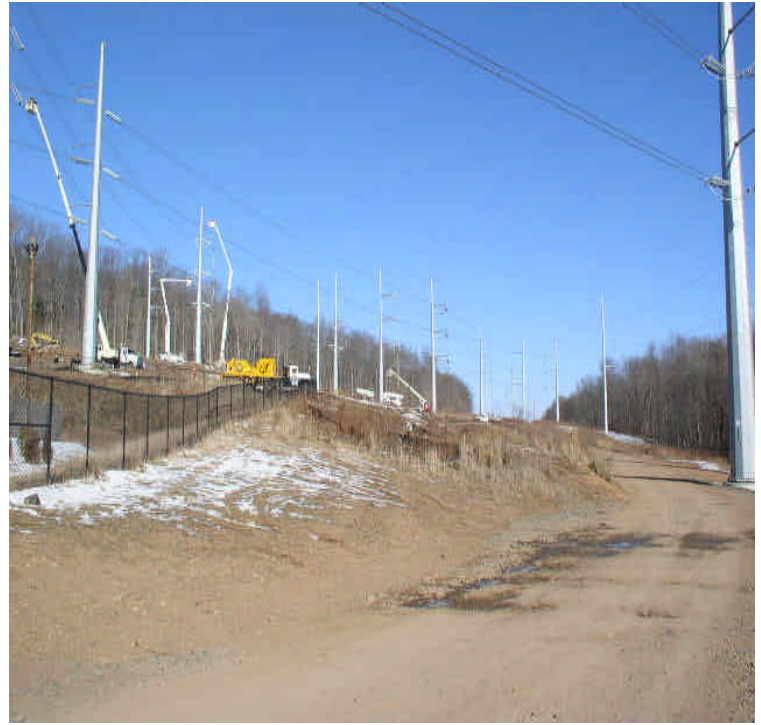
North of Beseck SS: Line work underway moving north from the switching station.

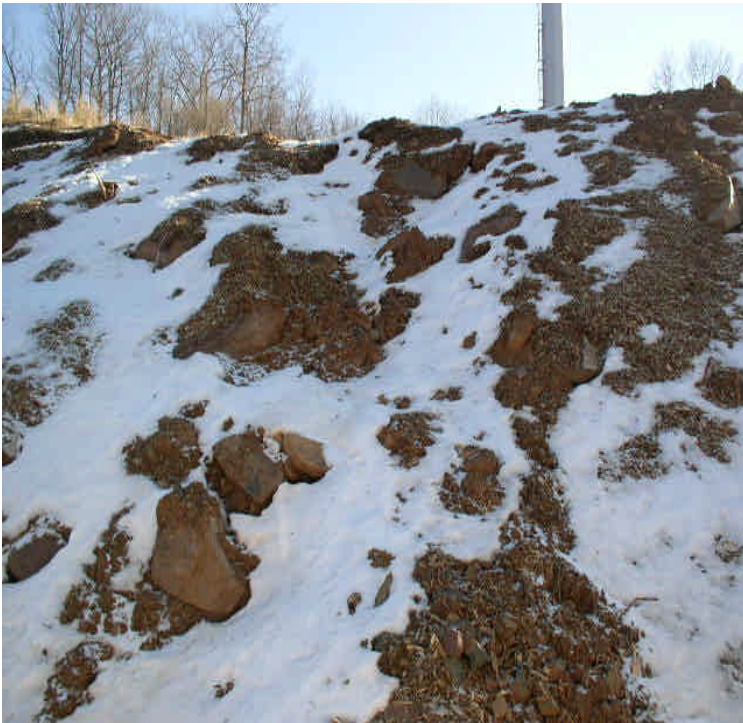
Areas of Inspection	Observation	Recommended Action	Corrected Action
<p>North of High Hill Rd. South of East Main St.</p>	<p>1/28/08</p> <p>In the vicinity of East Meriden SS, a small washout/rill was beginning to form in a steep slope of a pad that had previously been mulched. 1/7-1/28/08</p> <p>Some large areas of exposed soil remain adjacent to wetlands in these sections. 1/28/08</p>	<p>fence/ haybales/ fiber rolls alone are not sufficient. 11/26-1/28/08</p> <p>Monitor and ensure the area is stable. 1/28/08</p> <p>Maintain controls and monitor for vegetative growth. Attend to the remaining areas within the approved timelines. 11/12-1/28/08</p>	<p>Needs to be monitored</p> <p>Needs attention within timelines</p>
<p>Dewatering Oxbow Junction to Beseck SS</p> <p>Black Pond Junction to Beseck SS North of Beseck SS to East Meriden Substation</p>	<p>Dewatering will continue at new foundations as needed. 1/28/08</p> <p>Dewatering basins remain in place at some pad sites. 1/28/08</p>	<p>Continue to restore areas that are inactive. 1/28/08</p> <p>Continue to restore areas within timeframes. 1/28/08</p>	<p>NA</p> <p>Continue working on restoration</p>

E. Meriden SS: Line work was underway. Small eroded, rill channels were forming along a pad slope. Run-off was contained to site but provide stabilization when conditions permit.

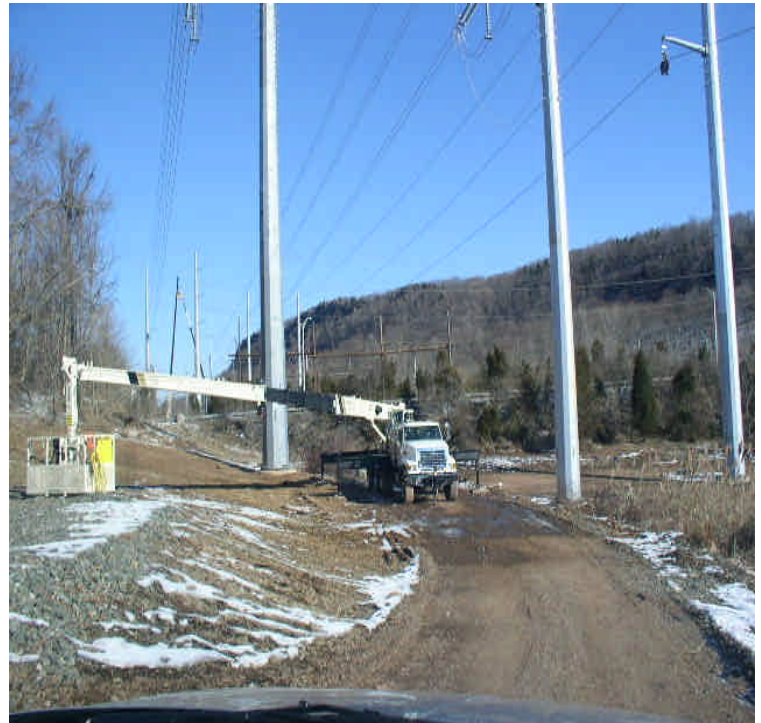
North of East Main Street: Line workers were preparing to install insulators.
