Docket No. 272 – Development and Management Plan Inspection

Segment 1a Inspection

Date: February 11, 2008

Location: Segment 1a – Scovill Rock Switching Station to Chestnut Junction, Oxbow Junction to Beseck Switching Station (excluding Royal Oak Bypass), and Black Pond Junction to Beseck Switching Station

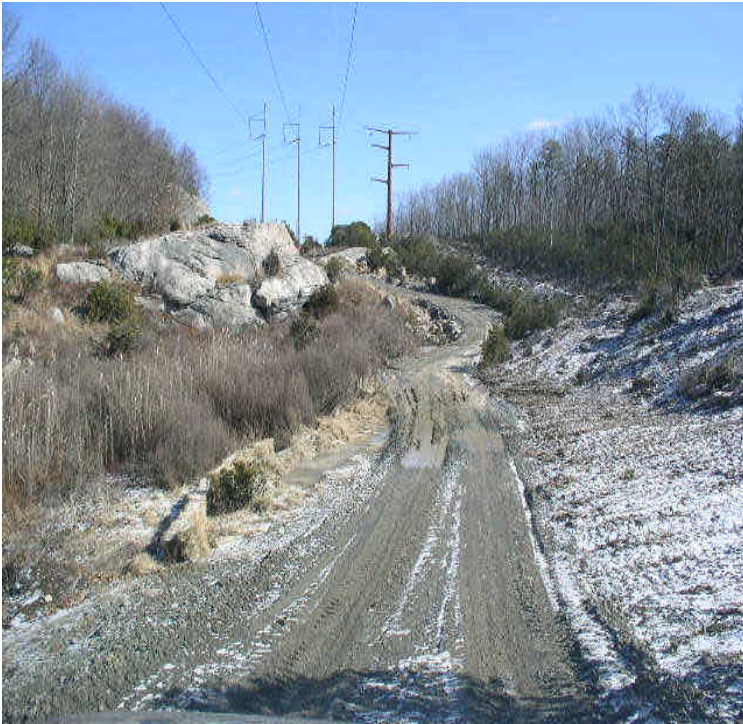
West of Scovill SS: Haybales installed to stop run-off to wetland #5.

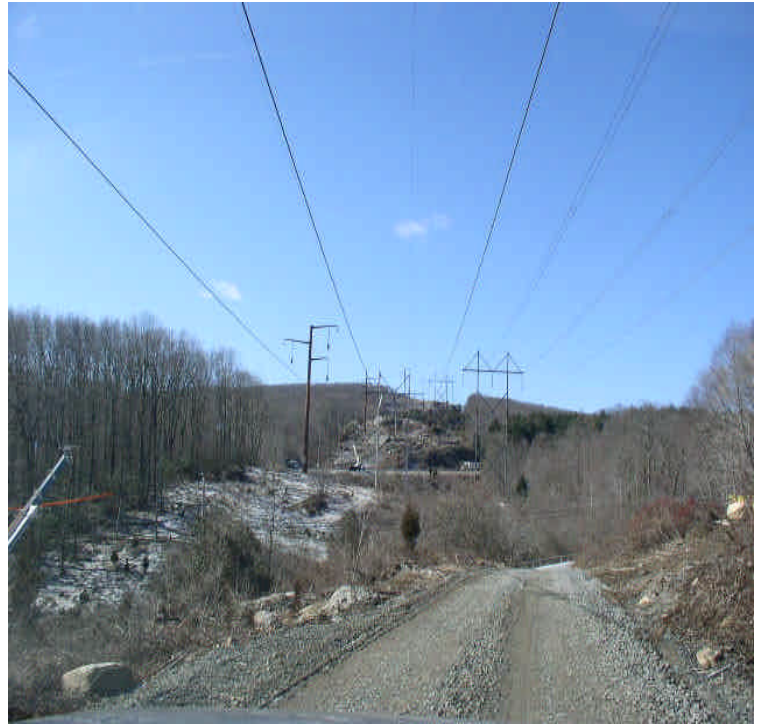
Route 9 Crossing: Line work was underway.

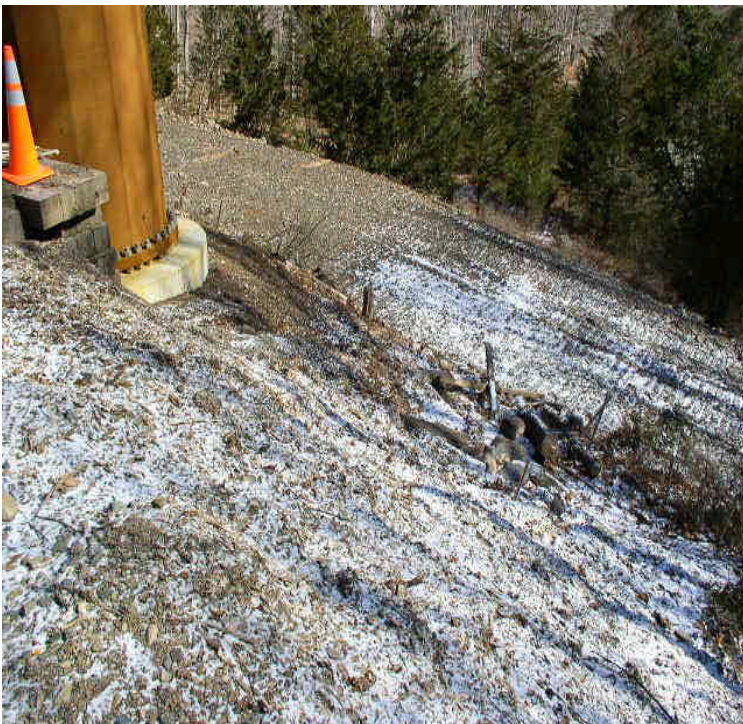
Black Walnut Dr: Grading noted around the last structure before Ball Brook to accommodate line pulling equipment.

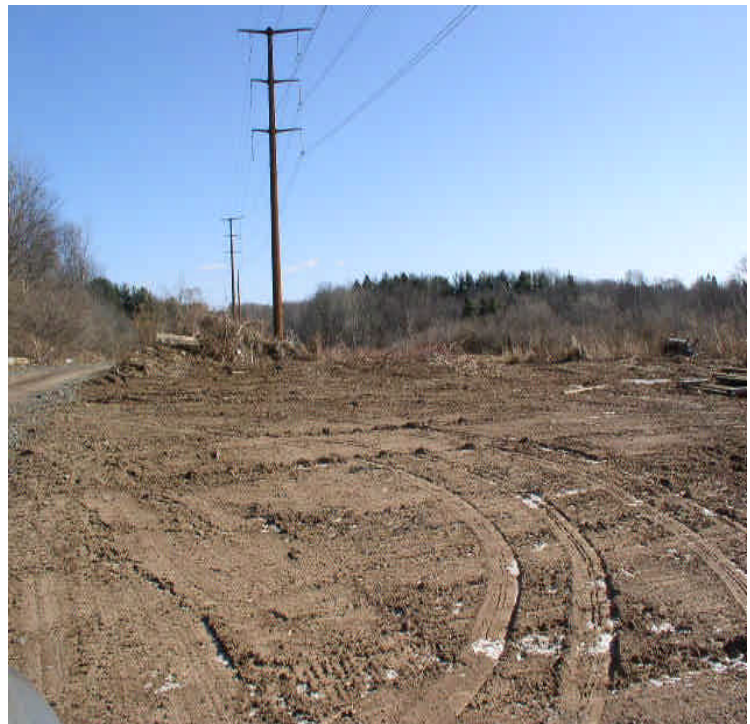
Little Ln: Wooden structures removed, final grading is complete. Temporary stabilization measures needed on exposed soils.

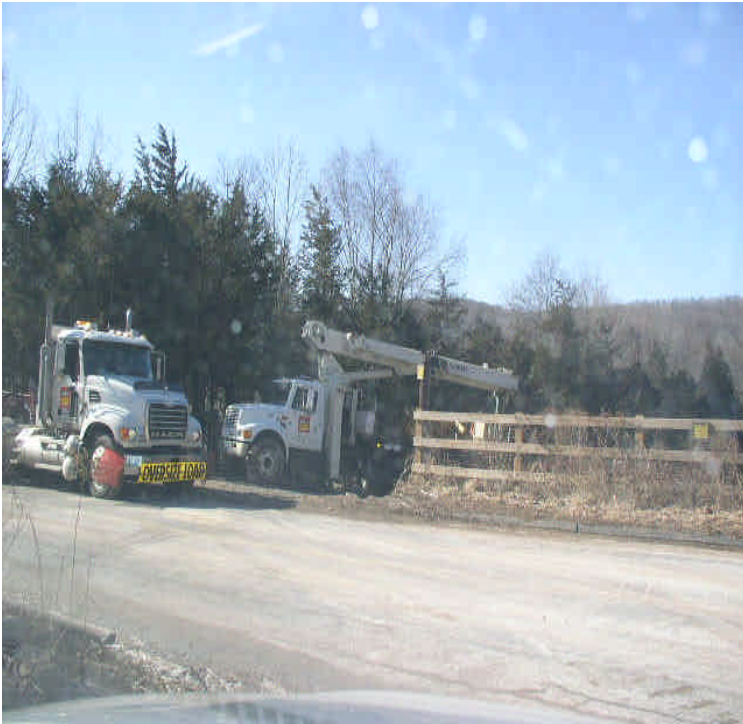
Powder Hill Rd: Sediment tracking was noted on the roadway. Equipment removal from this section was underway.

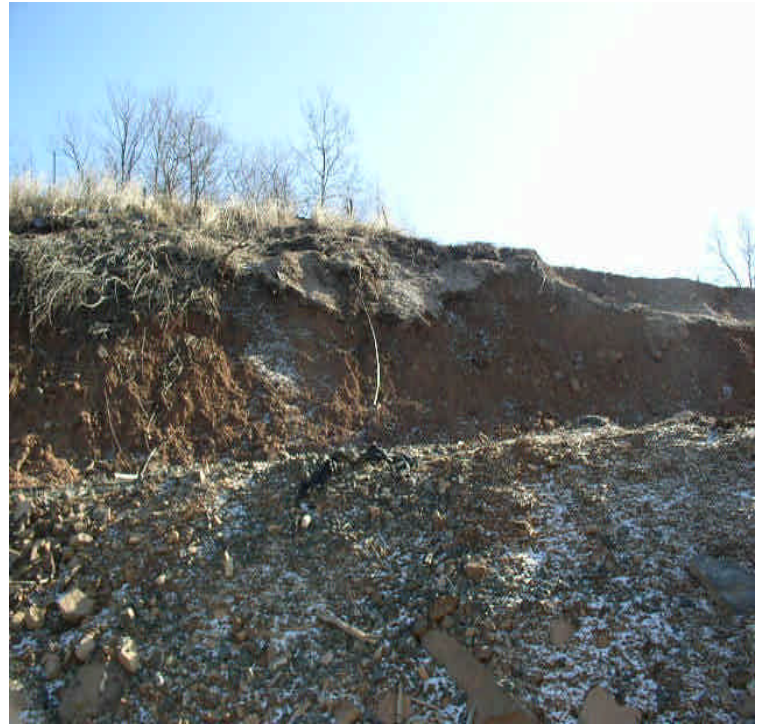
East Meriden SS: Erosion noted on the steep slopes at structure 2446. Run-off remains contained to the ROW but stabilize when feasible.

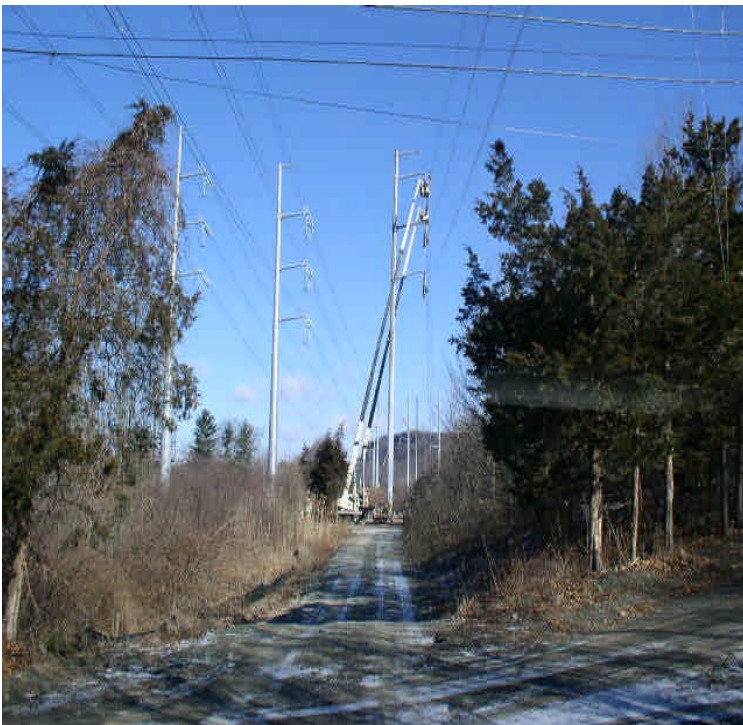
North of High Hill: Insulator installation continues moving toward Black Pond Jct.

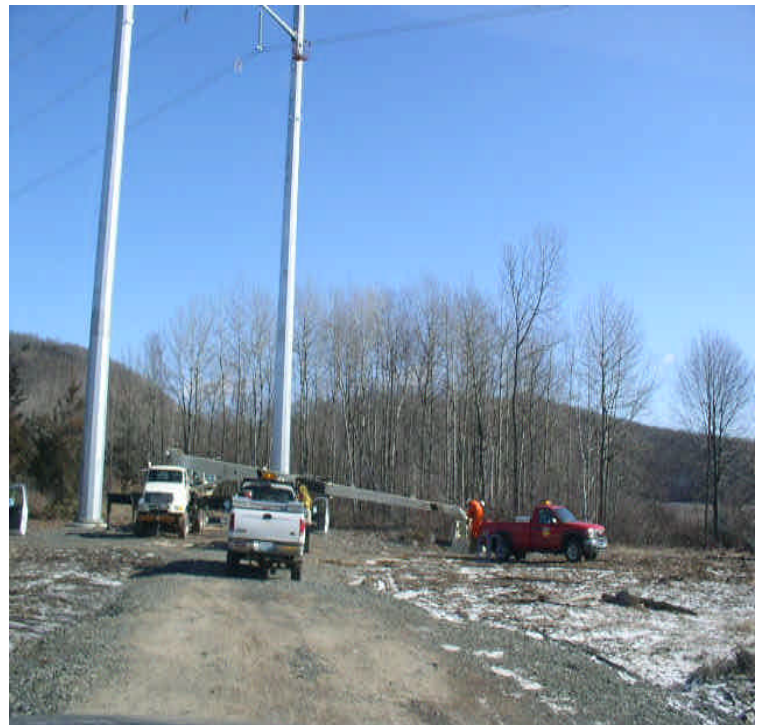
South of E. Main St: Line work underway adjacent to wetlands.
