Docket No. 272 – Development and Management Plan Inspection

Segment 1a Inspection

Date: March 3, 2008

Location: Segment 1a – Scovill Rock Switching Station to Chestnut Junction, Oxbow Junction to Beseck Switching Station (excluding Royal Oak Bypass), and Black Pond Junction to Beseck Switching Station

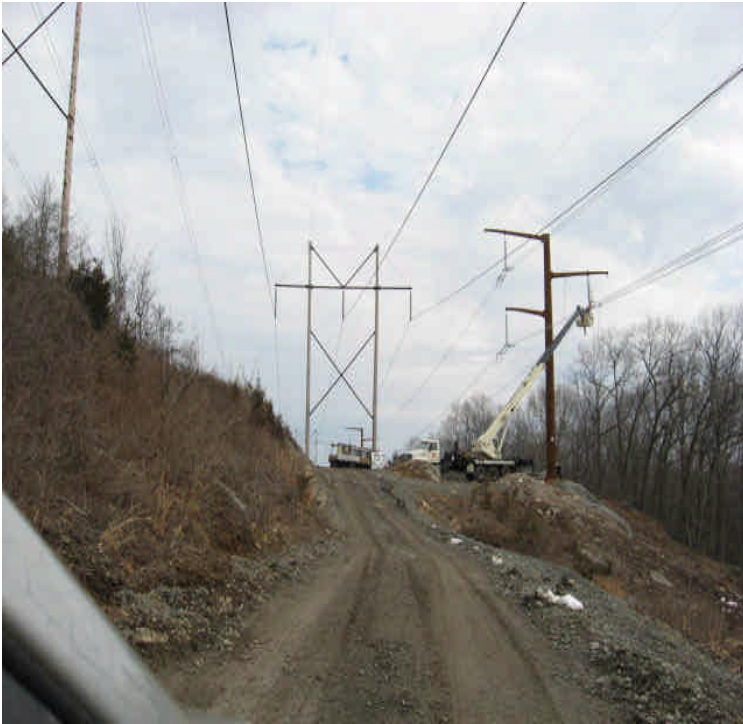
West of Scovill SS: Wetland #5 crossing is in good shape. Line work was underway.

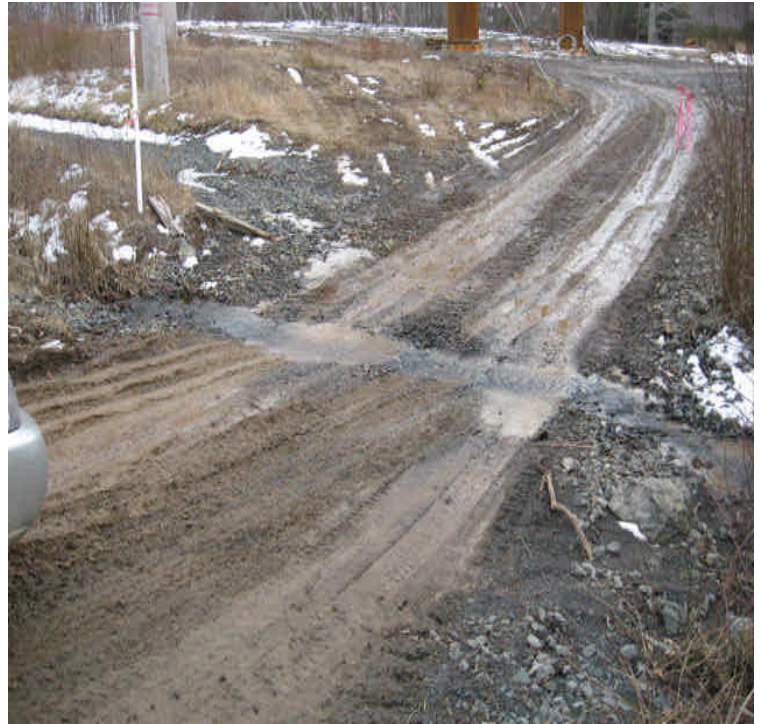
East Mount Rd: Run-off continues to flow at the saturated crossing, becoming slightly turbid across the access road.

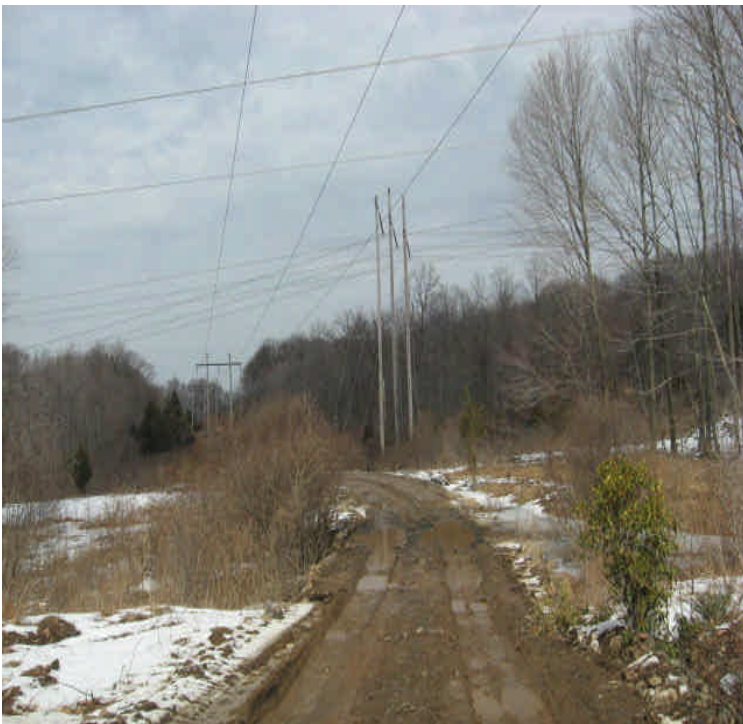
East Mount Rd: New section of access road extending through a saturated crossing, with water becoming turbid and flowing off site.

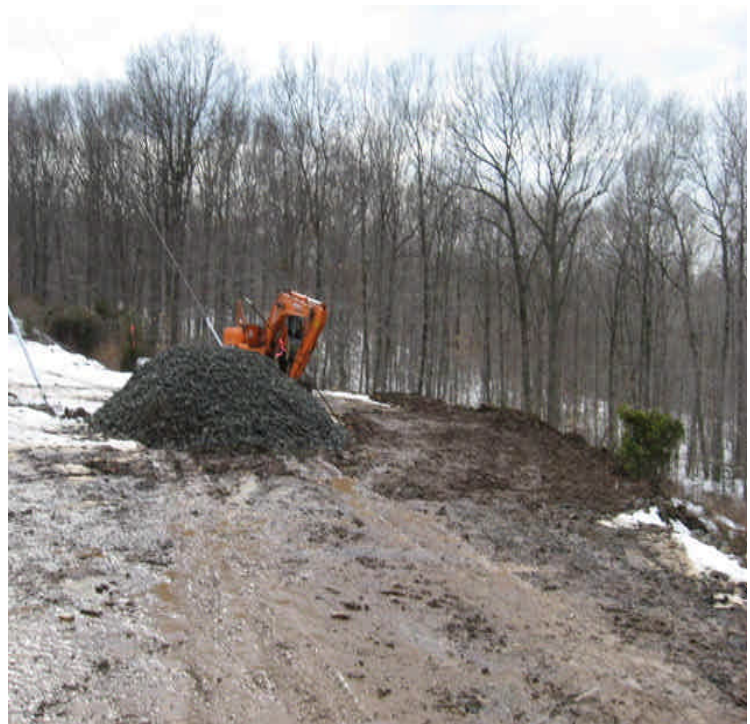
East Mount Rd: Access road and pad installation underway.

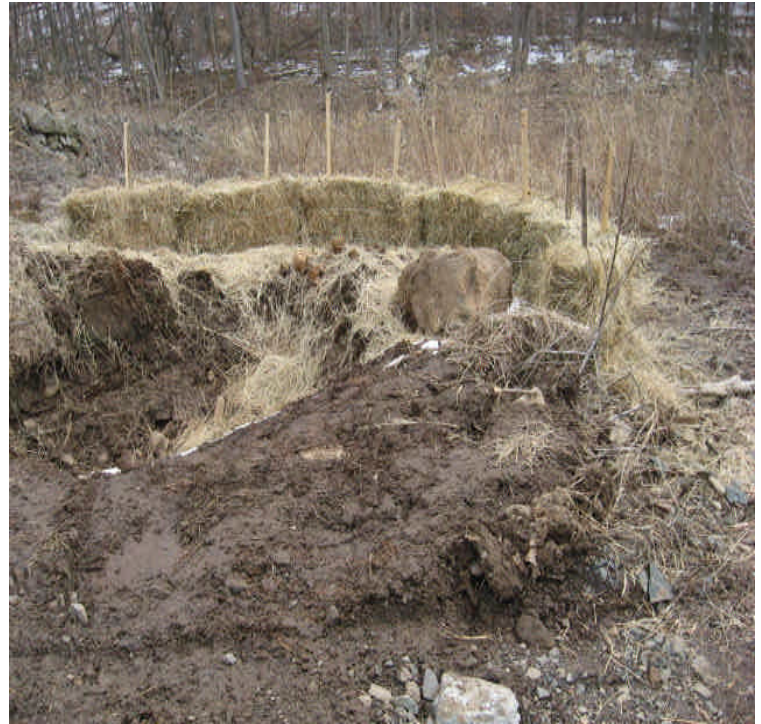
North of Beseck SS: Drainage ditches/water bars and settling basins have been regraded. New haybales were also installed.

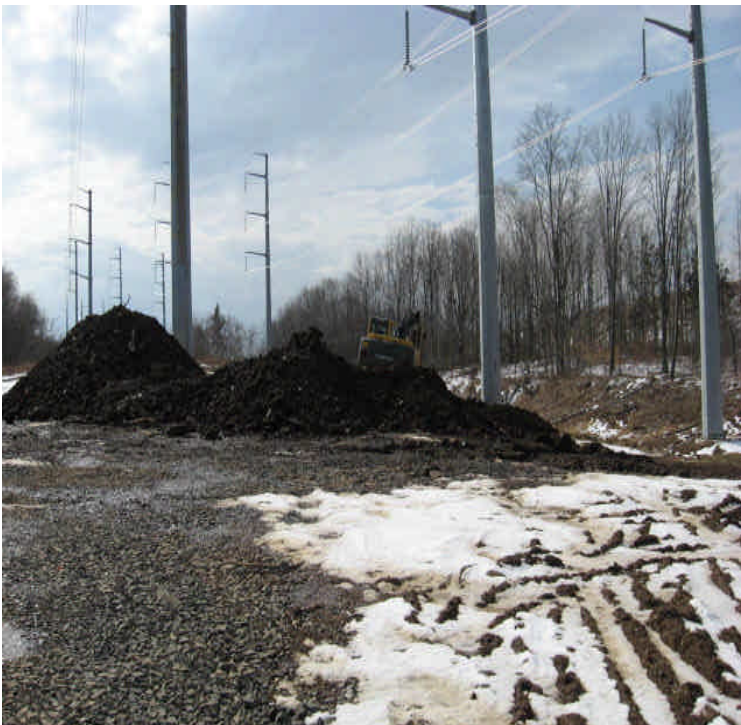
North of E. Meriden SS: Crews were reclaiming pad sites and removing mats and stone from above the second stream channel.

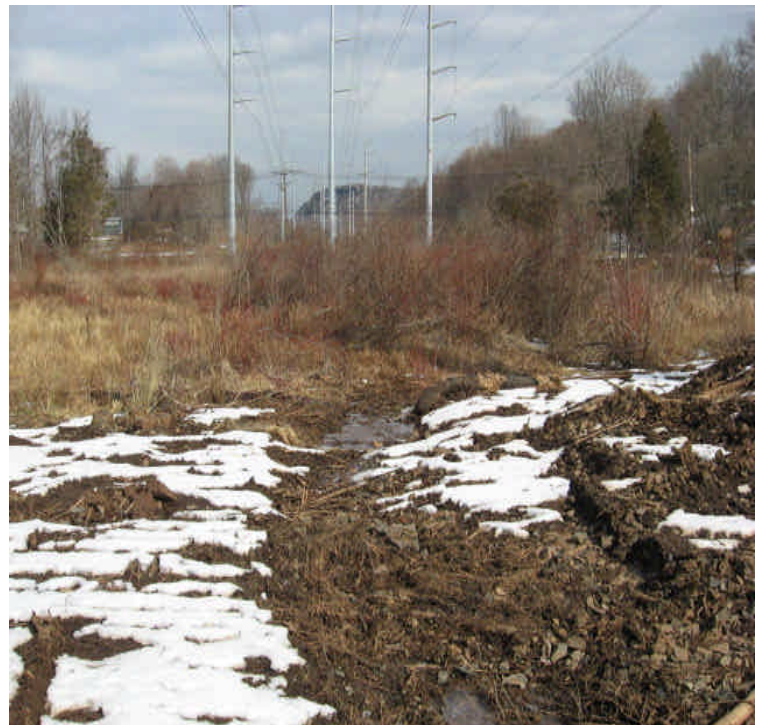
<p>South of High Hill Rd.</p>	<p>Restoration is occurring in the area of the second stream channel which was used for diverting water during the construction of the foundation for #24464 and #24415. Timber mats and sediment were being removed. 3/3/08</p>	<p>Monitor this area closely as the restoration requires increased disturbance and work at the stream. Stabilize this area as soon as possible upon completion of reclamation/restoration. 3/3/08</p>	<p>Restoration in this area is underway.</p>
<p>High Hill Rd. (north to Black Pond)</p>	<p>Timber mats have been removed from the wetlands south of High Hill Rd. near structure #24465. Gaps were noted in the controls/fiber rolls, particularly adjacent to the stream channel as it leaves the pad. Additional controls are needed in these areas. 3/3/08</p>	<p>Monitor the exposed areas for run-off and replace controls at gaps. The contractor plans to perform full restoration in this section shortly. 3/3/08</p>	<p>Timber mats have been removed from wetlands. Controls need attention.</p>

South of High Hill: Timber mats were removed from the wetland. A few gaps in controls were noted and should be repaired at this time. Crews are planning full restoration of areas in a linear fashion in this section.
