Docket No. 272 – Development and Management Plan Inspection

Segment 1a Inspection

Date: March 18, 2008

Location: Segment 1a – Scovill Rock Switching Station to Chestnut Junction, Oxbow Junction to Beseck Switching Station (excluding Royal Oak Bypass), and Black Pond Junction to Beseck Switching Station

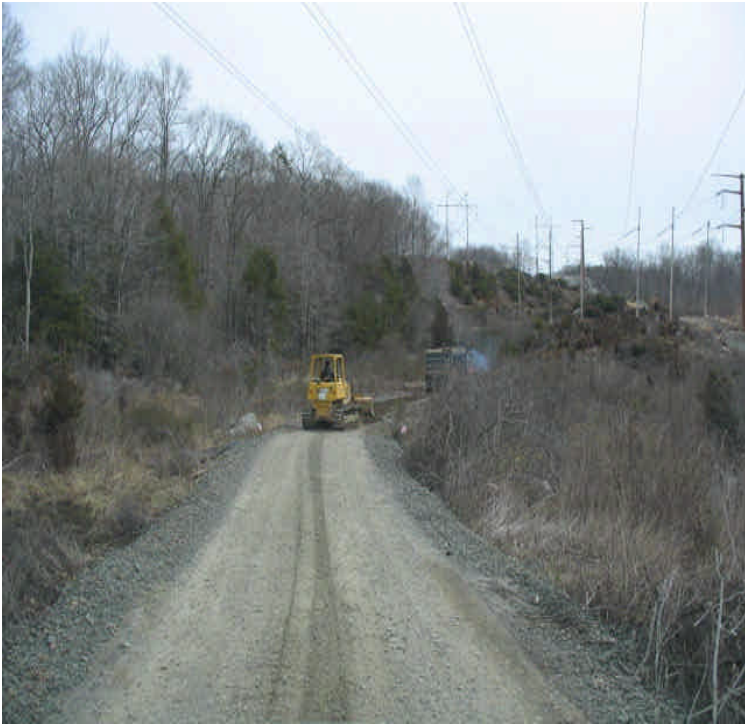
West of Scovill SS: Access road work is underway.

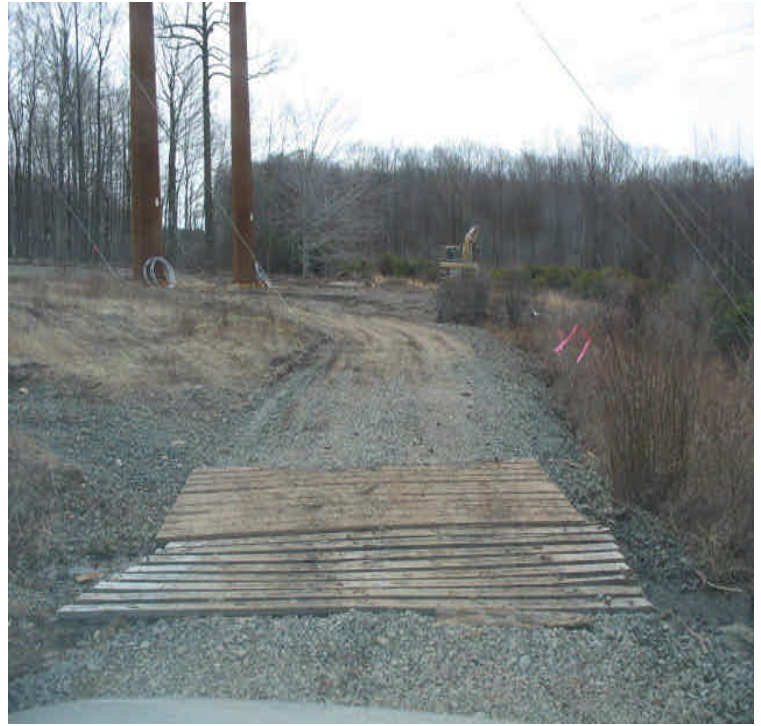
East Mount Rd: Stone and timber mats were added to the access road entrance at the saturated crossing

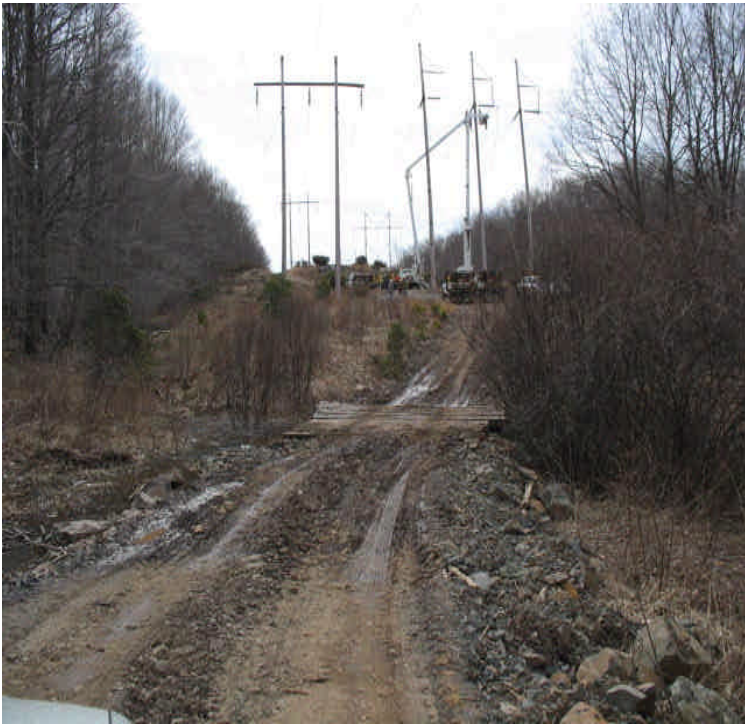
East Mount Rd: The new section of access road noted south of East Mount Rd. extends through a saturated crossing. Timber mats were installed to allow water to flow in its original path across the access.

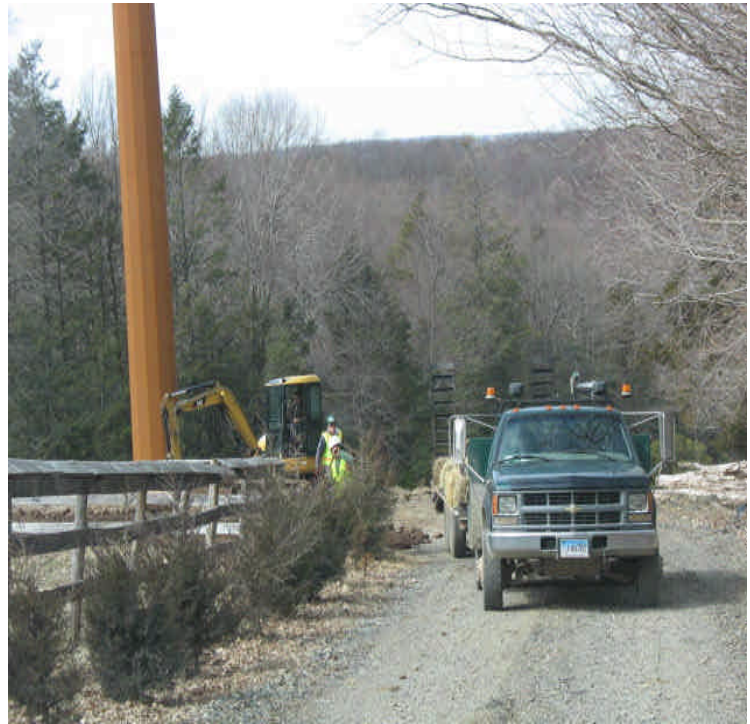
Foot Hills Rd: Crews were reclaiming pads and stabilizing soils.

<p>Foot Hills Rd.</p>	<p>Pad reclamation was underway during the inspection to Johnson Ln. 3/18/08</p>	<p>Stabilize disturbed areas upon completion of work. Catch basin controls should be installed along the roadway. 3/18/08</p>	<p>Needs evaluation. Reclamation underway.</p>
<p>Black Walnut Dr.</p>	<p>Grading and timber mat removal noted on the slope upgradient from Ball Brook. Some areas were mulched. Water bars have been installed to reduce flow down the slope. The slope grade has been reduced, however, the area had a high potential for erosion in the past and may need additional controls at the base of slope. 3/18/08</p>	<p>Monitor this area closely to see that the existing controls are sufficient to prevent erosion. Stabilize exposed slopes as soon as possible. 3/18/08</p>	<p>Water bars were installed and the slope grade was reduced.</p> <p>Monitor closely and provide additional stabilization.</p>

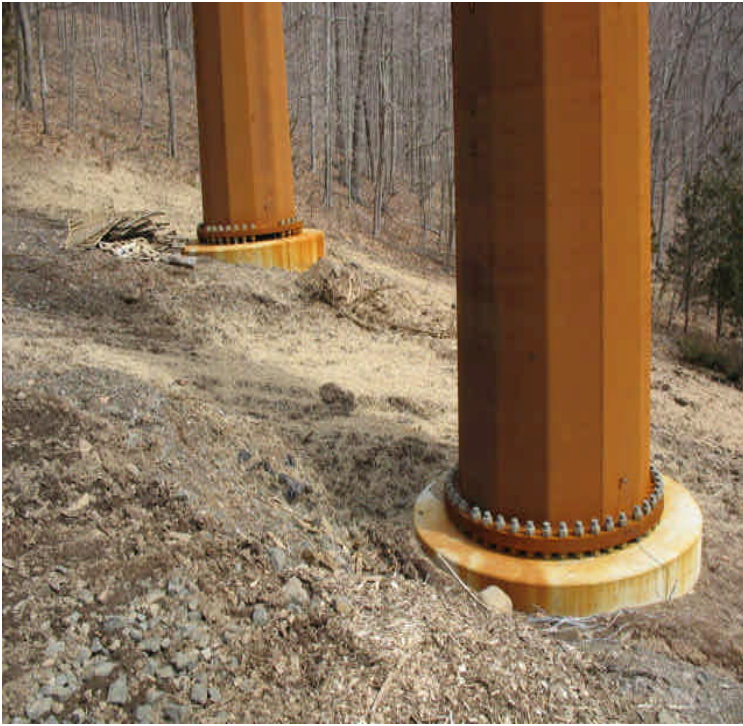
Black Walnut Dr: Reclaiming and regrading were occurring along the slope. Exposed soils were mulched and seeded. Continue to monitor since the slope has high erosion potential.

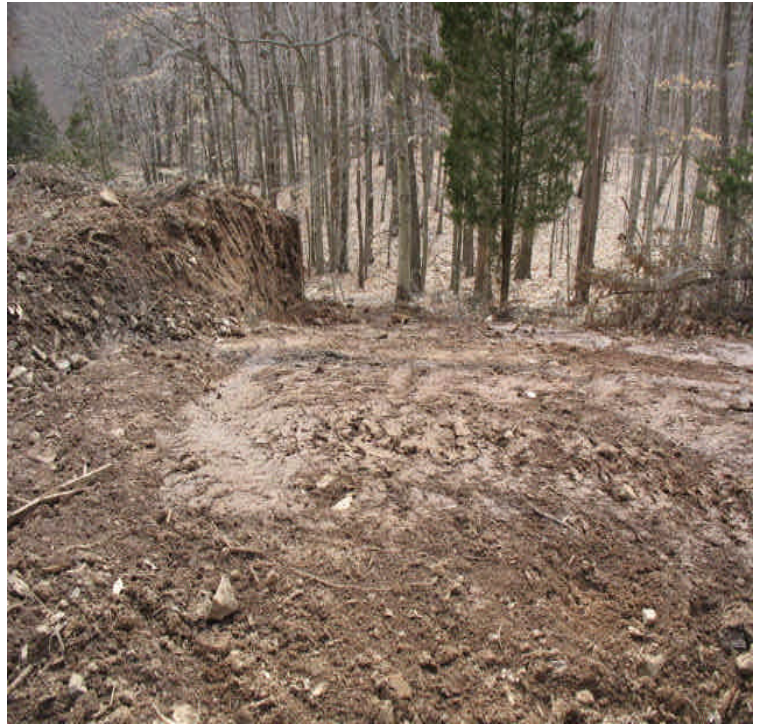
Black Walnut Dr.: Exposed slope from recent reclamation and grading. Crews were reducing the overall grade of the slope during this process. Water bars were installed to divert flow in this area. Additional stabilization is needed upon completion of work.

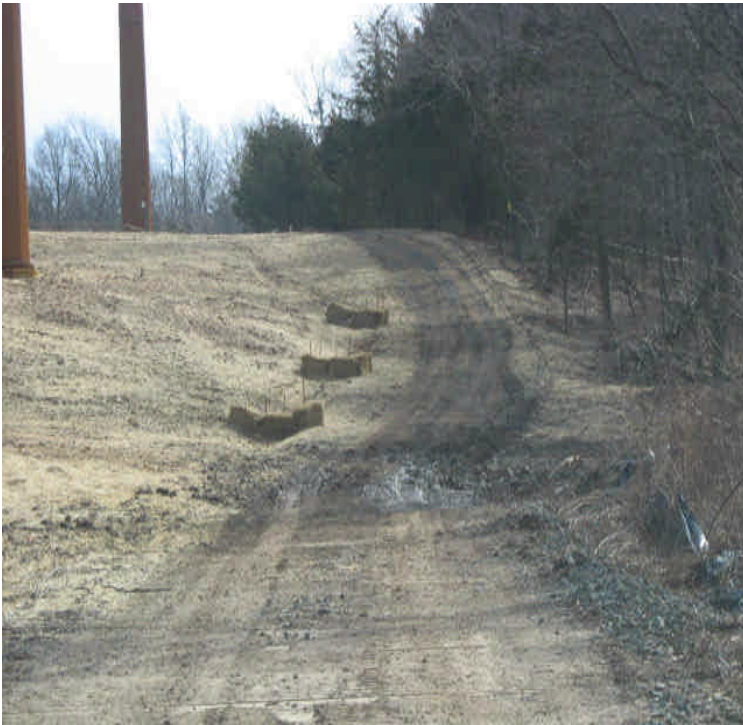
Powder Hill Rd: Reclamation and final grading is complete in some areas. Haybale check dams were added to a drainage ditch to filter and control stormwater.

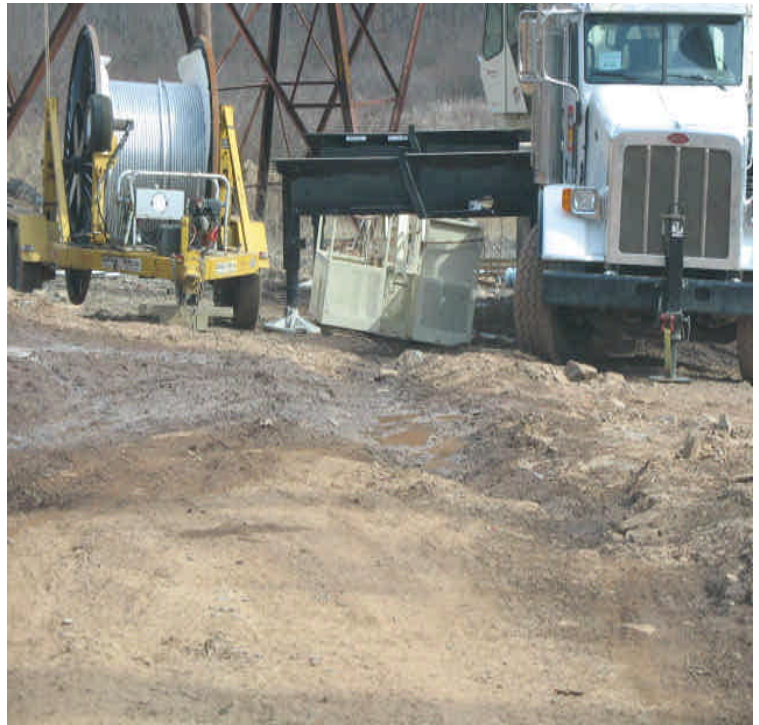
Black Pond Jct: Turbid water from the access roads and slopes are being redirected away from wetlands. Controls along the wetlands have been repaired/reinforced as needed.
