Docket No. 272 – Development and Management Plan Inspection

Segment 1a Inspection

Date: March 31, 2008

Location: Segment 1a – Scovill Rock Switching Station to Chestnut Junction, Oxbow Junction to Beseck Switching Station (excluding Royal Oak Bypass), and Black Pond Junction to Beseck Switching Station

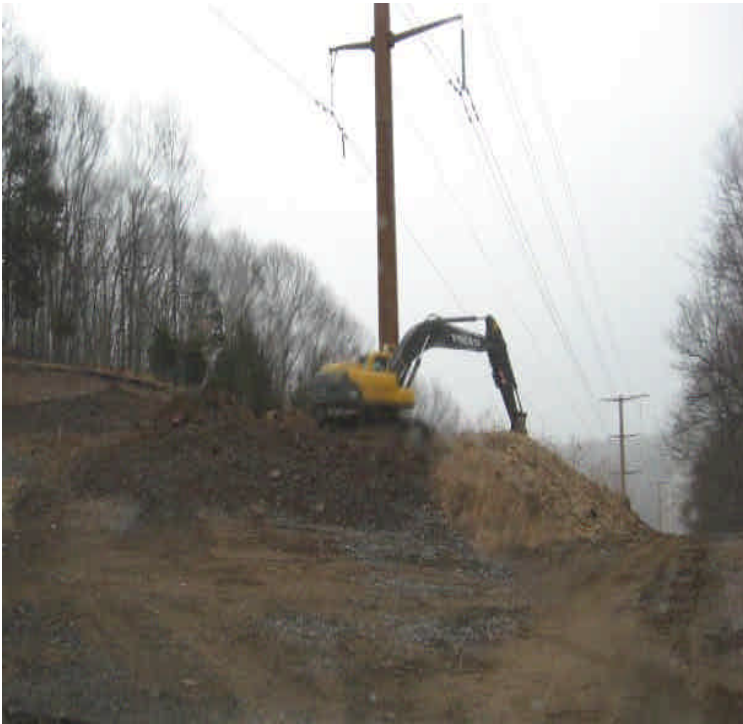
Foundation and site construction Oxbow Junction to Beseck SS Arbutus St.	Crews were reclaiming pads off Arbutus Street. 3/31/08	Add controls and stabilize the area when active work is complete. 3/31/08	Reclamation underway.

Arbutus St: Grading and pad restoration underway.

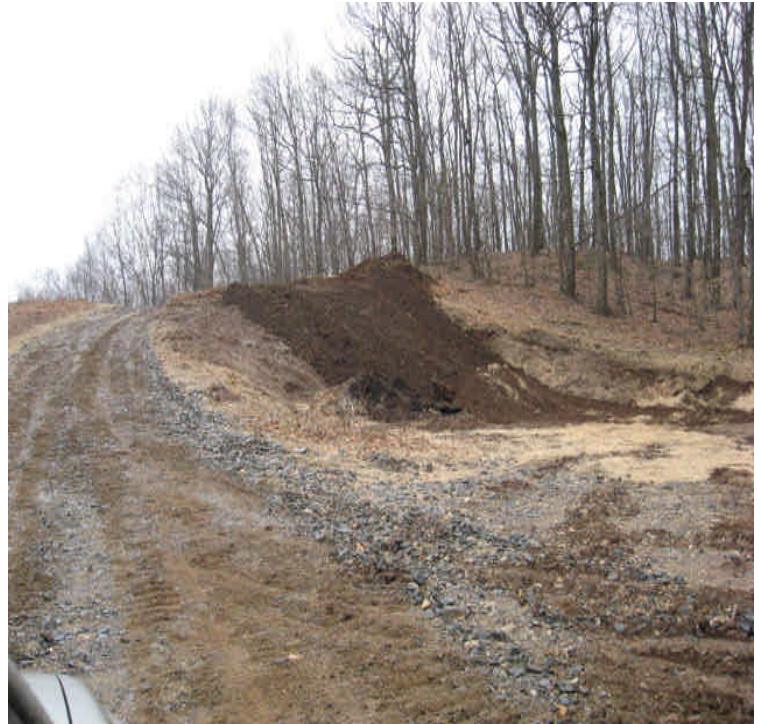
Arbutus St: Another view of the grading and restoration activities.

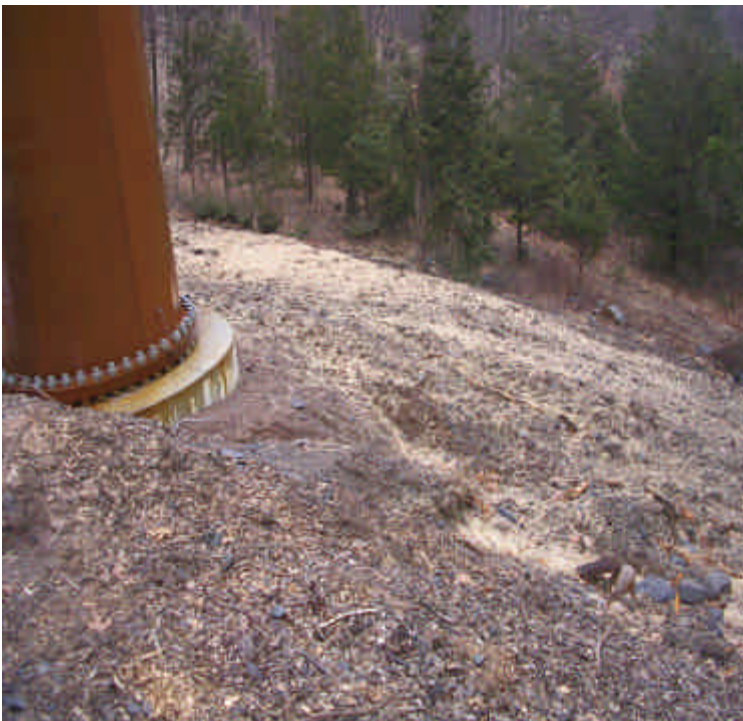
Areas of Inspection	Observation	Recommended Action	Corrected Action
Black Walnut Dr.	Grading and timber mat removal noted on the slope upgradient from Ball Brook. Some areas were mulched. Water bars have been installed to reduce flow down the slope. The slope grade has been reduced, however, the area had a high potential for erosion in the past and may need additional controls at the base of slope. 3/31/08	Monitor this area closely to see that the existing controls are enough to prevent erosion. Consider erosion control mats/blankets if necessary 3/31/08	Monitor closely and provide additional stabilization.
Contractor Receiving Yard and Storage Area	Silt fence and/or fiber rolls remain in good shape around the perimeter of the yard. Turbid run-off from site was not noted at this time. 3/31/08	Continue to add, maintain, and monitor controls as necessary. Consider extending controls at the culverted crossing. 3/31/08	NA

Black Walnut Dr: Final reclamation almost complete upgradient from Ball Brook. Continue to monitor this slope due to high potential for erosion.

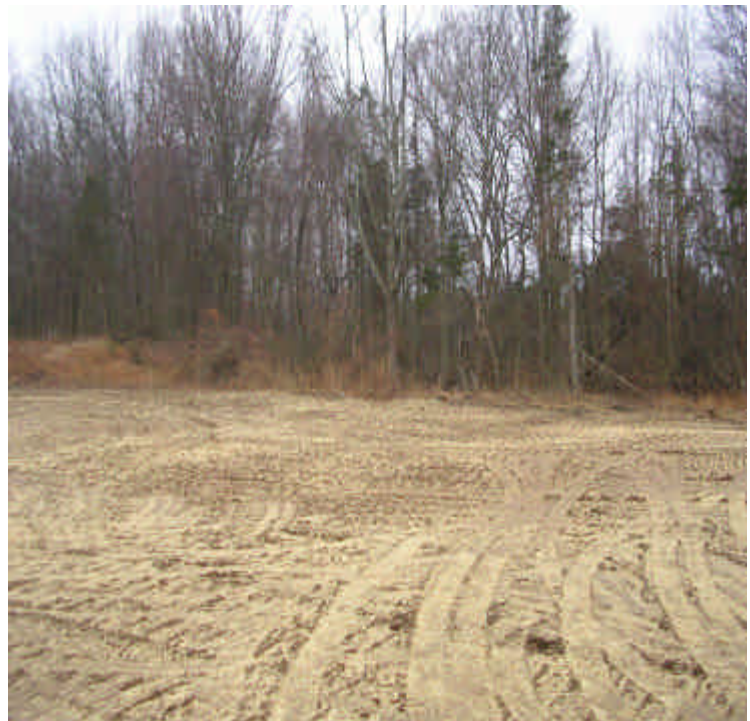
Black Walnut Dr: Several exposed areas continue to be graded, mulched and seeded.

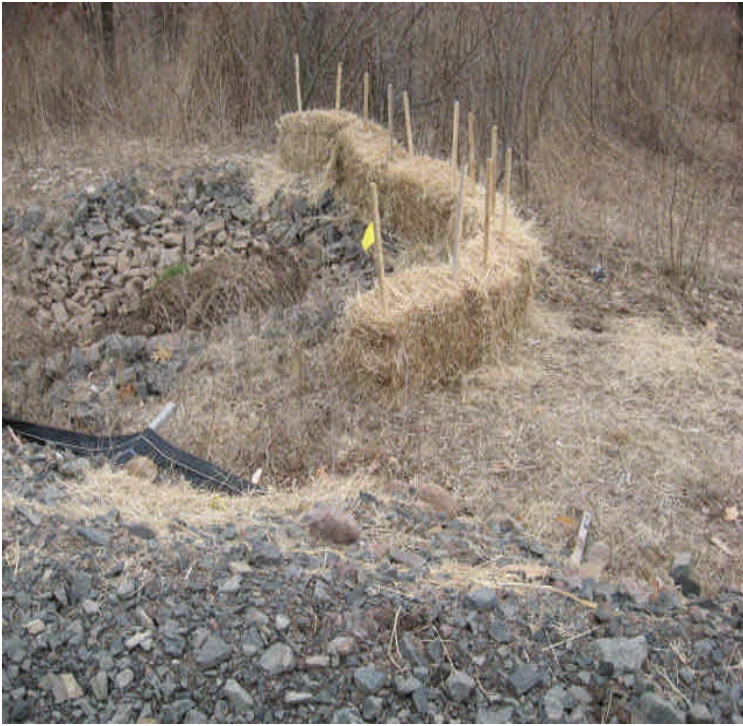
East of Beseck SS	<p>A pad is in place just upgradient from wetlands here. Sediment and stone/soil from the old pad remain in the wetlands. (noted since 10/22) 3/31/08</p> <p>Turbid water is noted in the outlet from the access road (2/5). Haybales were installed around the basin to filter any overflow. Sediment is extremely fine here and no removable amount of accumulation was noted in the wetlands. 3/31/08</p>	<p>Remove any stone/soil accumulation in the wetlands during final restoration of the site. (noted 10/22) Contractors plan to come in with a shaker attachment in this area, removing stone but leaving original soil.</p> <p>Monitor additional controls and continue to improve controls as needed. See erosion control section. Wetlands were evaluated and no accumulation was noted. 3/31/08</p>	<p>Additional attention is needed during restoration.</p> <p>Continue to monitor Wetlands were evaluated and no accumulation was noted</p>

East of BSS: Controls at the outlet appear to be holding up. No turbid water has been observed leaving the basin since the controls were installed. (However, recent rain events have not been significant).

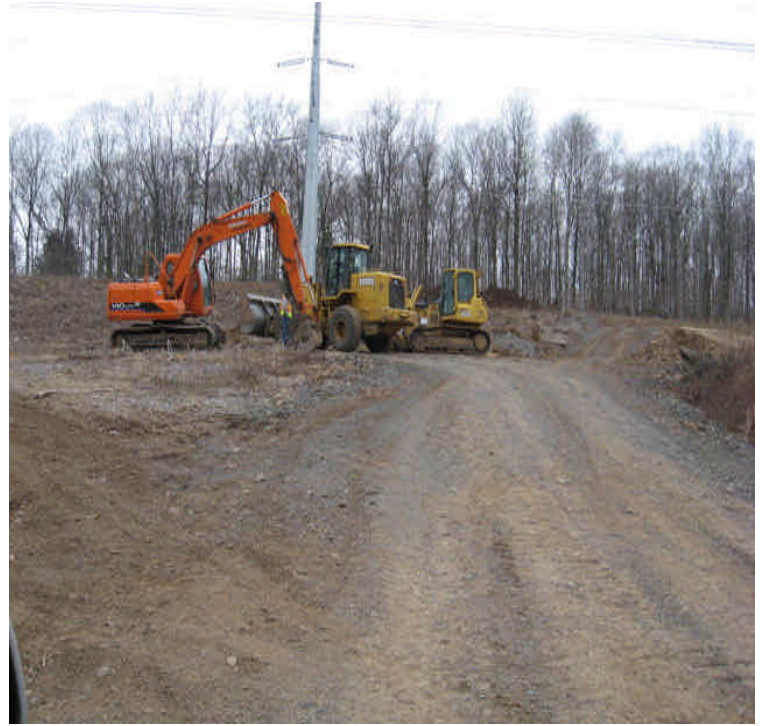
North of BSS: Reclamation continues moving north from BSS.

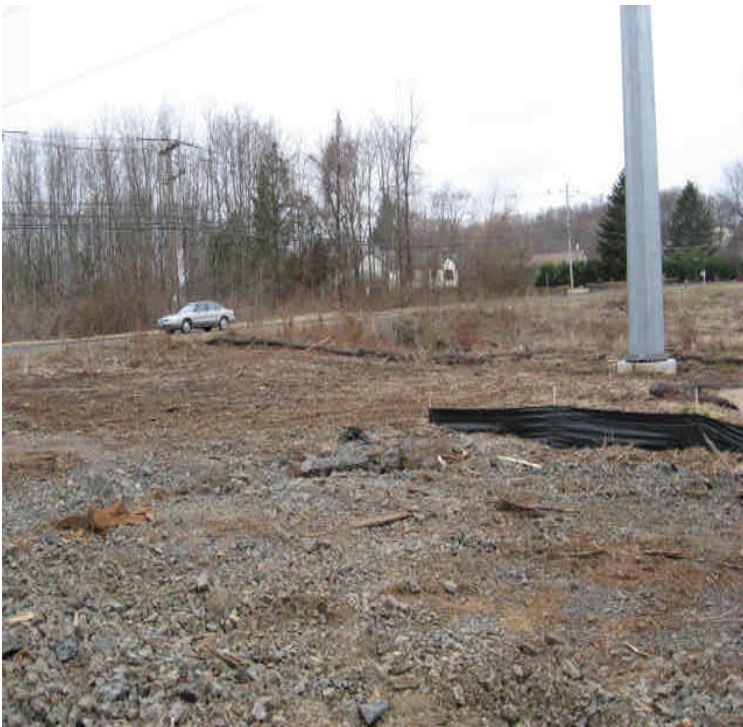
North of High Hill Rd: Reclamation and final grading is still needed in some areas. Final restoration will continue from BSS north.

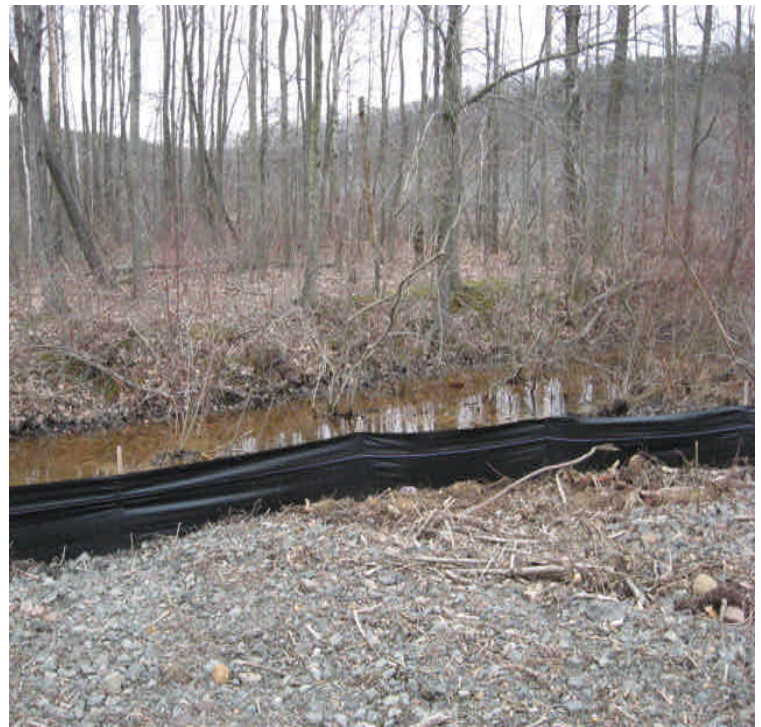
South of E. Main St: Adjacent stream is clear and controls remain in place at a pad waiting for reclamation.
