Docket No. 272 – Development and Management Plan Inspection

Segment 1a Inspection

Date: April 14, 2008

Location: Segment 1a – Scovill Rock Switching Station to Chestnut Junction, Oxbow Junction to Beseck Switching Station (excluding Royal Oak Bypass), and Black Pond Junction to Beseck Switching Station

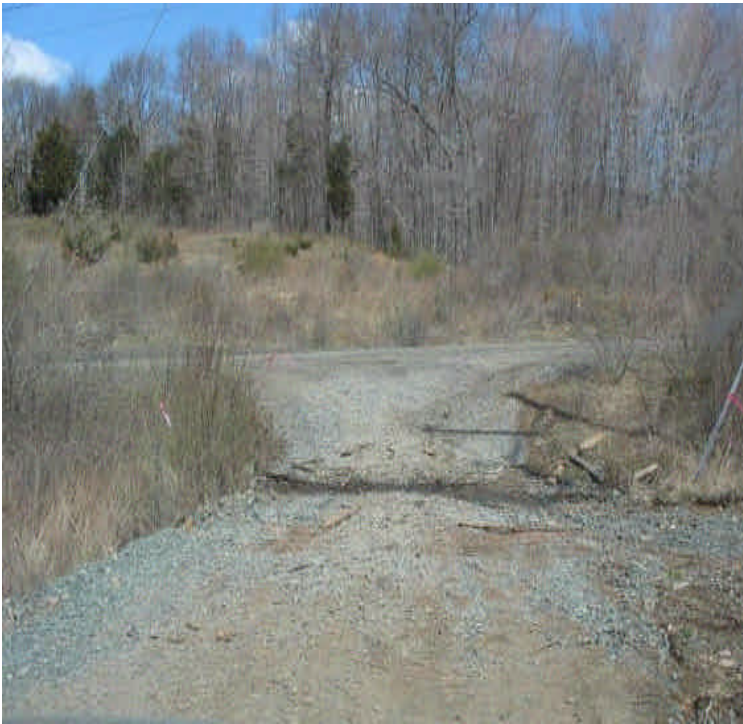
Timber mats were removed from the saturated crossing at the entrance off E. Mount Rd. However, timber mats at the second crossing remain. Some sediment was noted within the wetlands in the portion of the ROW that leads to Oxbow Jct. 4/4-4/14/08	Monitor controls for effectiveness and add/fix controls as needed. It appears access will still be needed; Timber mats will have to be restored to the first crossing. Remove any sediment that has accumulated more than 2”, by hand, from the wetlands as	Needs evaluation and sediment should be removed from the wetland as needed.

E. Mount Rd: Timber mats were removed from the wetland crossing at the E. Mount entrance. However, future access still appears to be needed and the crossing will need to be replaced.

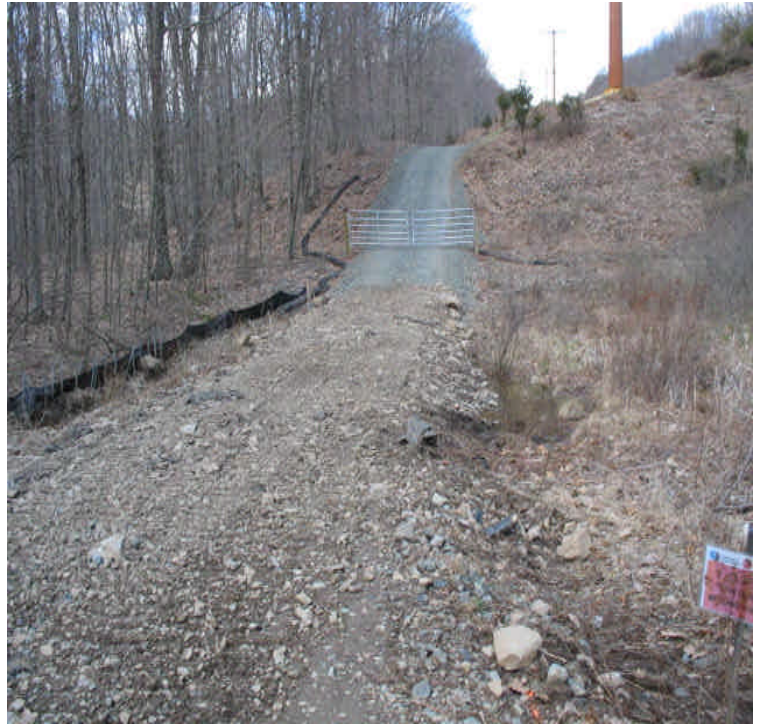
<p>Johnson Ln. to Arbutus St.</p>	<p>Timber mats and culvert were removed from this area and permanent (permitted) stone fill access roads were installed. However, the stone bisects the wetland crossing, interrupting flow/hydrology. 4/14/08</p>	<p>Continue to restore and stabilize. Add a culvert to wetland crossing to maintain the hydrologic connection. Or alternatively, bring down the grade of the road. 4/14/08</p>	<p>Needs attention/evaluation.</p>
<p>Black Walnut Dr.</p>	<p>Grading and timber mat removal noted on the slope upgradient from Ball Brook. Some areas were mulched. Water bars have been installed to reduce flow down the slope. The slope grade has been reduced.</p>	<p>Monitor this area closely to see that the existing controls are enough to prevent erosion. Consider erosion control mats/blankets if necessary. One section of slope upgradient of Ball</p>	<p>Monitor closely and provide additional stabilization. One area still needs attention.</p>

<p>Oxbow Junction to Beseck SS Johnson Ln., Arbutus St.</p>	<p>Timber mats/culvert were removed from the crossing off Johnson and replaced with permitted stone road. However this bisects the wetland and hydrology. 4/14/08</p>	<p>Install the culvert to restore the hydrologic connection within the wetland. See erosion control and access road sections. 4/14/08</p>	<p>Needs evaluation and attention</p>
<p>Durham Rd.</p>	<p>Sediment migration/accumulation and flooding was noted over the stone road and pad. More controls may be needed here. 10/9-4/14/08</p> <p>BSC was informed that ACOE is allowing this road to remain at or within 2" of the adjacent grade so that sheet flow can occur. The road will also be narrowed. 4/7-4/14/08</p>	<p>When restoration occurs, the road base will remain at grade (for structure access). Remove the appropriate amount of stone and narrow the road to the extent feasible (This will likely be 15 feet based on NU's needs). 4/7-4/14/08</p>	<p>NA until restoration. Continue to monitor.</p>

Johnson Ln: Timber mats and culvert were removed from the wetland crossing. A new permanent stone access road was installed, effectively bisecting the wetland and blocking hydrology. A culvert should be added.

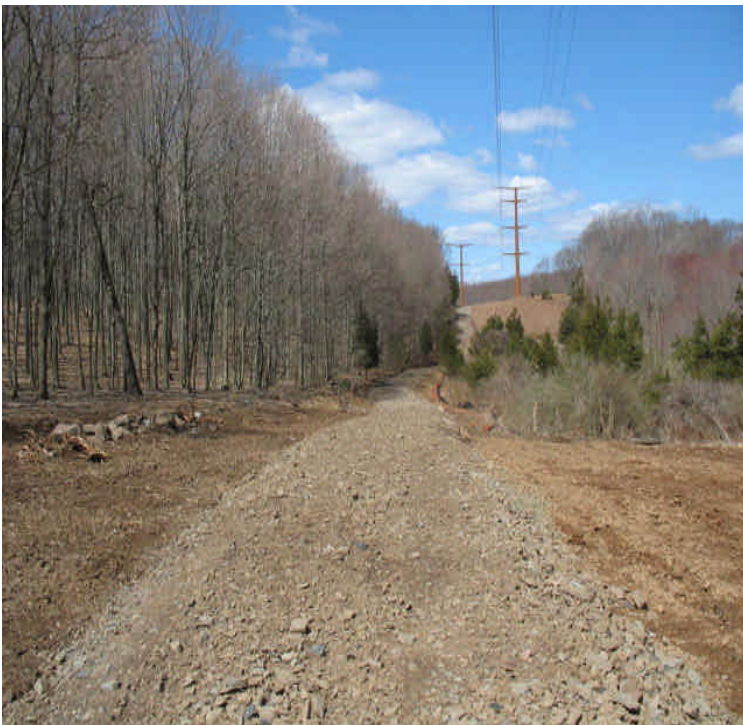
Arbutus St: Timber mats were removed and a new permitted stone access road was installed at the edge of the wetlands. Stabilize exposed soil as needed.

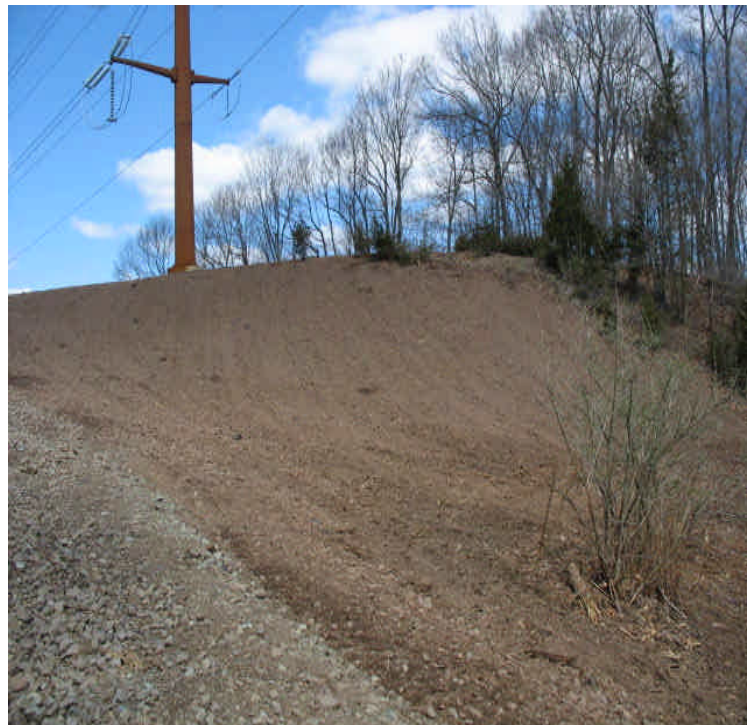
Arbutus St: Restoration almost complete west off the roadway. Final grading is complete, however hay/seed and controls are needed until the area is stable.

Areas of Inspection	Observation	Recommended Action	Corrected Action
<p>Little Lane; Durham Rd (Golf course) Black Walnut Dr; Valley View Dr.; Rte 157; ROW North of Besock SS to Black Pond</p> <p>Remaining work areas</p>	<p>during heavy rains. Most disturbed soil areas have been mulched and seeded as needed. Grass cover and revegetation noted in many areas. 4/14/08</p> <p>Contractors continue final grading and temporary stabilization measures as site work is completed in several areas. 4/14/08</p>	<p>Grass seed has started to germinate now do to warmer weather.</p> <p>The D&M states that areas should be temporarily stabilized if work will not return in 21 days. It is BSC's interpretation that silt fence/ haybales/ fiber rolls alone are not sufficient in most situations. 4/14/08</p>	<p>Reclamation is occurring. Continue to stabilize within timelines provided</p>
<p>Arbutus St.</p>	<p>Restoration is almost complete in this area. Additional hay/seed is needed on one slope. Controls may be needed until the area is stable. 3/31-4/14/08 Additional hay/seed is needed on one slope. 4/14/08</p>	<p>Add controls as needed. Apply hay/seed on the exposed slope west of Arbutus. 4/14/08</p>	<p>Hay/seed needed on a exposed slope</p>

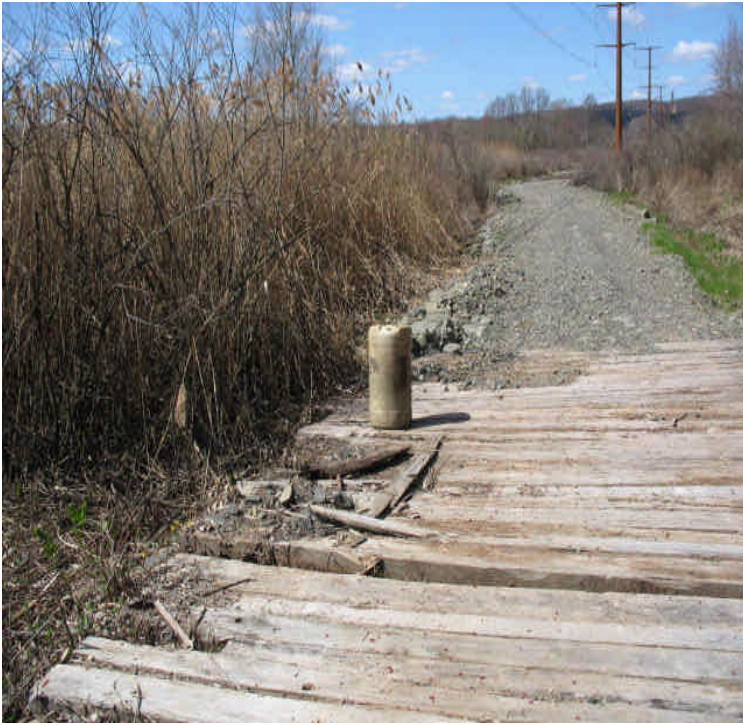
Durham Rd: It appears a non-project related container was dumped on the mats at the edge of the wetland. The container was ½ filled with a liquid that appears to be oil.

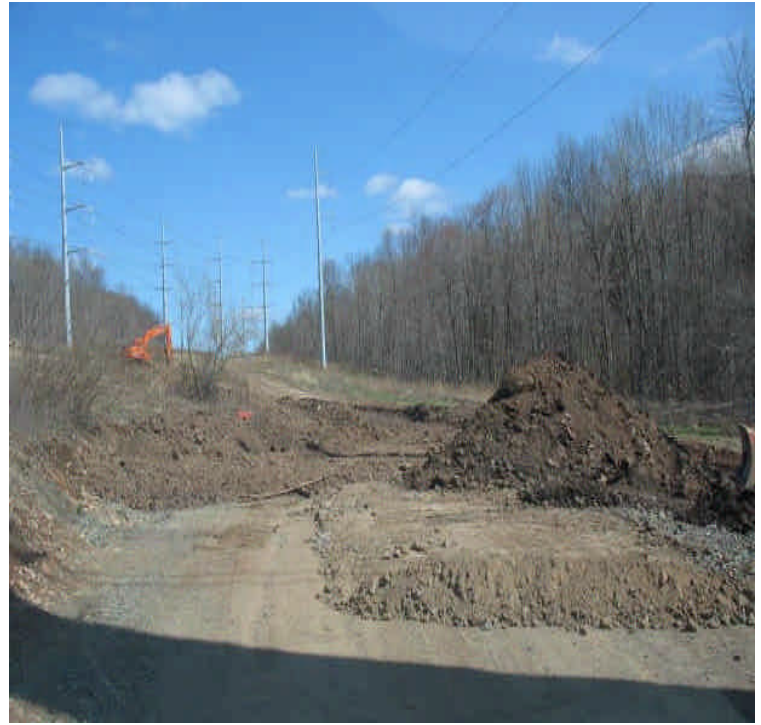
<p>North of BSS (to #24455)</p>	<p>Restoration is almost complete. All but one pad site have been reclaimed and exposed areas have been mulched/seeded. Access road reclamation was underway. 4/14/08</p>	<p>Continue to stabilize areas as applicable. Monitor exposed soils until full vegetative cover can establish. 4/14/08</p>	<p>Reclamation is almost complete.</p>
<p>North of High Hill Rd. South of East Main St.</p>	<p>In the vicinity of East Meriden SS, several washouts/rills have formed in a steep slope of a pad that had previously been mulched. 1/7-4/14/08 The controls had been replaced but the gullies had not been addressed. 2/25-4/14/08</p> <p>The area at E. Meriden SS. near #24464 is restored well and will likely be successful during the growing season. Good preservation of woody species was noted in</p>	<p>Regrade washouts and stabilize slopes as needed. Additional controls are needed to slow and filter stormwater. See erosion control section as well. 2/25-4/14/08 A more permanent solution was approved here. 3/31-4/14/08</p> <p>Ensure complete coverage with controls, return for final stabilization and monitor for vegetative growth. Attend to the remaining areas within the approved timelines. Ensure there is temporary</p>	<p>Erosion needs attention</p> <p><i>Contractors were give approval for a more permanent solution here</i></p> <p>Additional stabilization is needed. Restoration is being proposed in a linear fashion.</p>

North of Beseck SS: Final grading and access road work is underway. Stabilize exposed areas as needed and monitor the area.

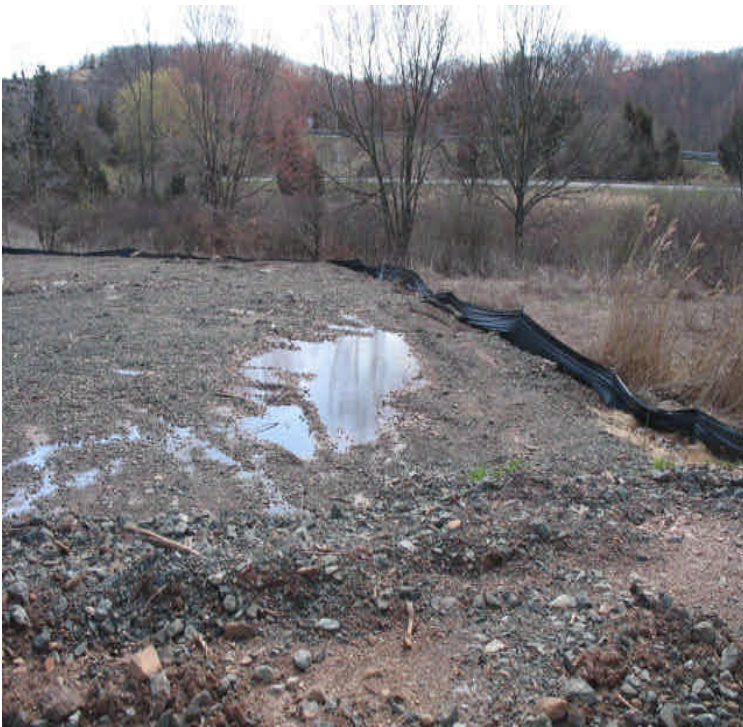
North of E. Main St: Controls are still in place along the wetlands and The new drainage channel is working well. These areas are waiting for reclamation.

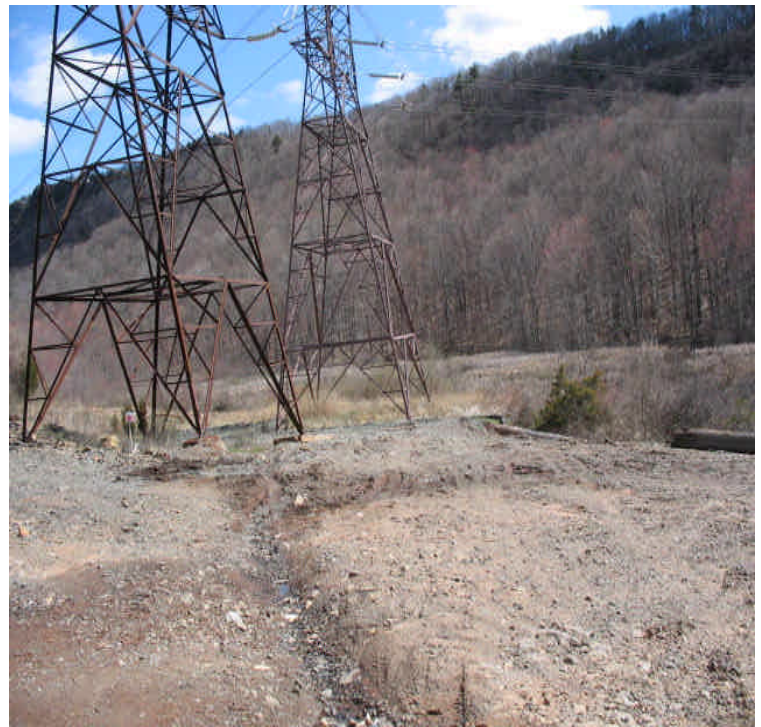
Black Pond Jct: Drainage channels and repaired controls appear to be working well. Stabilize/reclaim this area as soon as possible.
