Docket No. 272 – Development and Management Plan Inspection

Segment 1a Inspection

Date: April 21, 2008

Location: Segment 1a – Scovill Rock Switching Station to Chestnut Junction, Oxbow Junction to Beseck Switching Station (excluding Royal Oak Bypass), and Black Pond Junction to Beseck Switching Station

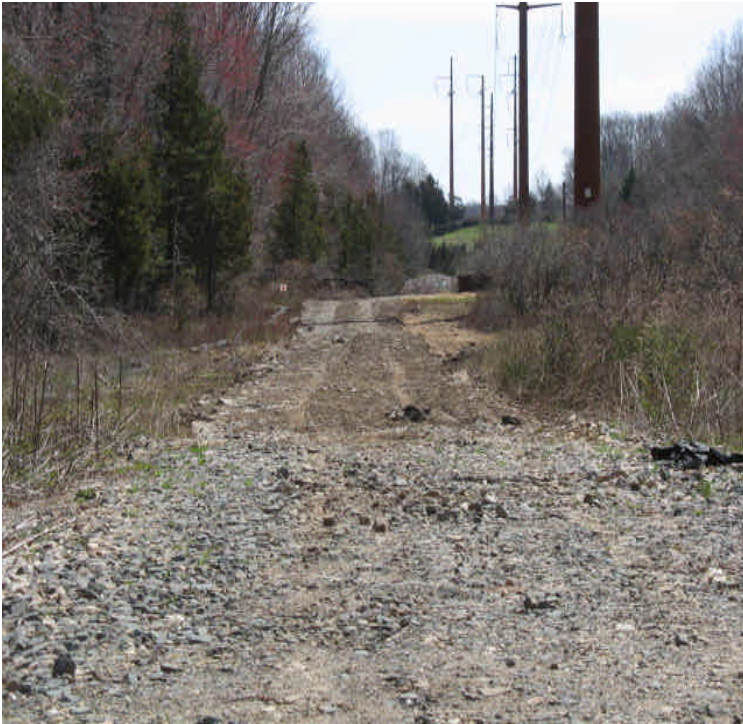
Haddam Quarter Rd: Timber mats were removed from the wetland crossing. Stone and soil were installed for the permanent access road. Consider installing culverts in this area to avoid altering wetland hydrology.

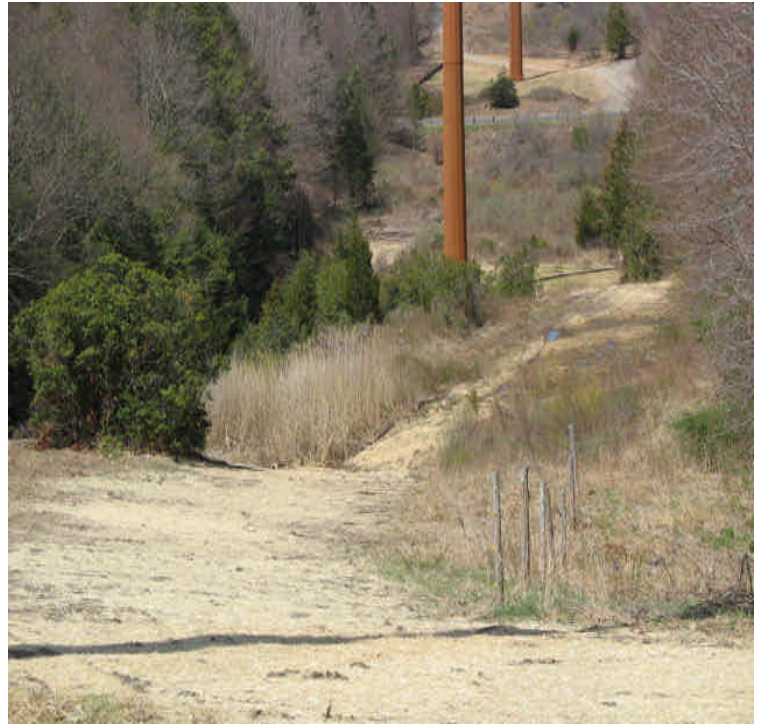
Foot Hills Rd: Timber mats and access road were removed within the ROW and wetlands and the areas were reclaimed. Mulch and seed were applied.

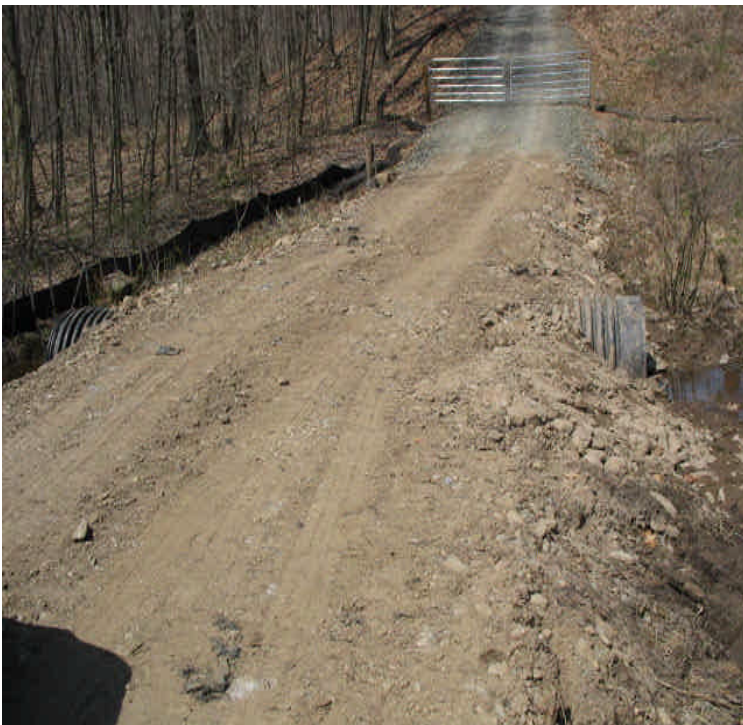
Johnson Ln: A new culvert was installed at the stone wetland crossing to maintain the hydrological connection within the wetland.

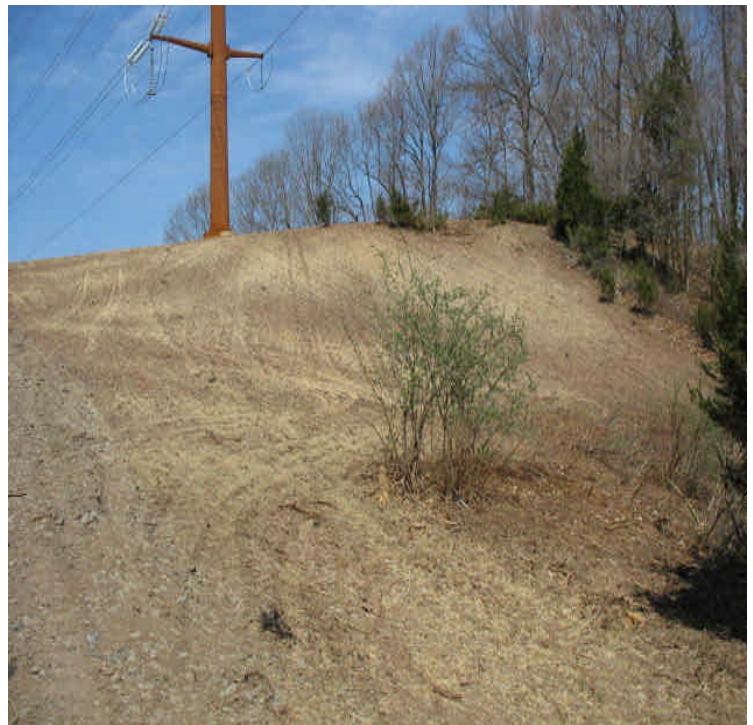
Arbutus St: Restoration and final grading complete west off Arbutus St. Hay/seed have been applied at the last disturbed slope. Add controls along the slope as needed.

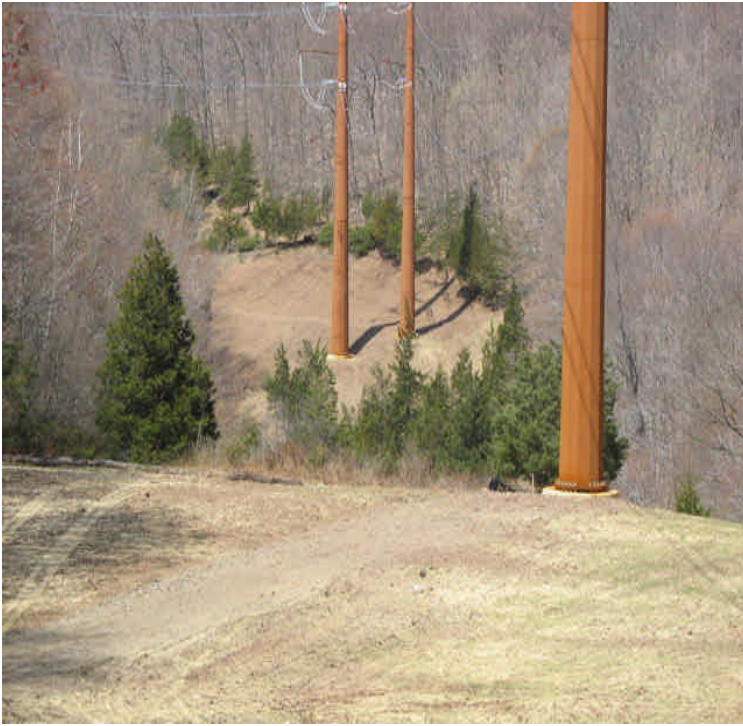
Arbutus St to Black Walnut Dr: Final mulch and seeding complete at Arbutus. However, additional mulch and seed needed on exposed slope off Black Walnut.

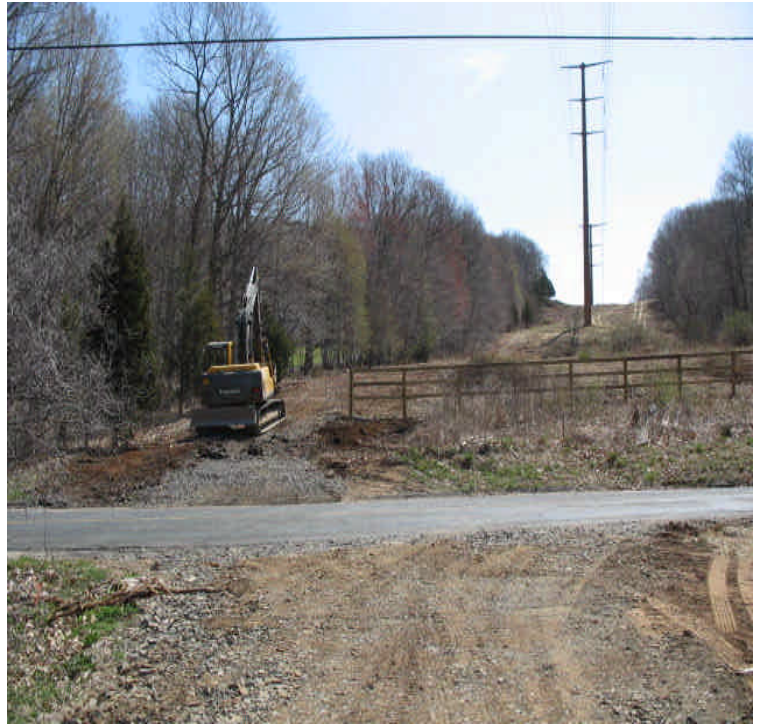
Arbutus East: Final grading and access road work is underway. Stabilize the exposed areas as needed and continue to monitor.

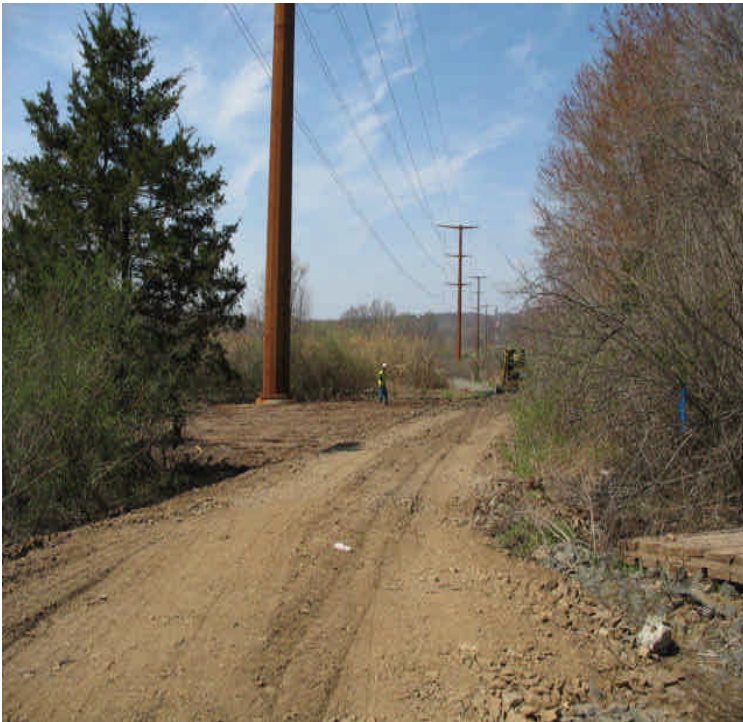
Durham Rd: Timber mats have been removed and contractor is working on the access road.

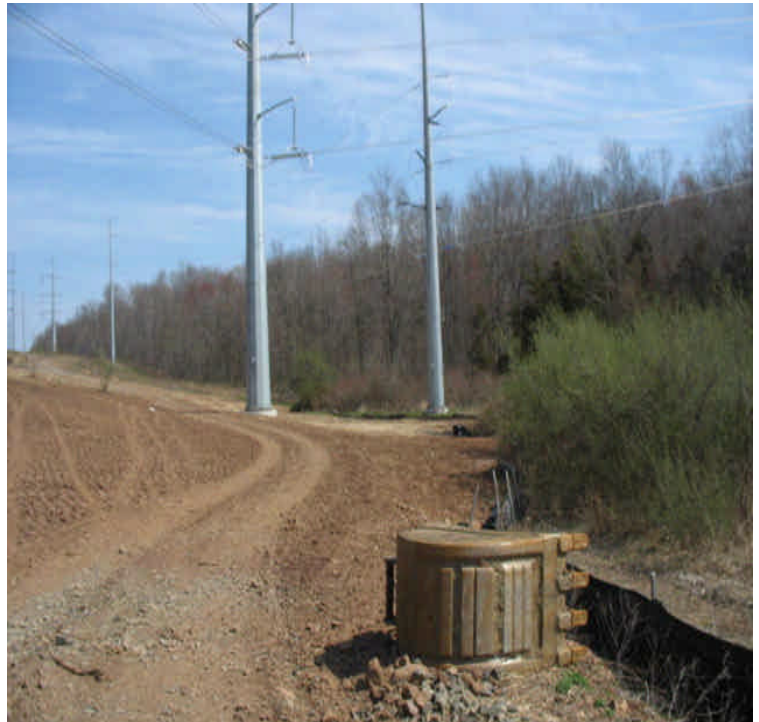
Beseck SS North: Final restoration and access road removal complete from BSS north. Monitor for final stabilization through vegetative cover Access road and final restoration still needed east of BSS.
