**Docket No. 272 – Development and Management Plan Inspection**

**The Connecticut Light and Power Company Certificate of Environmental Compatibility and Public Need for the construction of a new 345-kV electric transmission line and associated facilities between Scovill Rock Switching Station in Middletown and Norwalk Substation in Norwalk, Connecticut, including reconstruction of portions of existing 115-kV and 345-kV electric transmission line, the construction of Beseck Switching Station in Wallingford, East Devon Substation in Milford, (and Singer Substation in Bridgeport), modifications at Scovill Rock Switching Station and Norwalk Substation, and the reconfiguration of certain interconnections.**

**Segment 1a Inspection**

**Date:** May 5, 2008

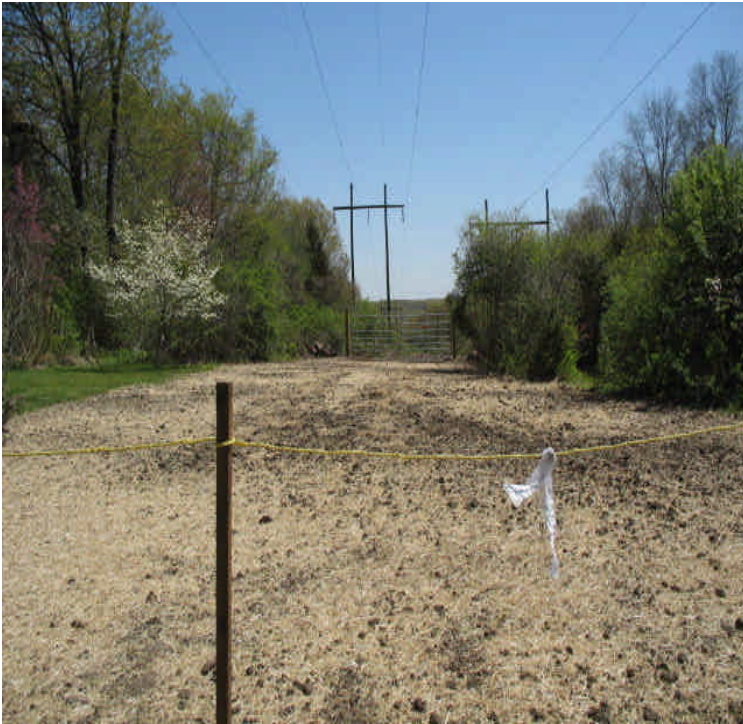
**Black Walnut Dr.: Final reclamation is complete at the site entrance. Soils have been seeded and mulched.**

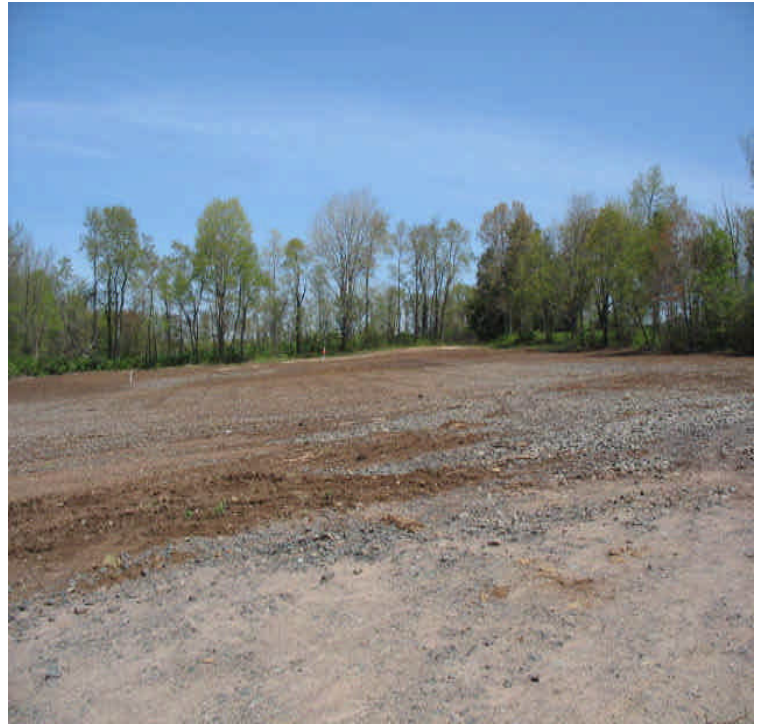
**Contractor Yard: Final grading is complete within the field. Measures (mulch/seed) should be applied for stabilization but coordination may be needed with the landowner.**

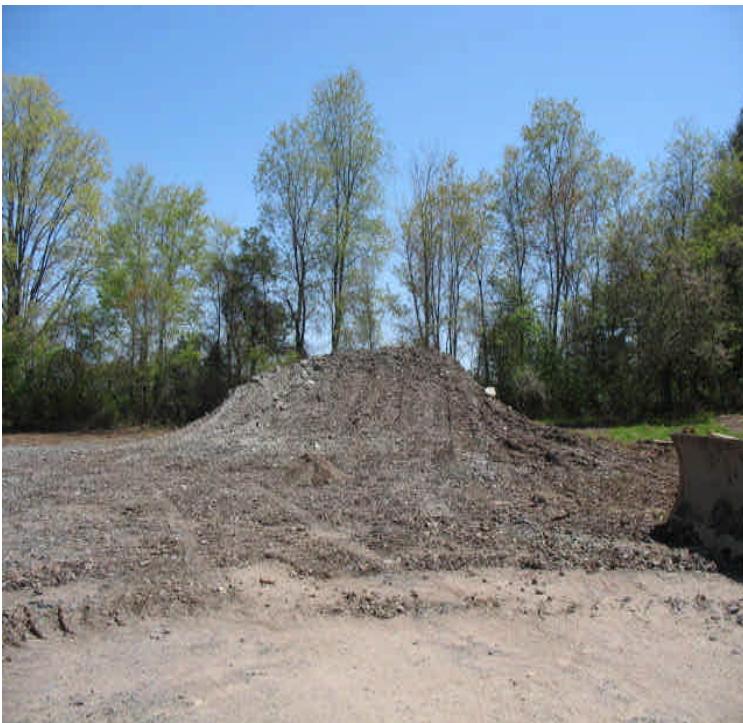
**Contractor Yard: Stone and soil stockpiles from Black Walnut Dr. were stockpiled at the edge of the field staging area. Controls or removal are needed.**

<p>South of Contractor Yard Along Rte. 17 and Little Lane</p>	<p>Crews are stockpiling soils from Black Walnut Dr. here and controls will be needed. 4/29-5/5/08</p> <p>Hay/seed remain over exposed surfaces. 5/5/08</p>	<p>Add controls around the stockpiles or remove in accordance with the D&amp;M plan. 4/29-5/5/08</p> <p>Monitor stabilization measures and controls until the area is stable with vegetative cover. 5/5/08</p>	<p>Stockpiles need attention.</p> <p>Reclamation measures complete.</p>

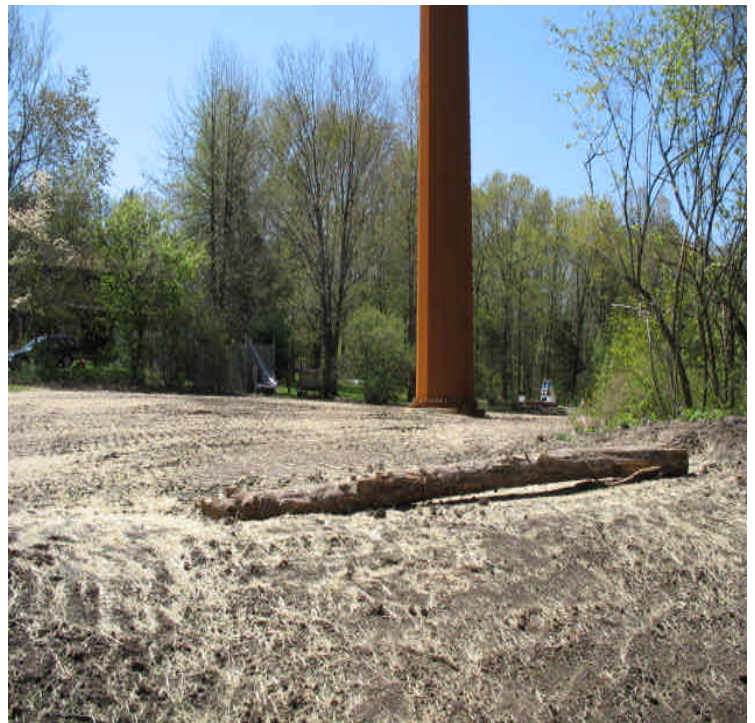
**Little Lane: Final grading and stabilization are complete.**

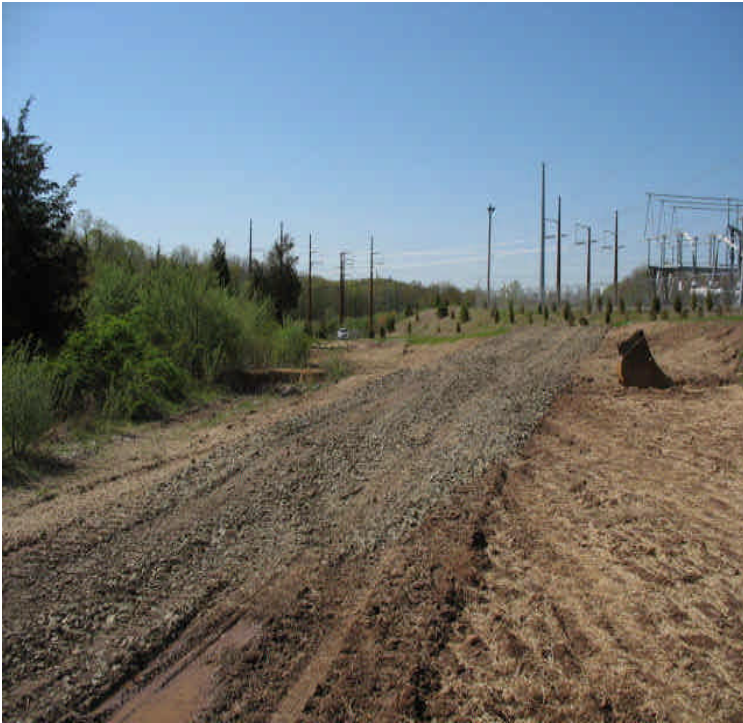
**Beseck SS: Old ROW access road has been removed and reclaimed. Access to the ROW was now connected to the BSS eastern access.**

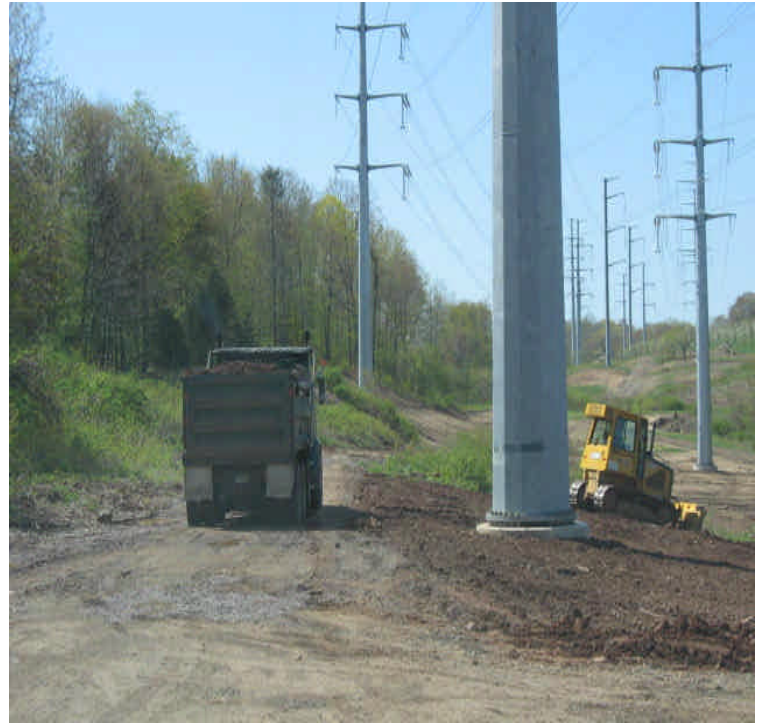
**E. Meriden SS (south): Final grading and soil/stone removal is underway.**

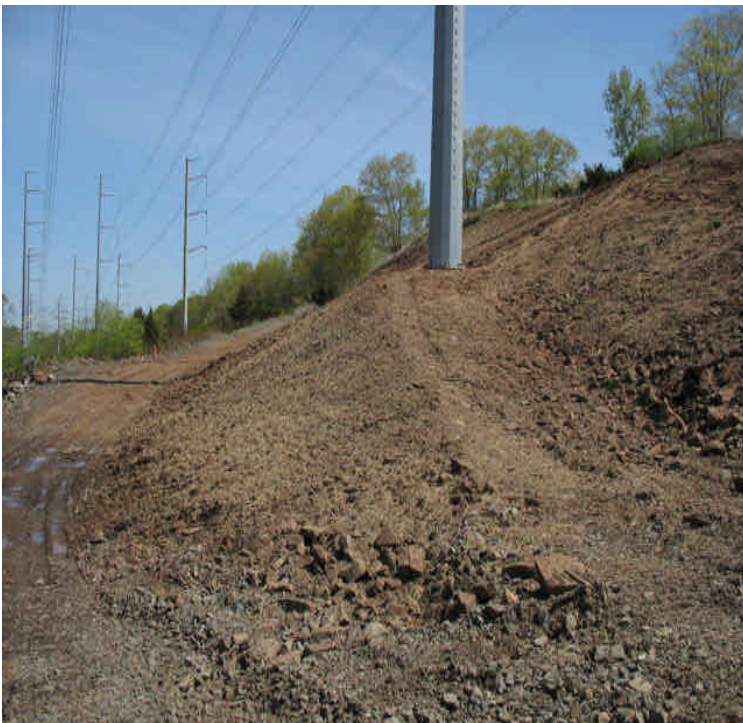
**E. Meriden SS (west): Final grading was completed and seed and mulch have been applied at structure #24462. New grading should help minimize erosion issues.**

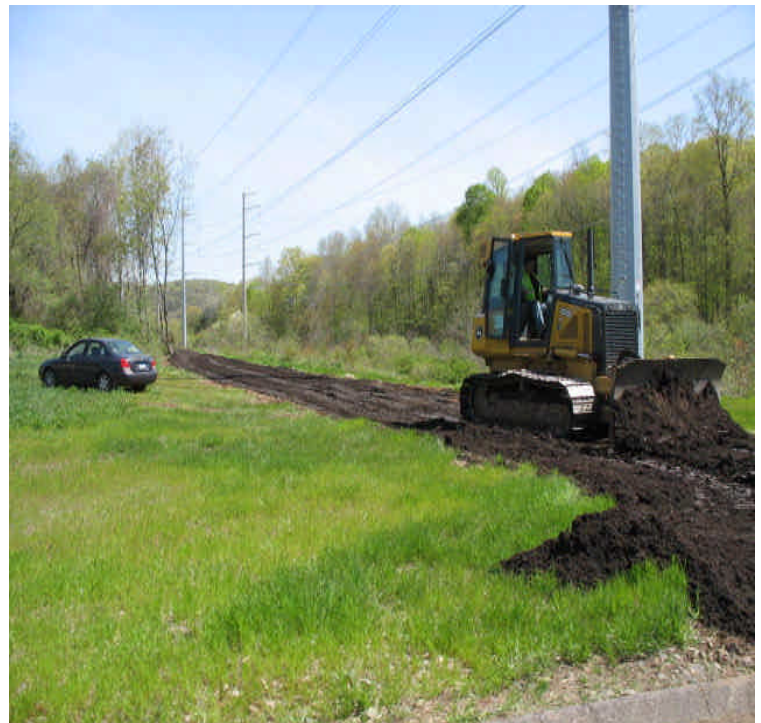
**High Hill Rd: Final grading and topsoil application was underway at the western access north of High Hill.**
