Docket No. 272 – Development and Management Plan Inspection

Segment 1a Inspection

Date: May 19, 2008

Location: Segment 1a – Scovill Rock Switching Station to Chestnut Junction, Oxbow Junction to Beseck Switching Station (excluding Royal Oak Bypass), and Black Pond Junction to Beseck Switching Station

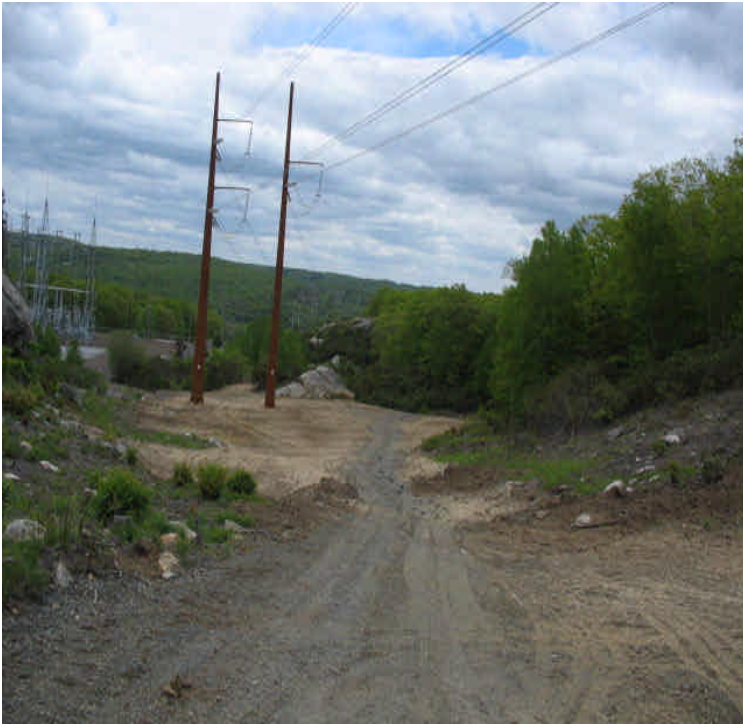
West of Scovill SS: Final grading and reclamation underway.

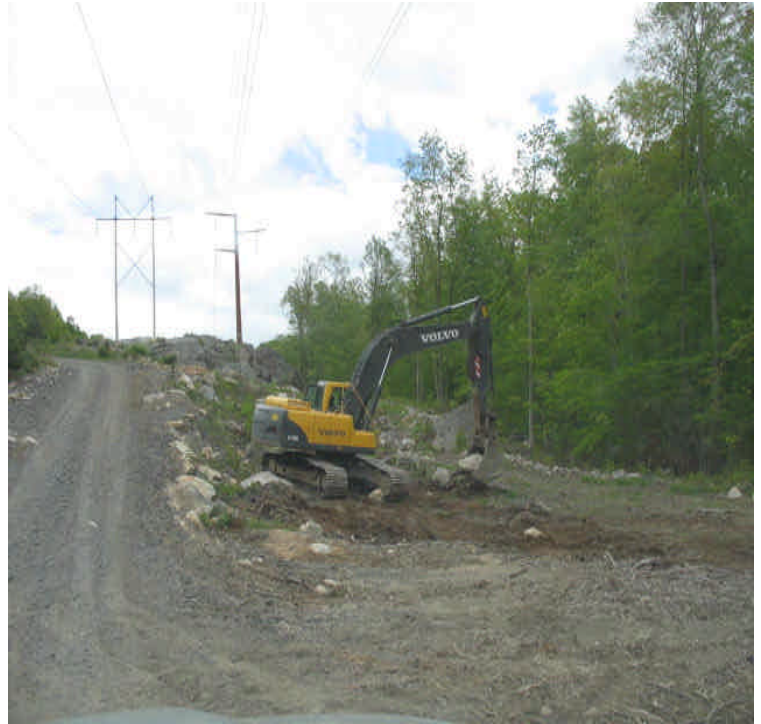
West of Scovill: Final grading and stabilization measures underway. Crews were replacing a section of stonewall.

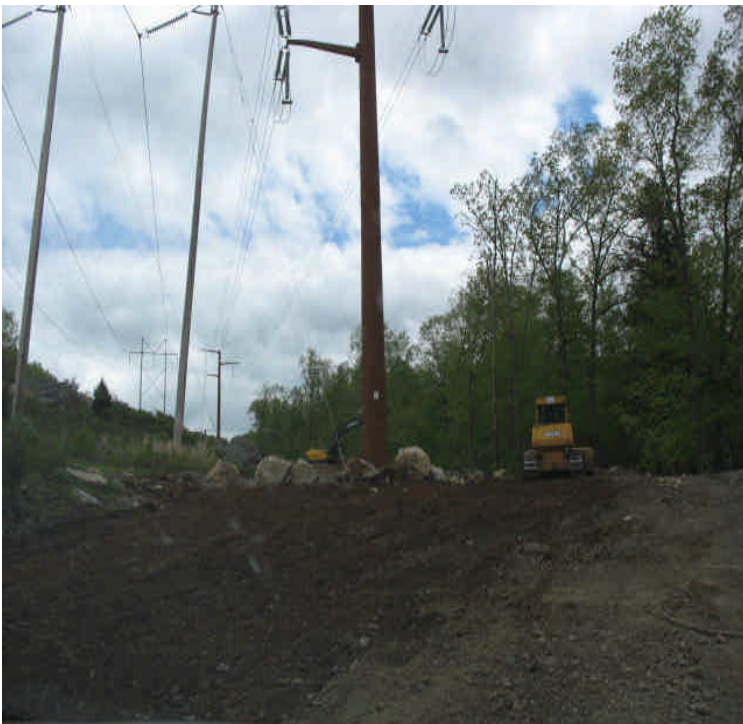
West of Scovill SS: Final grading along the edge of the access road almost complete.

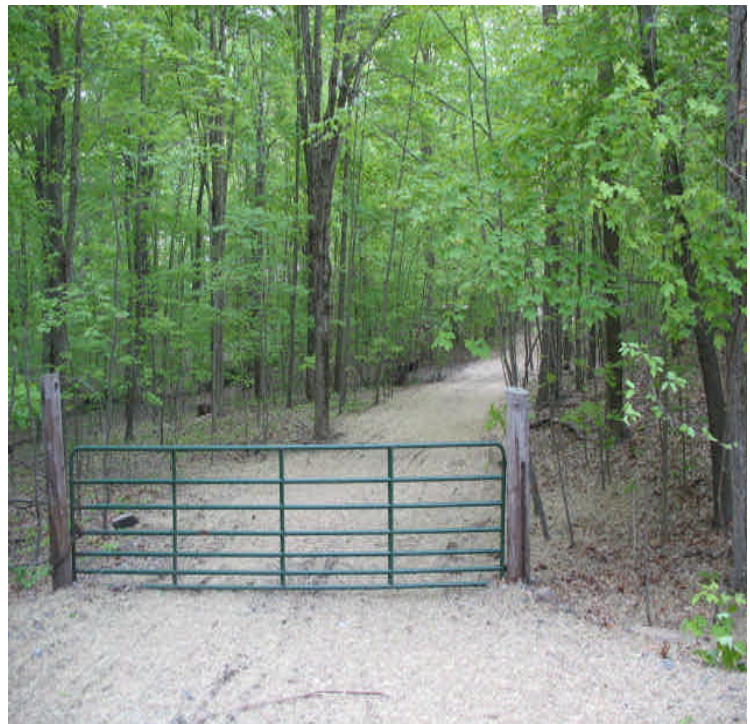
Shumpike Rd East: Final restoration complete from the eastern access to Rte 9

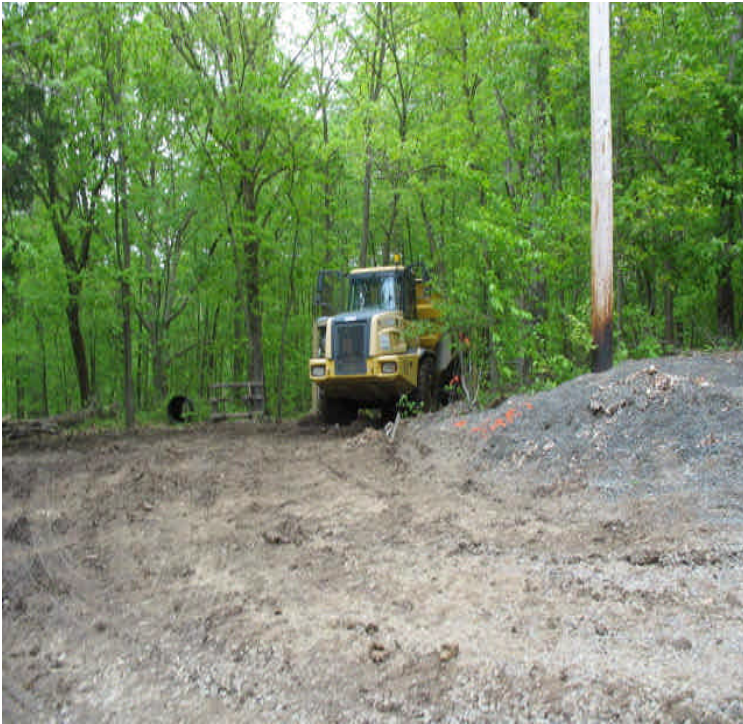
Shumpike Rd. West: Final grading and restoration measures underway.

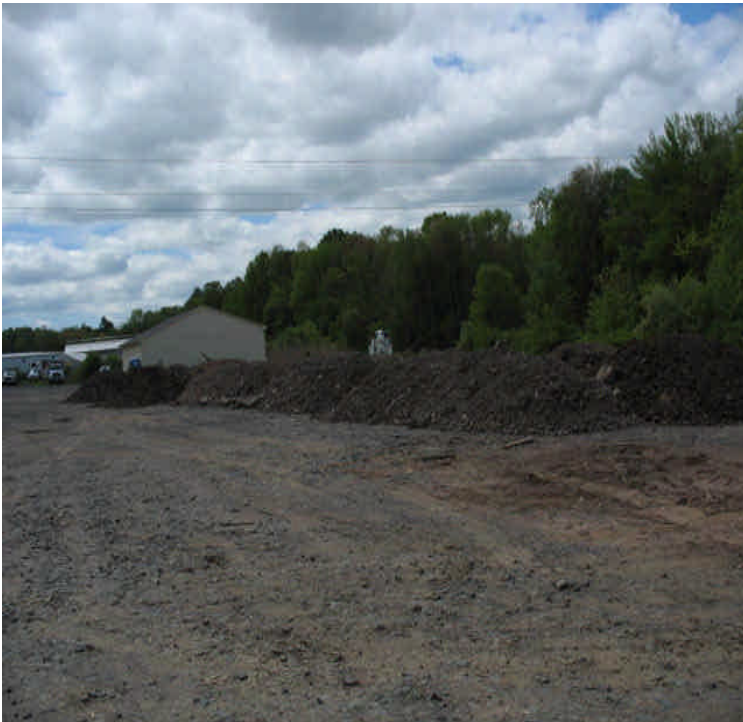
Contractor Yard: Stockpiling soils from restoration at Scovill SS to Chestnut Jct.

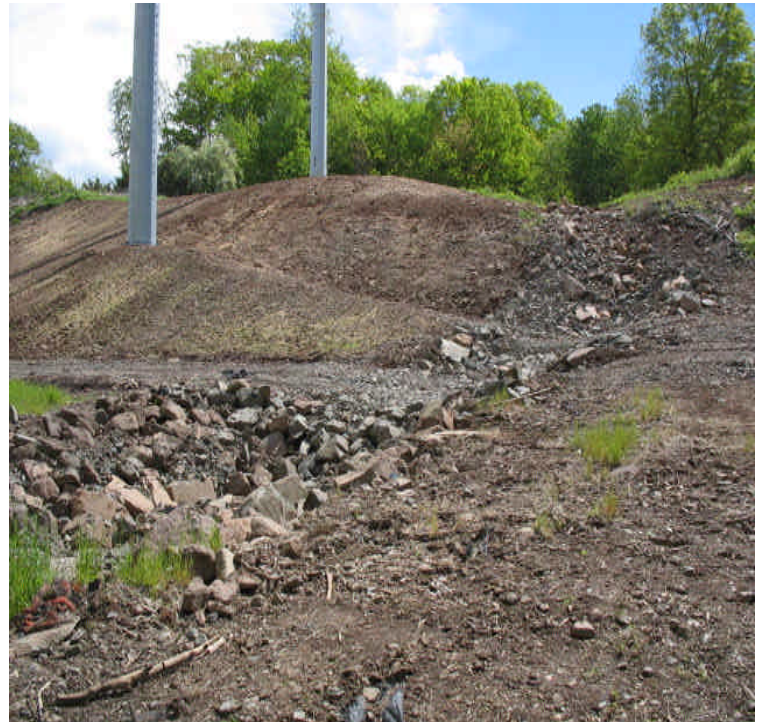
E. Meriden SS (West): Final restoration complete. Riprap settling area and drainage area installed from the runoff near the switching station. Monitor to ensure effectiveness in preventing erosion near the pond.
