**Docket No. 272 – Development and Management Plan Inspection**

**Segment 1a Inspection**

**Date:** May 27, 2008

**Location:** Segment 1a – Scovill Rock Switching Station to Chestnut Junction, Oxbow Junction to Beseck Switching Station (excluding Royal Oak Bypass), and Black Pond Junction to Beseck Switching Station

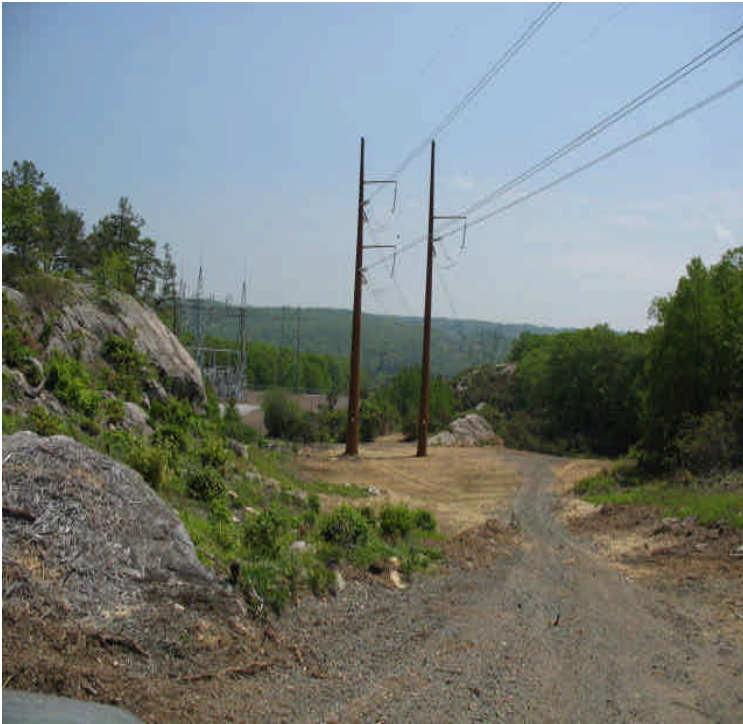
**West of Scovill SS: Final grading and reclamation complete.**

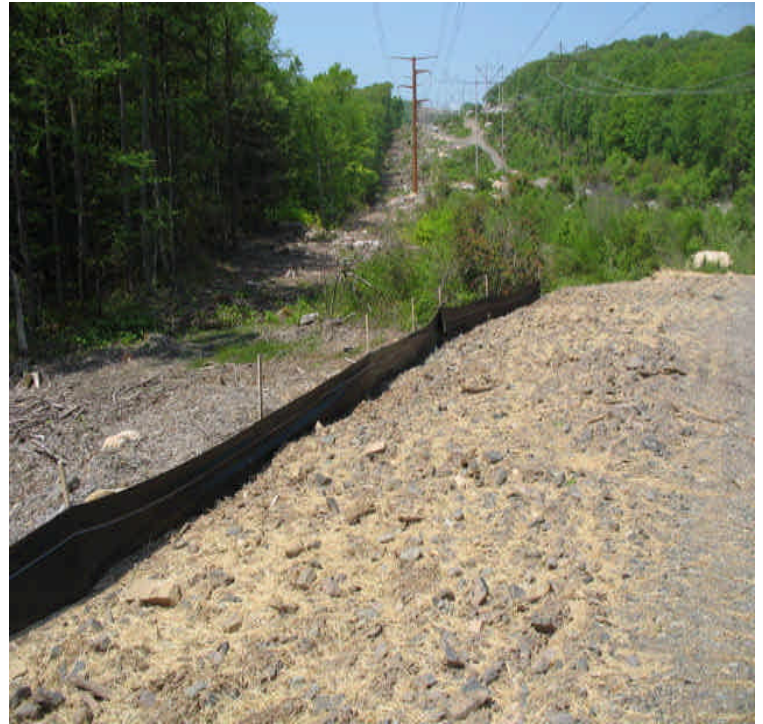
**West of Scovill: Final grading and stabilization measures complete. Controls remain in place as needed above sensitive/resource areas. When areas have established cover, silt fence will need to be removed**

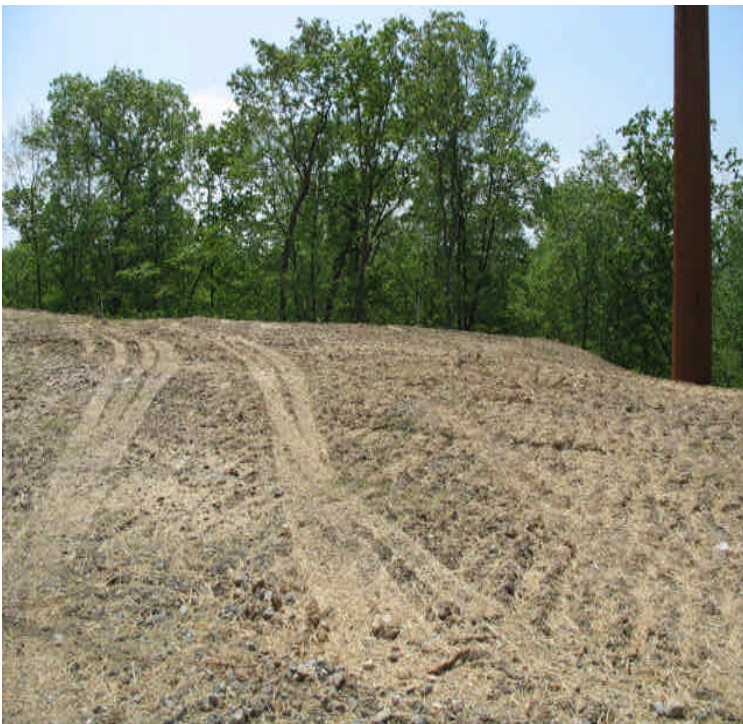
**West of Scovill SS: Final grading along the edge of the access road complete.**

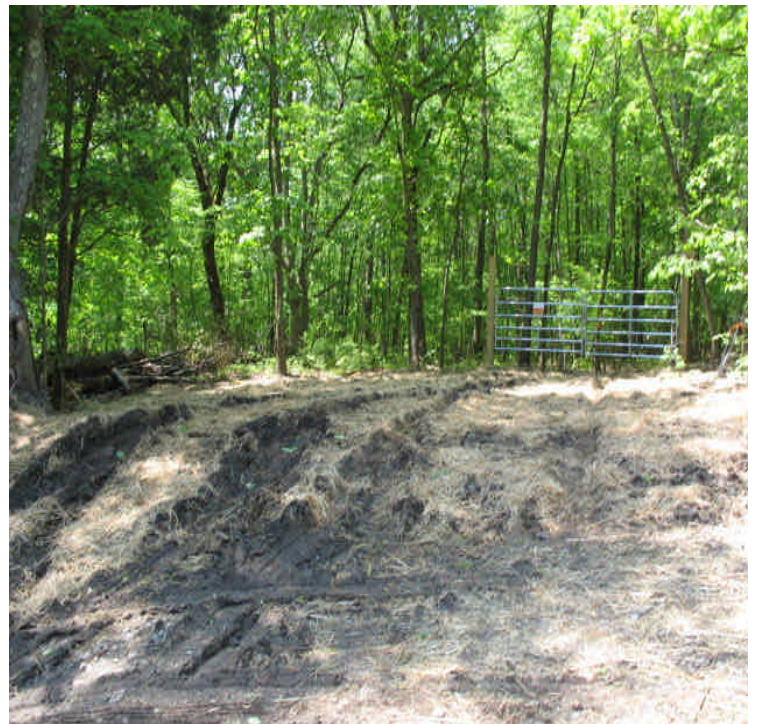
**Shunpike Rd East: Final restoration complete off Shunpike Rd. It appears other vehicles are tracking through this area.**

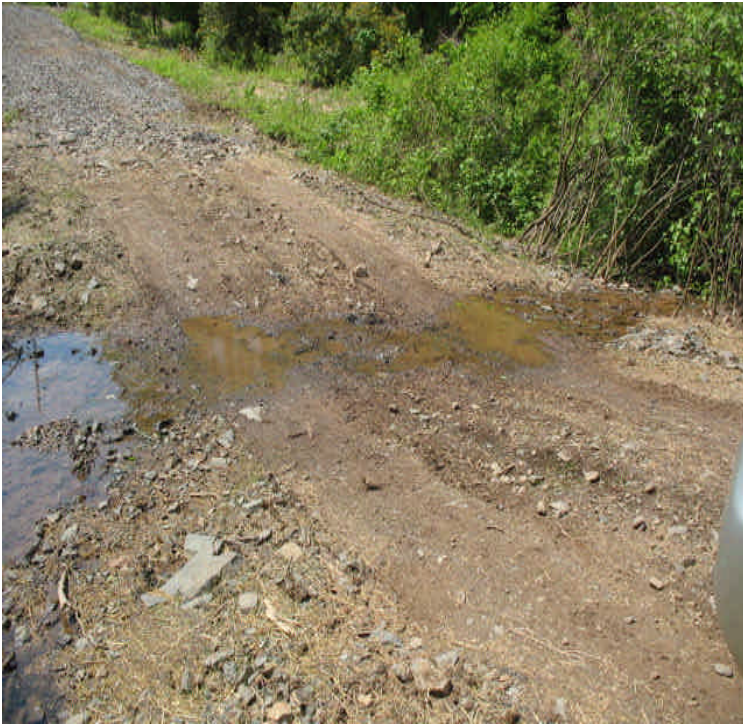
<b>Timber mats remain at the 1<sup>st</sup> saturated crossing off E. Mount Rd. but the 2<sup>nd</sup> has been final graded/restored 5/27/08</b>	<b>Continue to monitor. 5/27/08</b>	<b>Hydrology was intact at the 2<sup>nd</sup> crossing.</b>
	<b>Some sediment was noted within the wetlands in the portion of the ROW off E. Mount that leads to</b>	<b>Remove any sediment that has accumulated more than 2”, by hand, from the wetlands as</b>	<b>Sediment should be removed from the wetland as needed.</b>

**East Mount Rd: Second wetland crossing removed and final graded. Hydrology remains intact but a small amount of sediment was noted downstream.**

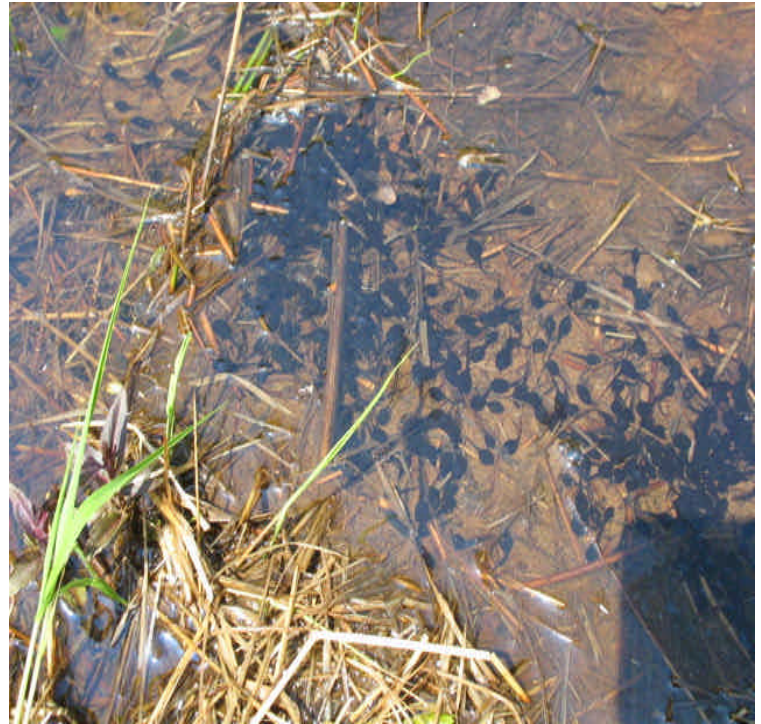
**East Mount Rd: Tadpoles within the wetlands at the second crossing**

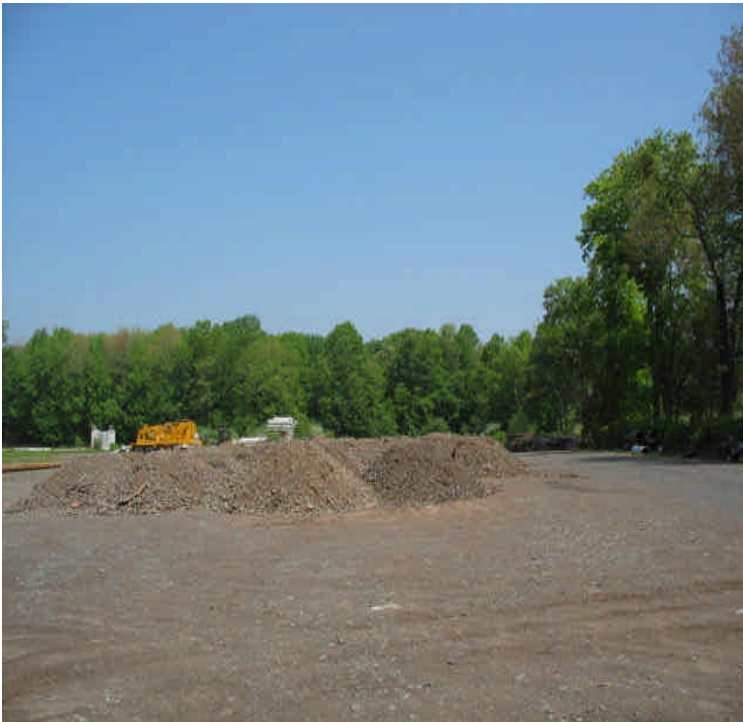
Areas of Inspection	Observation	Recommended Action	Corrected Action
Durham Rd.	<p>in the upper yard have been temporarily stabilized with hay/seed. (Since 5/19) 5/27/08</p> <p>Stockpiles from the Scovill SS section are also being piled in the lower yard and will need to be stabilized. 5/19-5/27/08</p> <p>Timber mats/stone access road was removed west of Durham Rd. Some controls are in place including fiber rolls adjacent to the stone pad at structure # 24521 which regularly floods. 5/27/08</p>	<p>feasible. 5/27/08</p> <p>Add controls around the new stockpiles, stabilize, or remove in accordance with the D&amp;M plan. 5/19-5/27/08</p> <p>Monitor carefully and reduce grade and width of the road to the maximum extent feasible. Avoid entering/working on the access road when it is flooded. 5/27/08</p>	<p>New stockpiles will need controls.</p> <p>Needs careful monitoring. See Inland wetland section.</p>

**Contractor Yard: Stockpiling soils from restoration at Scovill SS to Chestnut Jct. Remove or stabilize as feasible.**

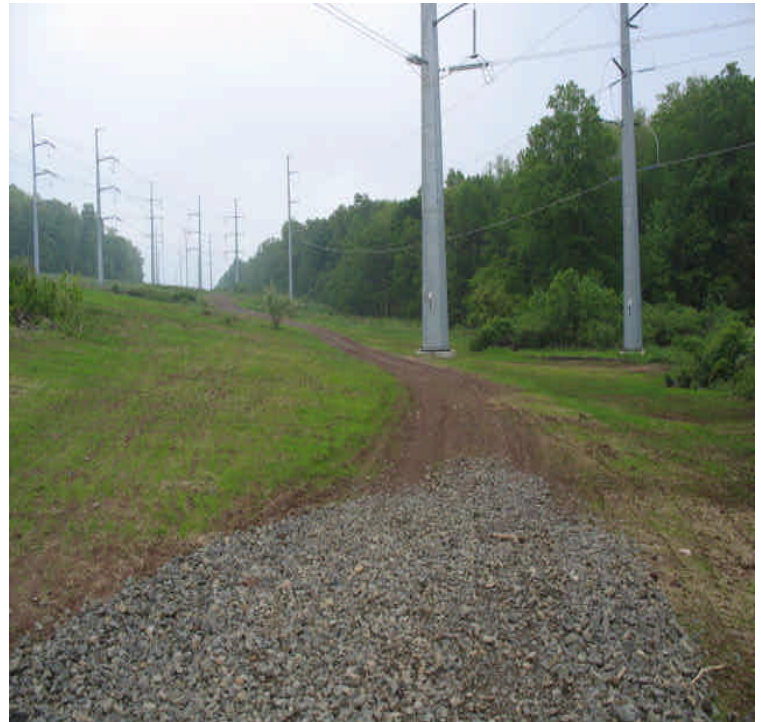
**BSS North: Final restoration complete. Grass growth noted in reclaimed areas along the ROW.**
