**Docket No. 272 – Development and Management Plan Inspection**

**Segment 1a Inspection**

**Date:** June 16, 2008

**Location:** Segment 1a – Scovill Rock Switching Station to Chestnut Junction, Oxbow Junction to Beseck Switching Station (excluding Royal Oak Bypass), and Black Pond Junction to Beseck Switching Station

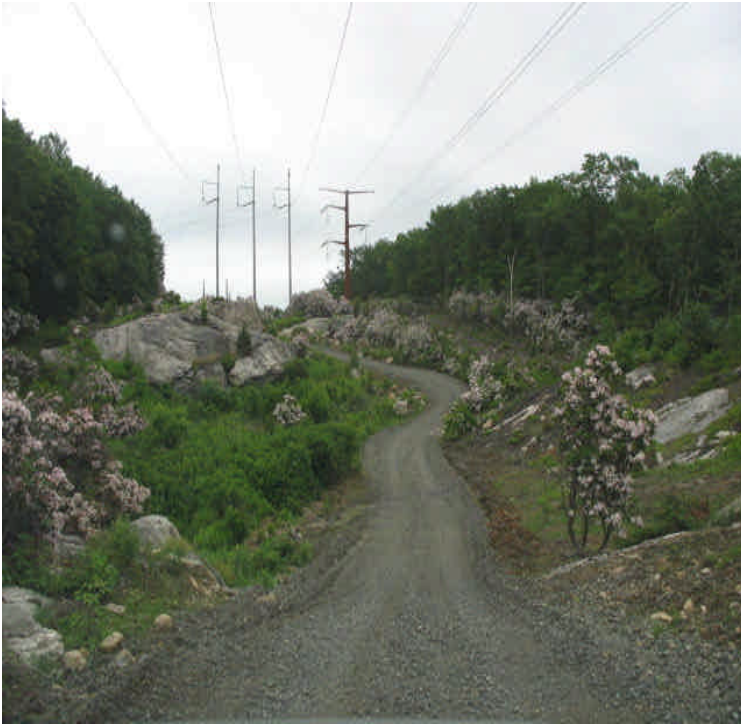
**Scovill SS: View of vegetative growth along the access road near the switching station. Mountain laurels were retained as appropriate low growth, woody species.**

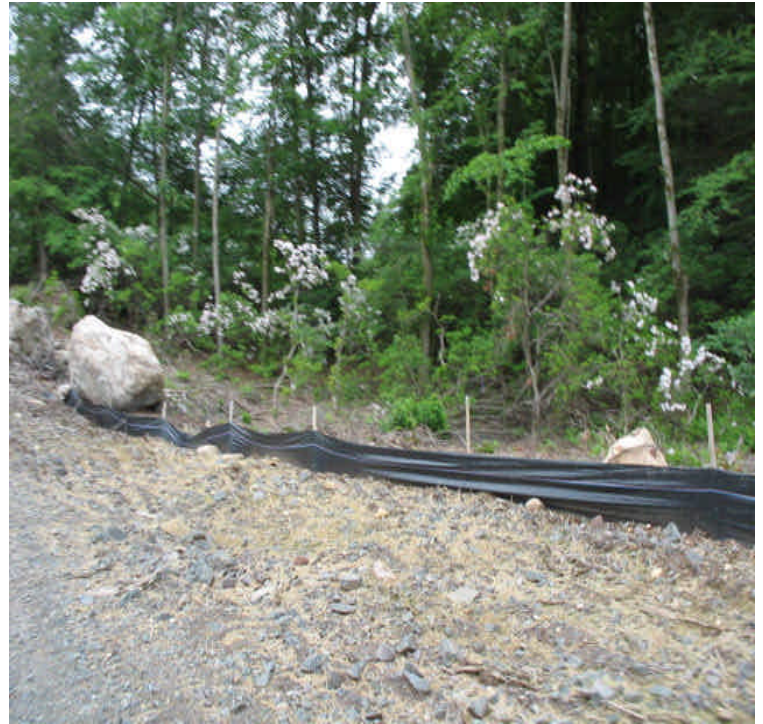
**Saybrook Road: Final restoration complete, controls remain from Saybrook to Scovill. When adjacent areas stabilize, silt fence will have to be removed.**

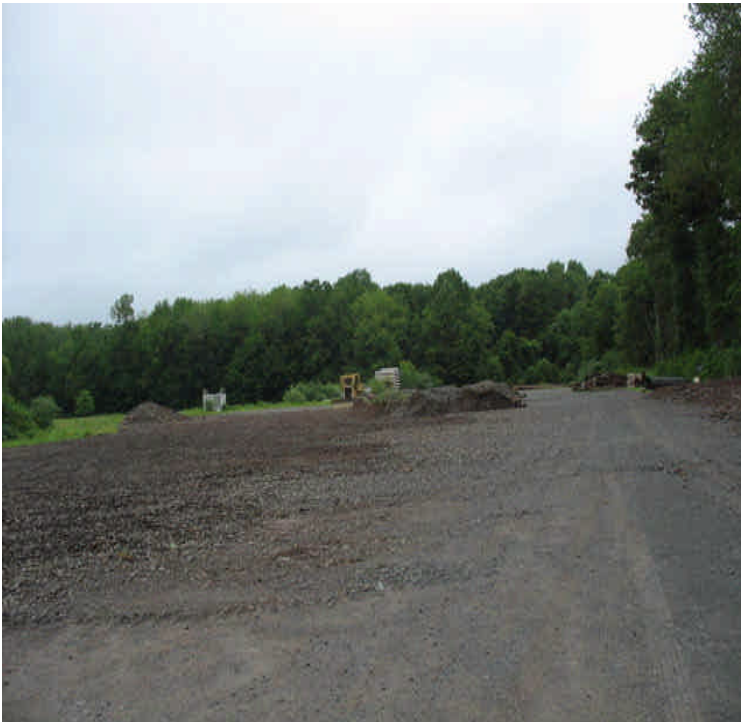
**Contractor Yard: Contractor is grading/spreading the previously stored stone/soil stockpiles that originated from several sites along the ROW, at the yard.**

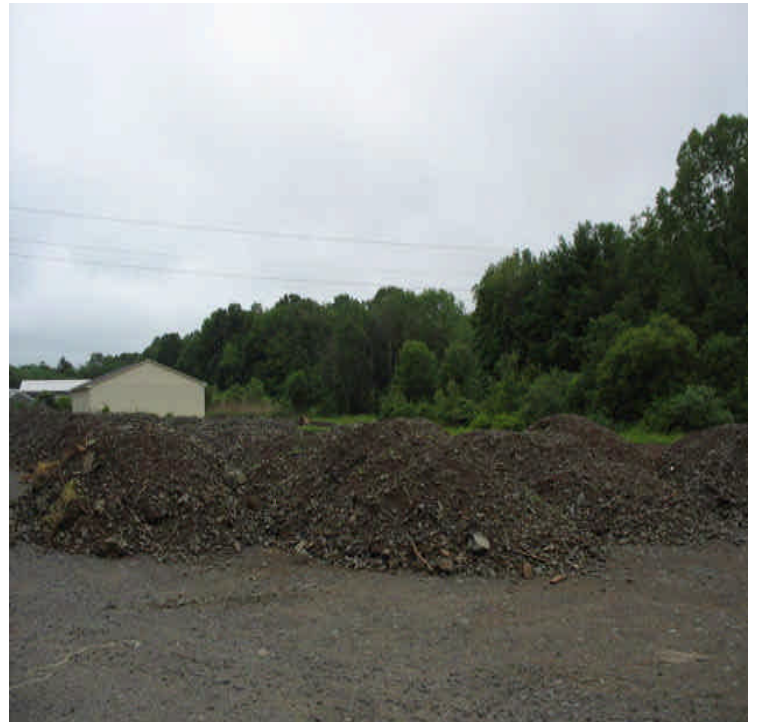
Areas of Inspection	Observation	Recommended Action	Corrected Action
	<p><b>Contractor is spreading/grading stockpiles around the yard as fill. Several stockpiled soils from multiple sites remain stored around yard and will need to be temporarily stabilized or removed. 6/16/08</b></p>	<p><b>Add controls around the stockpiles to stabilize, or remove in accordance with the D&amp;M plan. The land owner requested the fill but confirm with the water district that this practice is acceptable. 6/16/08</b></p>	<p><b>Stockpiles will need controls. Needs evaluation.</b></p>
<p><b>Durham Rd.</b></p>	<p><b>Some controls are in place including fiber rolls adjacent to the stone pad at structure # 24521, which regularly floods. 6/16/08</b></p>	<p><b>Monitor carefully and reduce grade and width of the road to the maximum extent feasible. Avoid entering/working on the access road when it is flooded. 6/16/08</b></p>	<p><b>Needs careful monitoring. See Inland wetland section.</b></p>

**Contractor Yard: Remaining additional soil stockpiles from several sites should be temporarily stabilized or removed.**

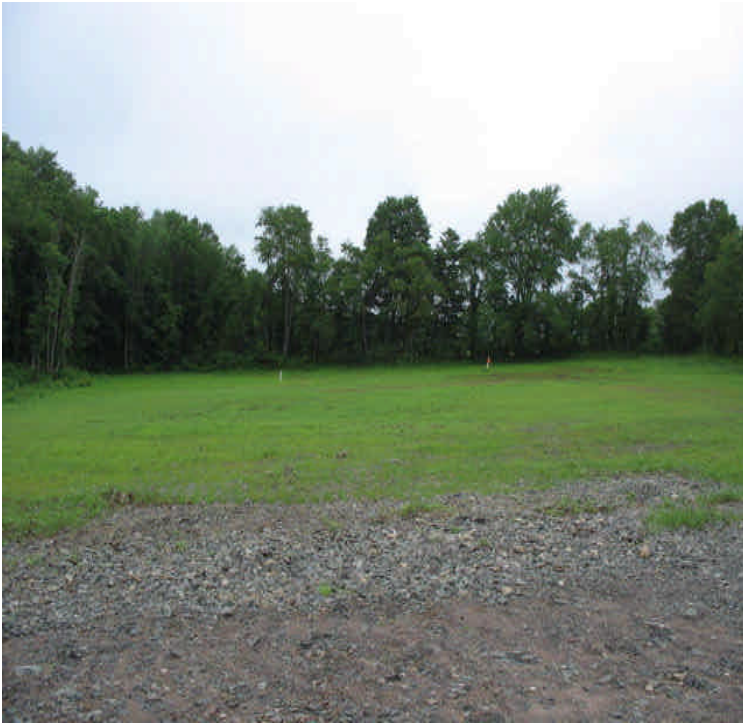
**Contractor Yard:** Upper yard is almost completely stabilized with vegetative cover.

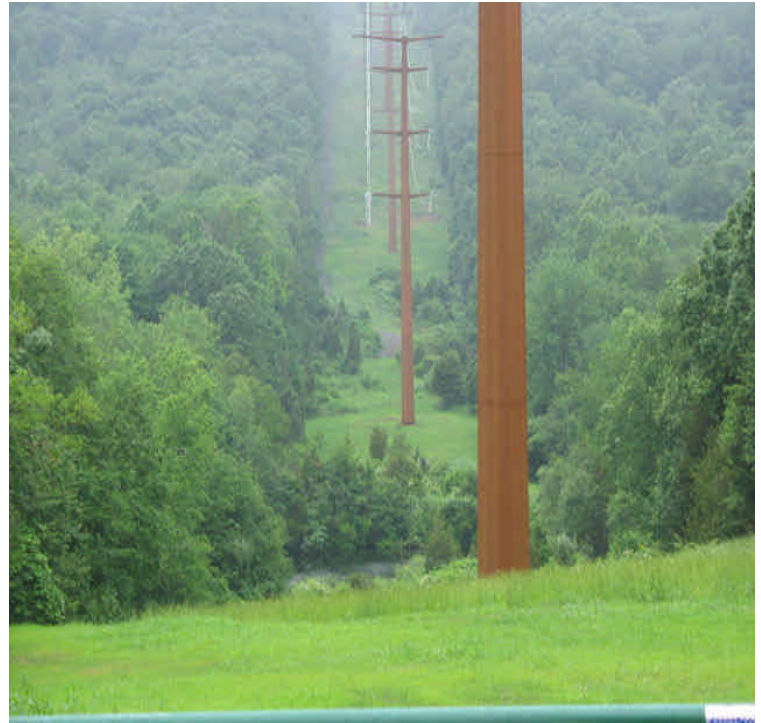
Powder Hill Rd.	<b>The major crossing near the pond remains but all other crossings and channels remain restored 6/16/08</b>	<b>Monitor the exposed areas and controls closely in this area until stabilization is complete. 6/16/08</b>	<b>Continue to monitor.</b>
East of Beseck SS	<b>The minor sediment and stone/soil from the old pad (noted since 10/22) removed by hand, from</b>	<b>Monitor the exposed soils around the wetlands for stabilization. Maintain controls until stable.</b>	<b>NA at this time.</b>

**Powder Hill Rd:** Final restoration complete. Grass growth noted along the slopes and the ROW is in good shape.

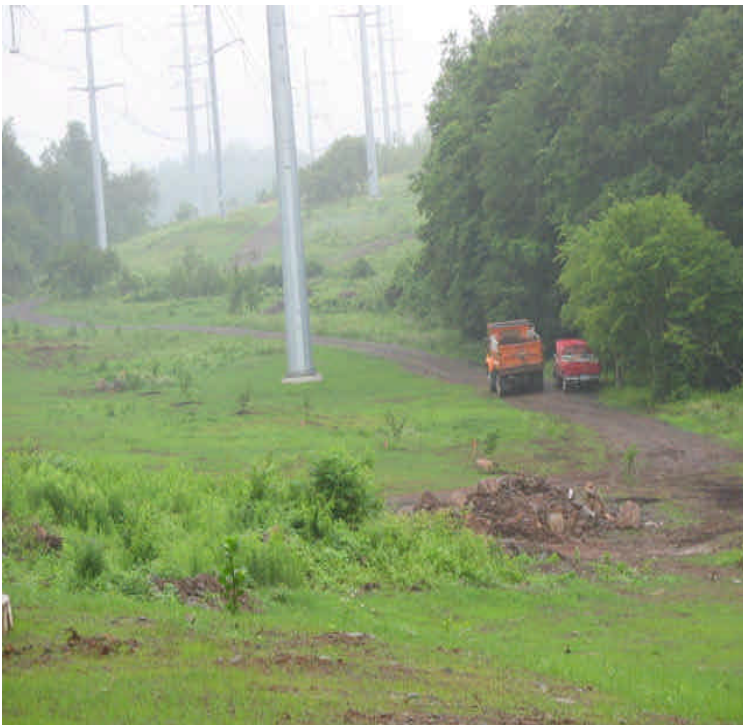
**E Meriden SS:** Crews were planting shrubs along the ROW. Grass cover was noted in recently seeded areas.

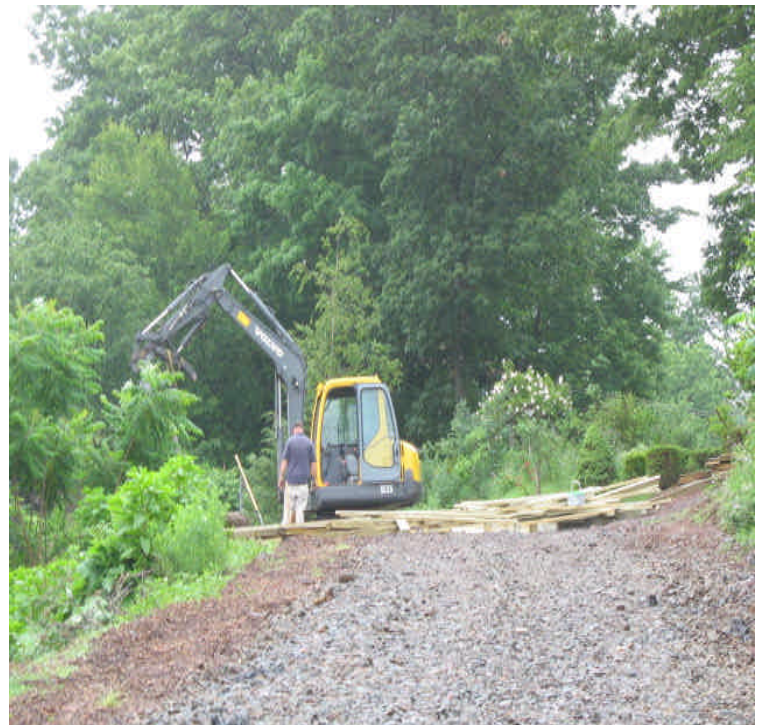
<p><b>East Meriden SS</b></p>	<p><b>A fence was being installed along the access road. New shrubs were also being planted along the ROW. 6/16/08</b></p>	<p><b>Monitor for stabilization and add controls as needed along the slope. Monitor newly planted shrubs until established. 6/16/08</b></p>	<p><b>New shrubs and a fence were being installed.</b></p>

**E. Meriden SS:** Crews were installing a fence near the horse stable.
