Docket No. 272 – Development and Management Plan Inspection

Segment 1a Inspection

Date: July 7, 2008

Location: Segment 1a – Scovill Rock Switching Station to Chestnut Junction, Oxbow Junction to Beseck Switching Station (excluding Royal Oak Bypass), and Black Pond Junction to Beseck Switching Station

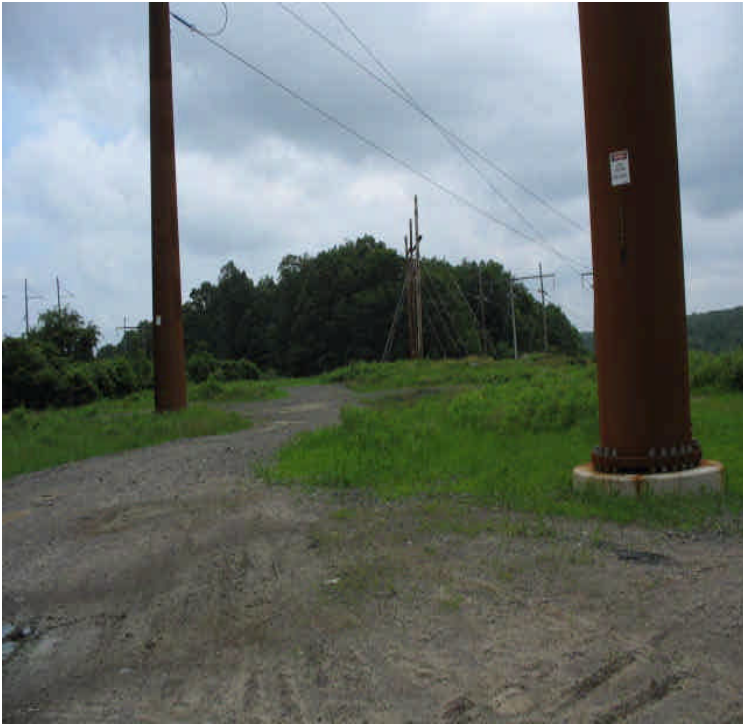
Oxbow Jct: View of vegetative growth/cover at Oxbow.

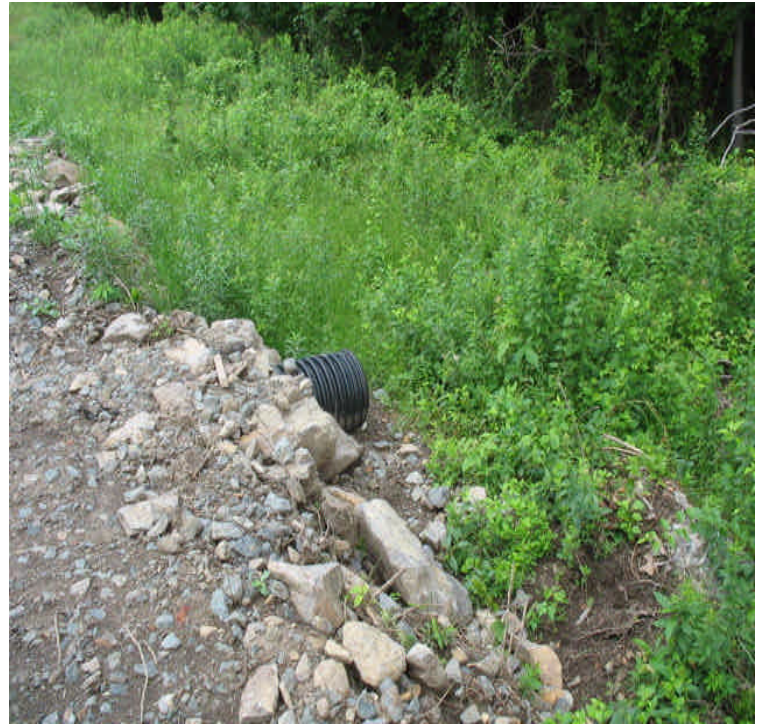
Haddam Quarter Rd: View of the culvert at the saturated crossing. This area is currently dry and good vegetative growth was noted.

Oxbow Junction to Beseck SS Haddam Quarter Rd.	The new culvert remains at the previously bisected wetland. 7/7/08	Monitor the new culvert and controls for effectiveness. 7/7/08	NA

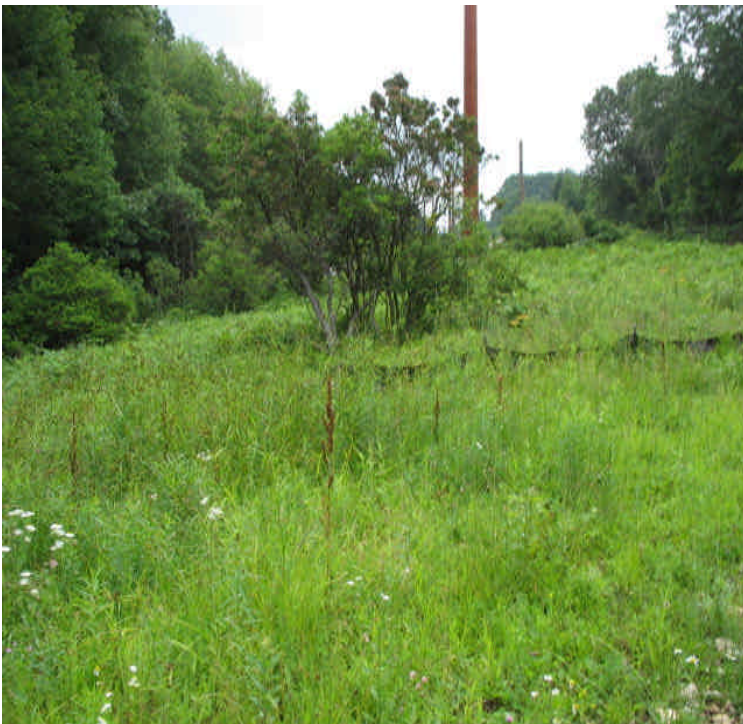
Haddam Quarter: Old silt fence at the turn along the access road can be removed now that the area is stable.

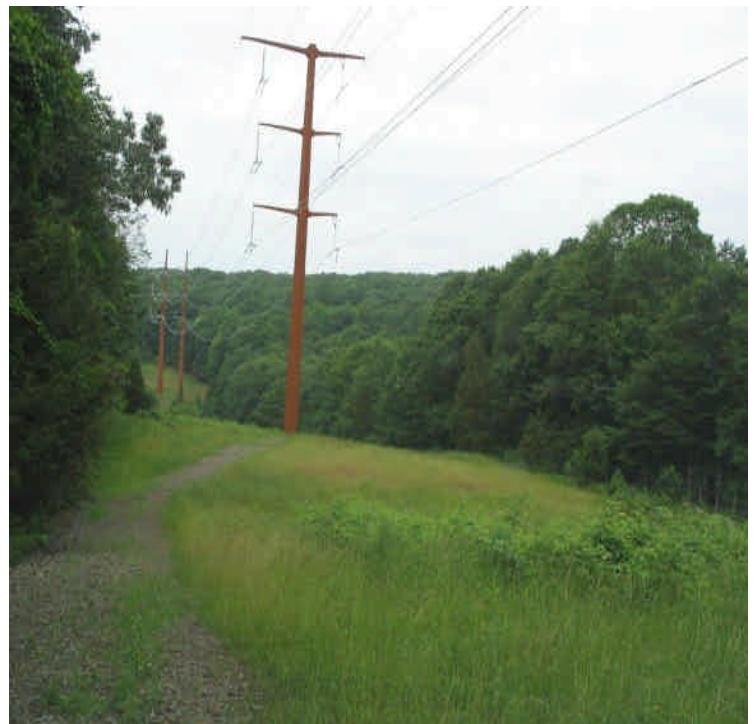
Arbutus St: Top of the slope looking toward Ball Brook and the last structure off Black Walnut Dr. Good grass cover was noted.

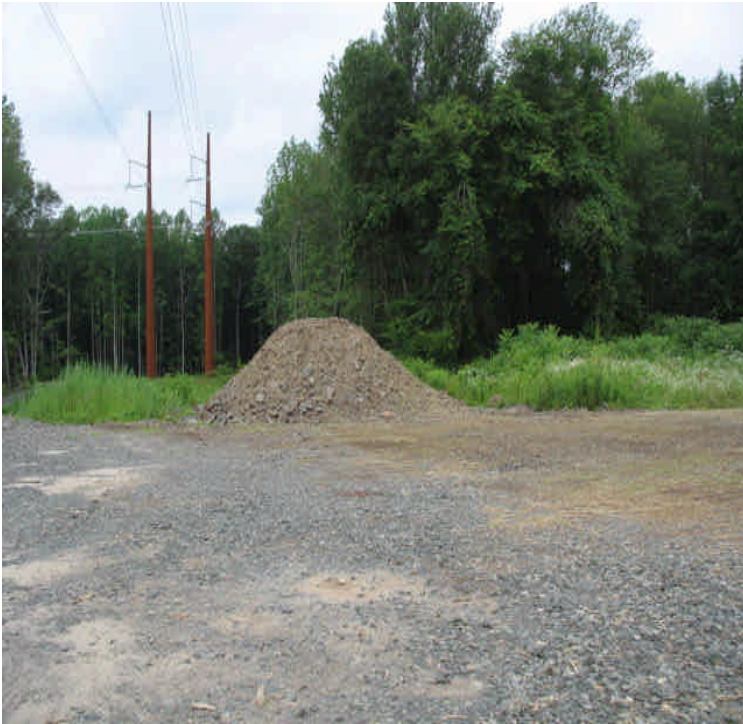
Contractor Yard: Even though it has been temporarily stabilized with seed and mulch and controls are in place, the stockpile located upgradient from the wetlands at 1B should be moved.

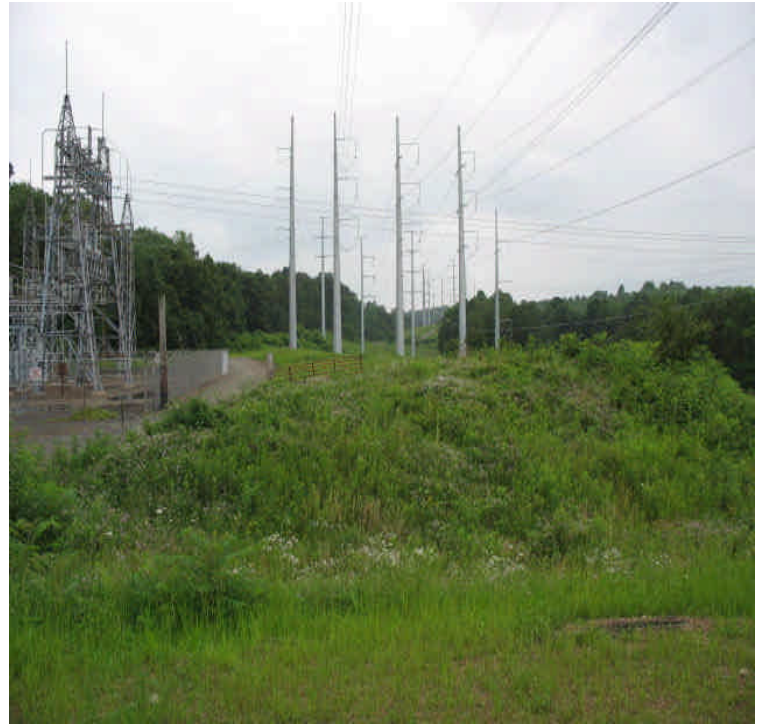
E. Meriden SS: View of vegetative growth adjacent to the switching station

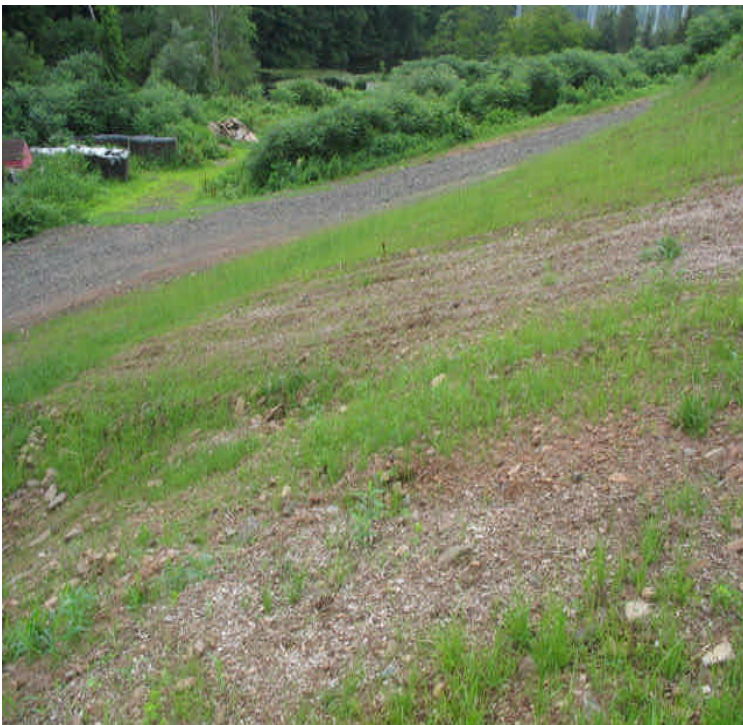
E. Meriden SS: Vegetative growth along the slope below the switching station is sparse and may need additional seed under more favorable conditions.

Areas of Inspection	Observation	Recommended Action	Corrected Action
<p>Powder Hill Rd.</p> <p>East of Beseck SS</p> <p>Black Pond Junction to Beseck SS ROW, North of Beseck SS to Black Pond Jct.</p>	<p>private driveway within an area of lawn. 4/29-7/7/08.</p> <p>Restoration is complete. Slopes appear to be well vegetated and stabilizing. 7/7/08</p> <p>Haybales remain around the riprap sediment trap to filter any overflowing water from the basin. 7/7/08</p> <p>All pads north of Beseck to Black Pond Jct. have been reclaimed well and the ROW is in good condition. All controls remain in place until final stabilization has been achieved. 7/7/08</p>	<p>hand and seed when feasible. 4/29-7/7/08</p> <p>Controls should be maintained until the area is stable. 7/7/08</p> <p>Continue to monitor the controls for effectiveness and add/replace as needed. 7/7/08</p> <p>Continue to monitor and maintain controls until final stabilization and vegetative cover has established. Any silt fence will have to be removed upon stabilization. Sparse areas of vegetation may need to be reseeded. 7/7/08</p>	<p>NA at this time.</p> <p>NA at this time.</p> <p>Good grass growth is noted in many areas.</p> <p>Additional seed may be needed at Black Pond Jct. and on the slopes to East Meriden SS.</p>

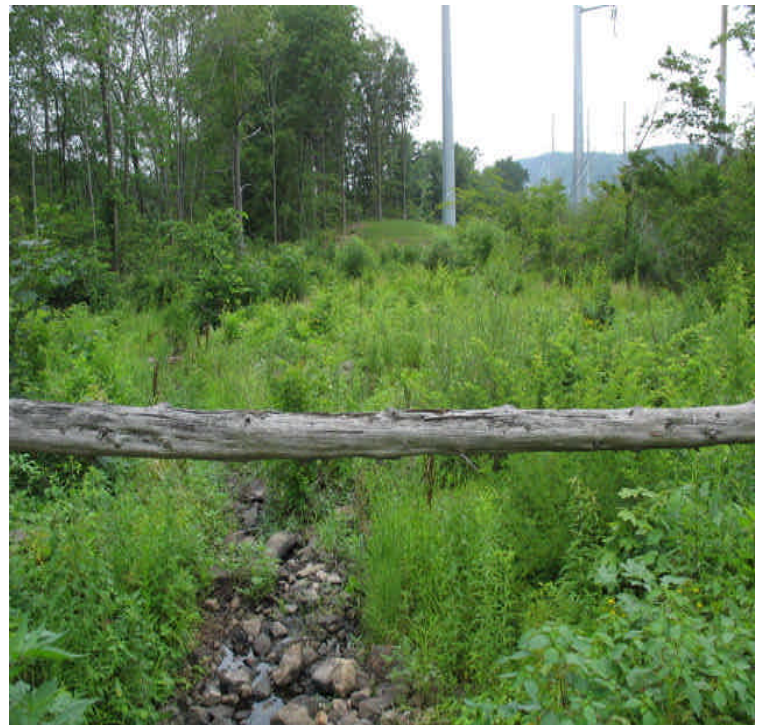
North of High Hill Rd: View of vegetative growth along the stream channel.
