Docket No. 272 – Development and Management Plan Inspection

Segment 1a Inspection

Date: July 14, 2008

Location: Segment 1a – Scovill Rock Switching Station to Chestnut Junction, Oxbow Junction to Beseck Switching Station (excluding Royal Oak Bypass), and Black Pond Junction to Beseck Switching Station

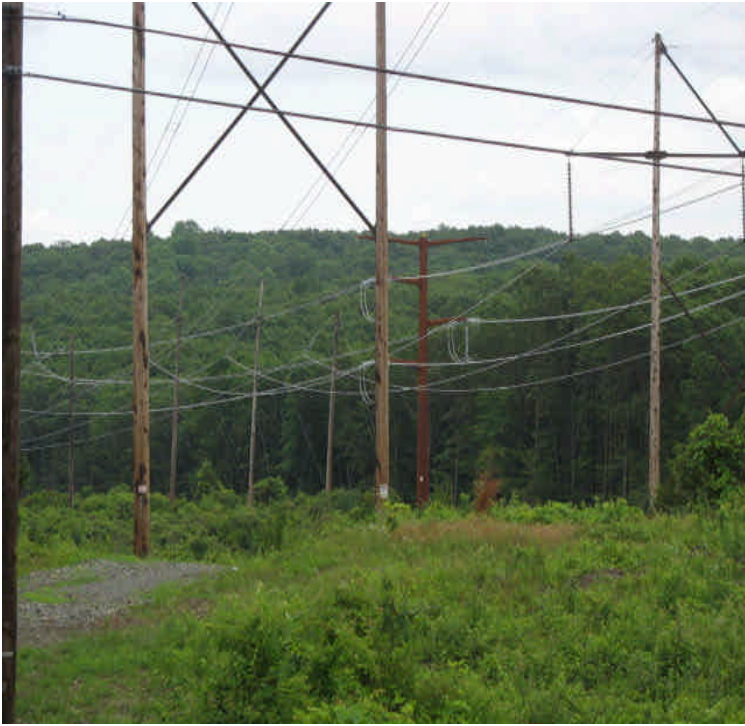
Bartholomew Rd: View of vegetative growth/cover east of the roadway.

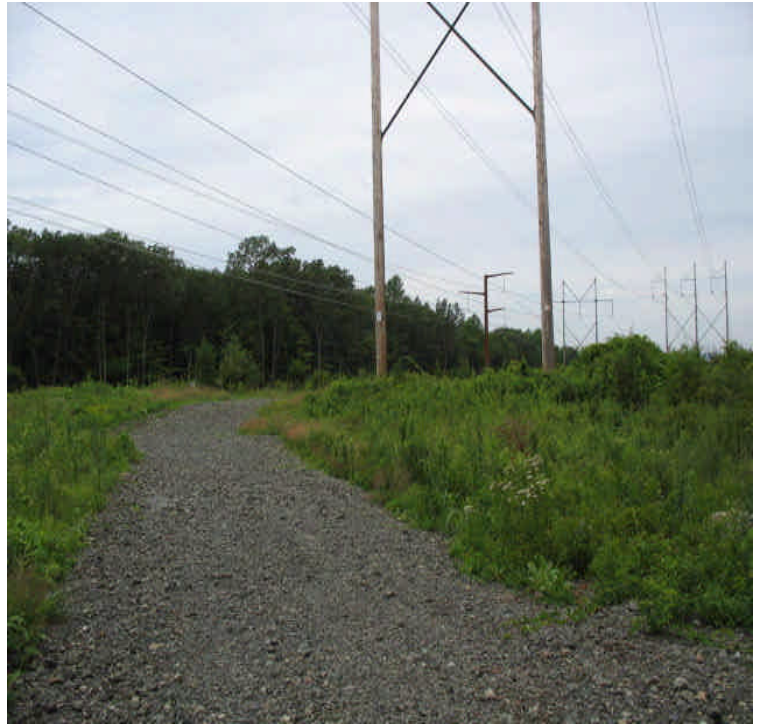
Bartholomew Rd: View of vegetative growth/cover west of the roadway.

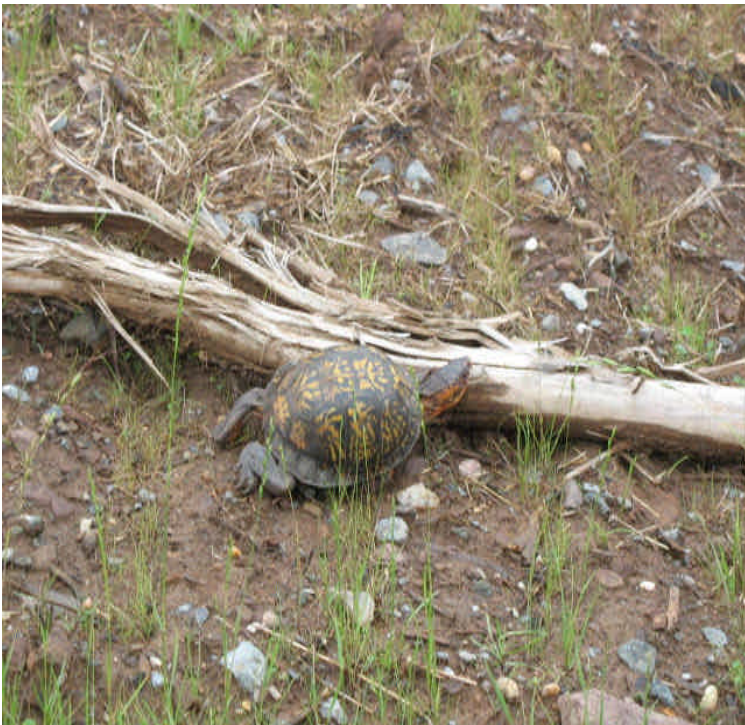
E. Mount Rd: Eastern Box turtle crossing the ROW and access road. Sweeps should be performed if any further access is needed in this area.

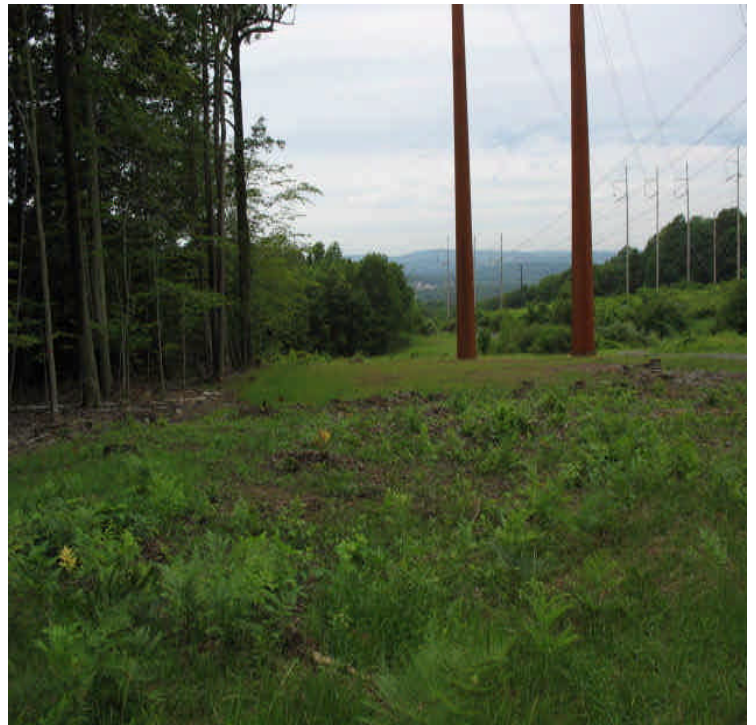
E. Mount Rd: View of vegetative growth/cover looking toward Chestn Jct.

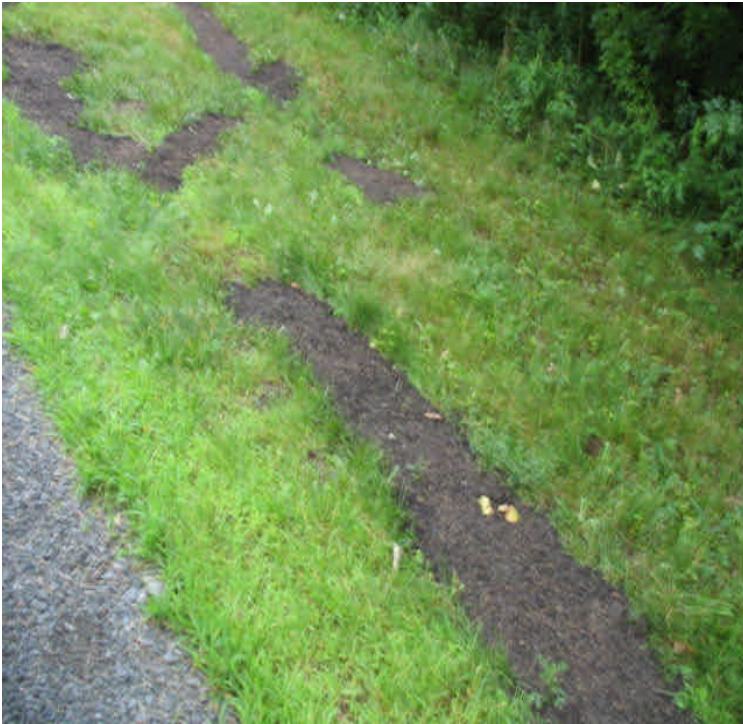
Rte 157: Small ruts along a private driveway east of Rte. 157 were filled in with topsoil and seeded.

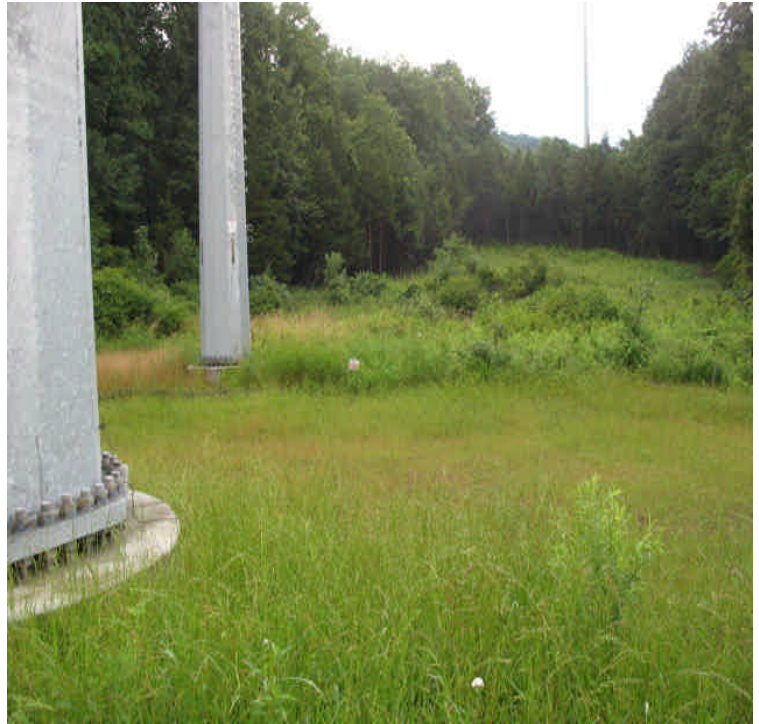
East of Besock SS: View of vegetative cover upgradient and within the wetlands.

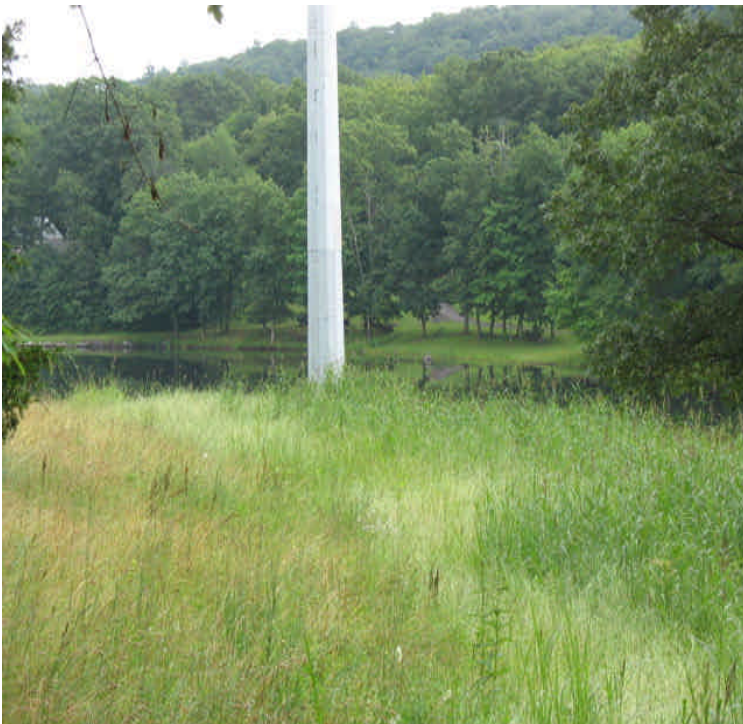
Fleming Rd: Vegetative growth/cover along the slope upgradient of the pond.

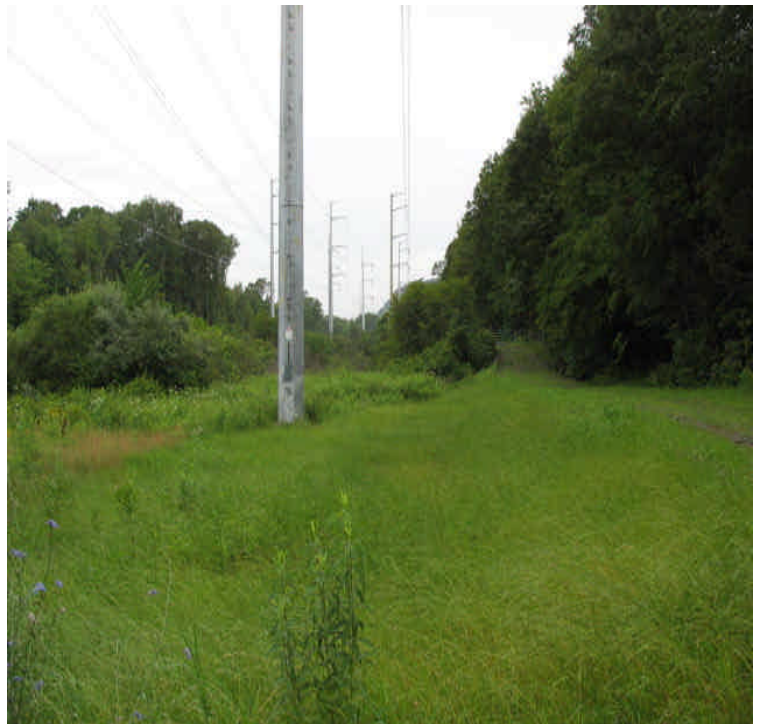
North of High Hill Rd: Vegetative growth/cover along the stream.
