Docket No. 272 – Development and Management Plan Inspection

Segment 1a Inspection

Date: July 28, 2008

Location: Segment 1a – Scovill Rock Switching Station to Chestnut Junction, Oxbow Junction to Beseck Switching Station (excluding Royal Oak Bypass), and Black Pond Junction to Beseck Switching Station

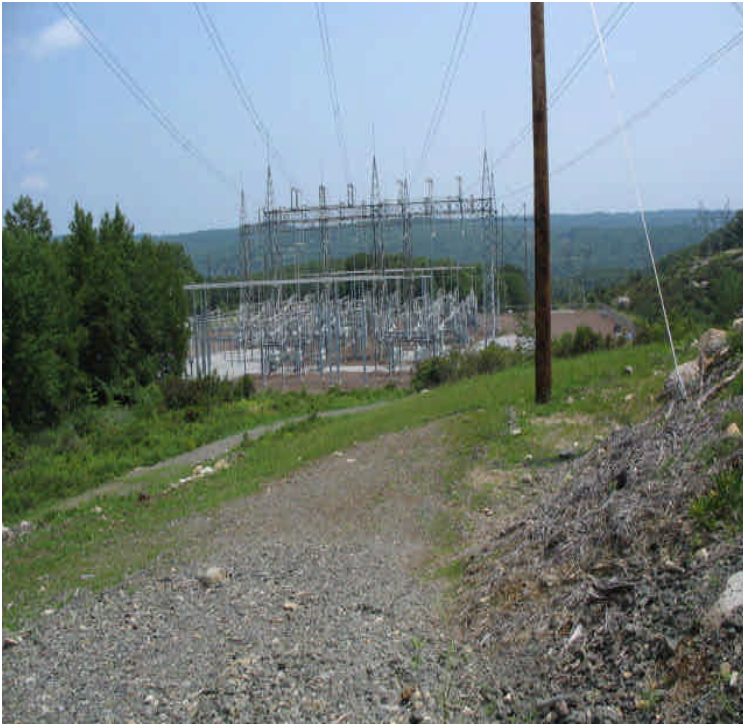
Scovill SS: Vegetative growth has started but is still sparse in many areas from Rte. 9 to Scovill SS.

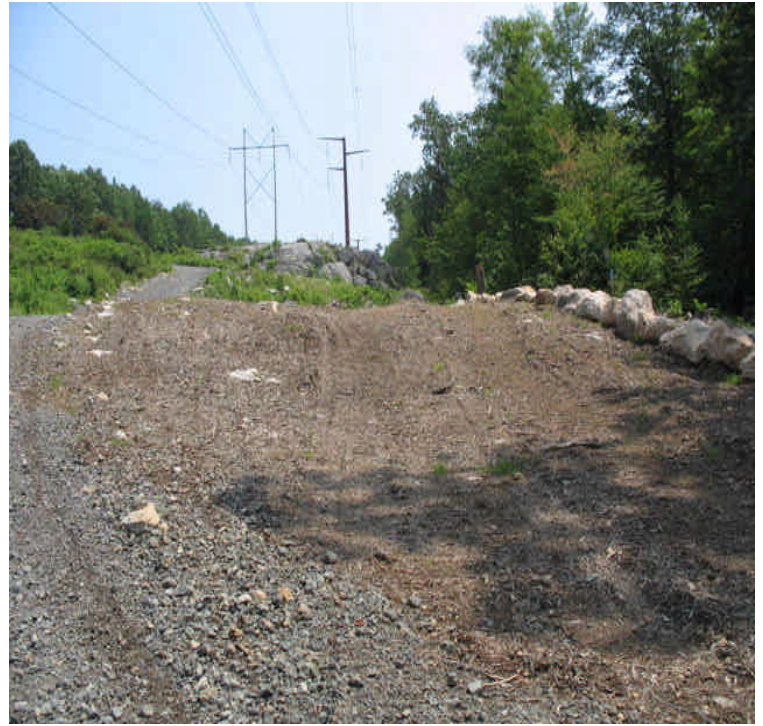
Rte 9: Unvegetated slope upgradient from wetlands; view looking towards Scovill SS

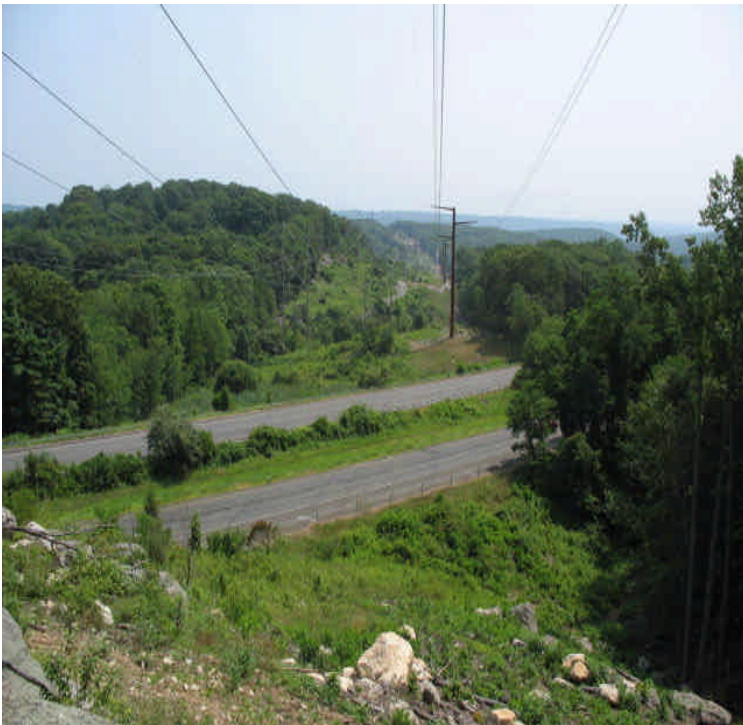
Shumpike Rd: View of ROW crossing over Rte 9 then Rte 154 toward Scovill.

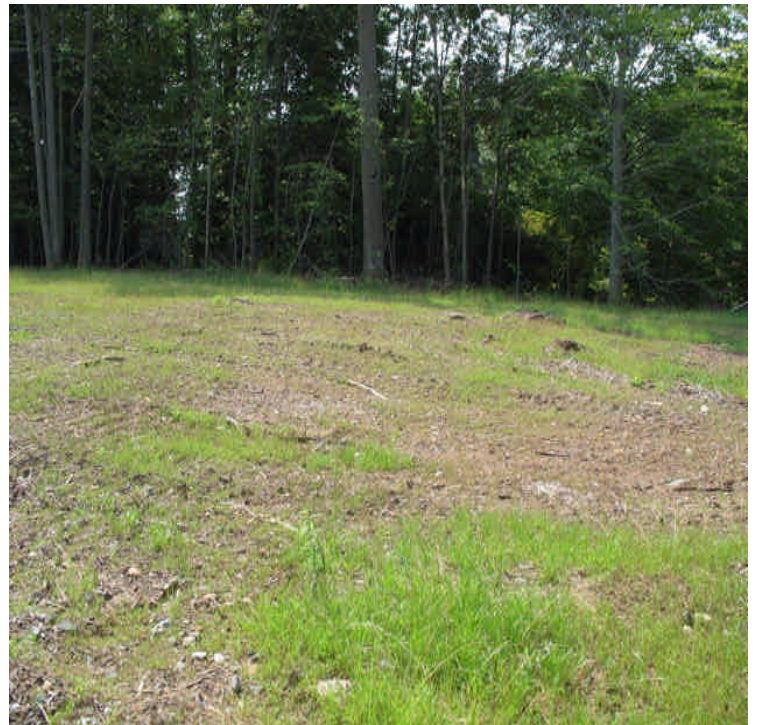
East Mount Rd: View of sparse vegetative growth/cover near the ROW entrance.

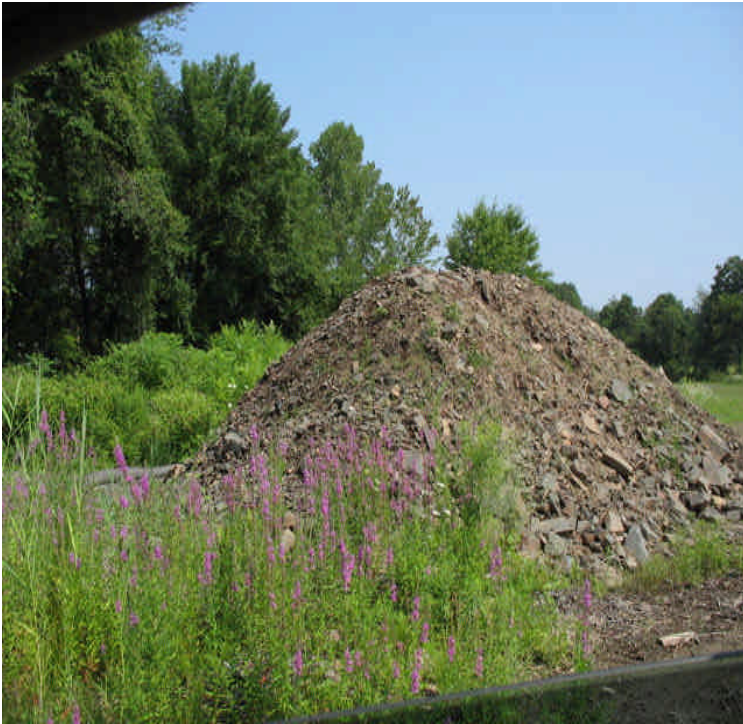
Contractor Yard: Stockpile located upgradient of the wetlands in the receiving yard. A filter sock is in place at the base of the pile.

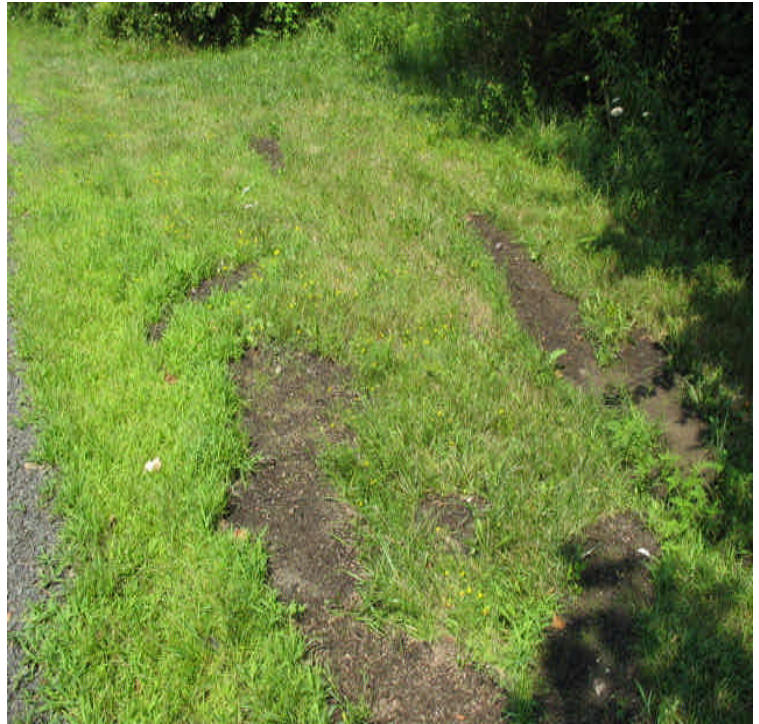
Rte 157; Private Driveway: The recently repaired ruts have started to grow grass

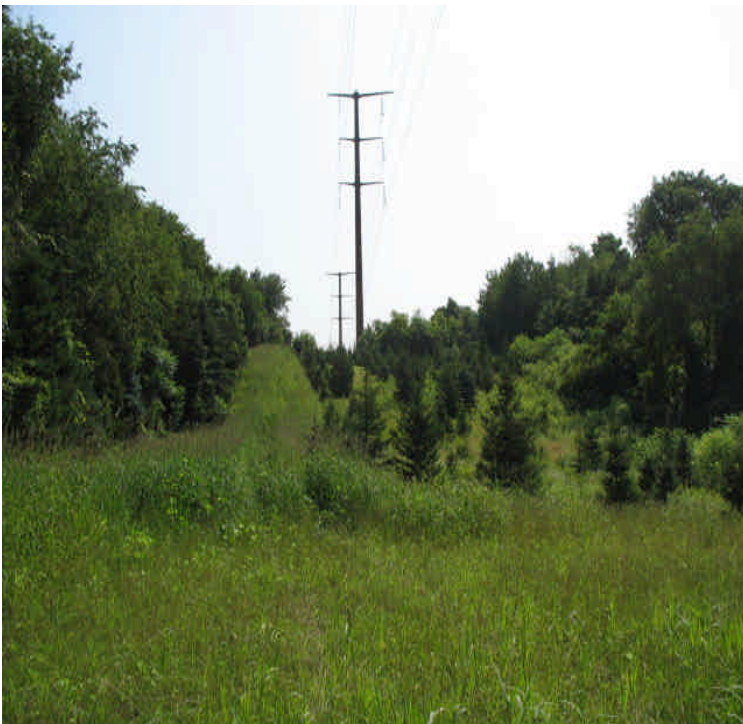
Powder Hill Rd: Vegetative growth/cover along the slope east off the roadway.

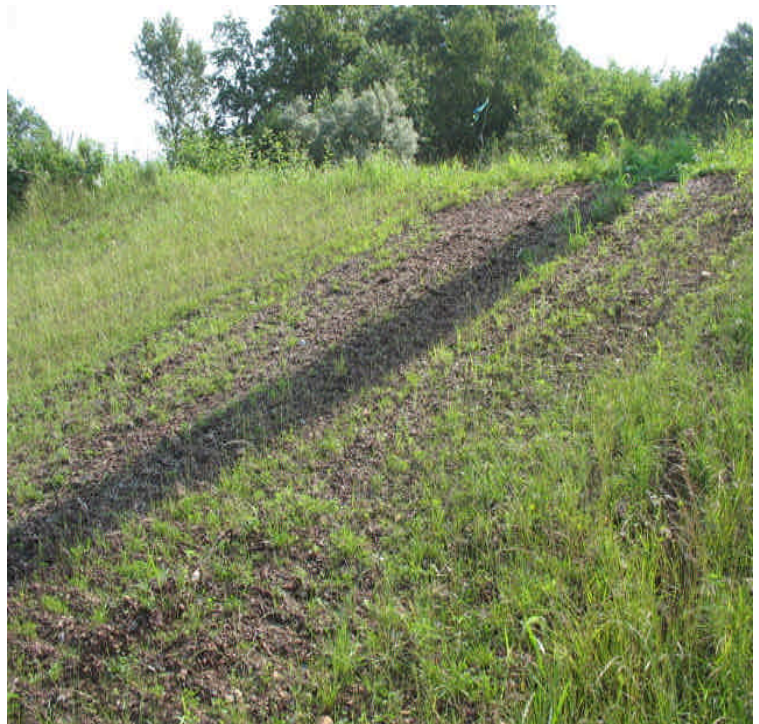
E. Meriden SS: Sparse vegetative growth/cover was noted on the slope downgradient of the substation but the area is fairly small.
