**Docket No. 272 – Development and Management Plan Inspection**

**Segment 1a Inspection**

**Date:** August 25, 2008

**Location:** Segment 1a – Scovill Rock Switching Station to Chestnut Junction, Oxbow Junction to Beseck Switching Station (excluding Royal Oak Bypass), and Black Pond Junction to Beseck Switching Station

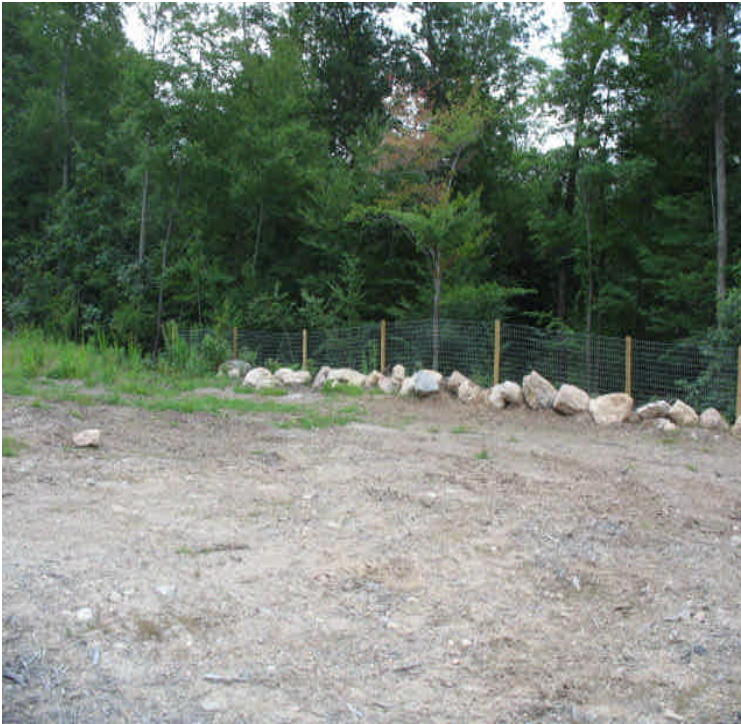
**Rte 9: View of restoration of a hiking path along the ROW between Rte 9 and Scovill SS.**

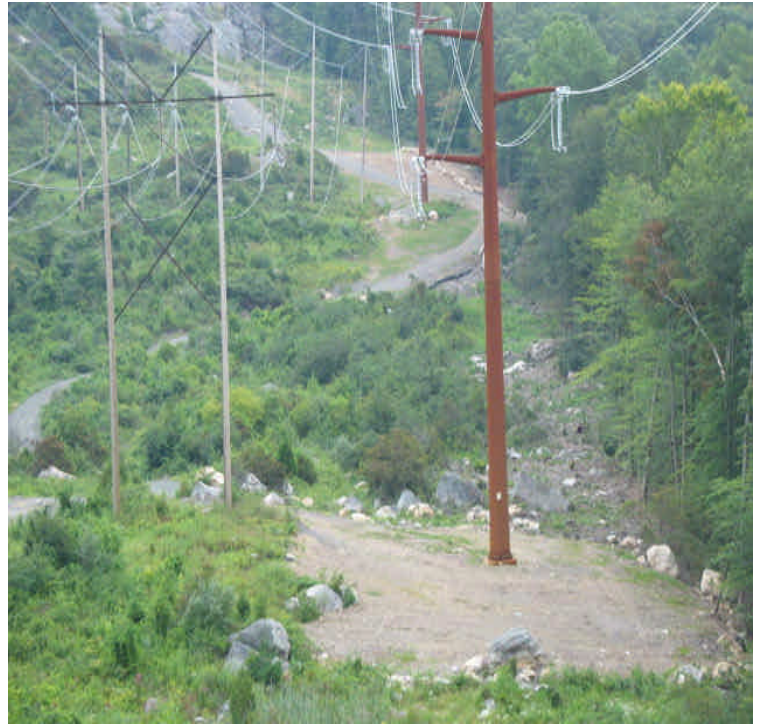
**Rte 9: Several exposed, reclaimed areas remain from Scovill SS to E. Mount Rd. Reseeding may be needed during favorable weather.**

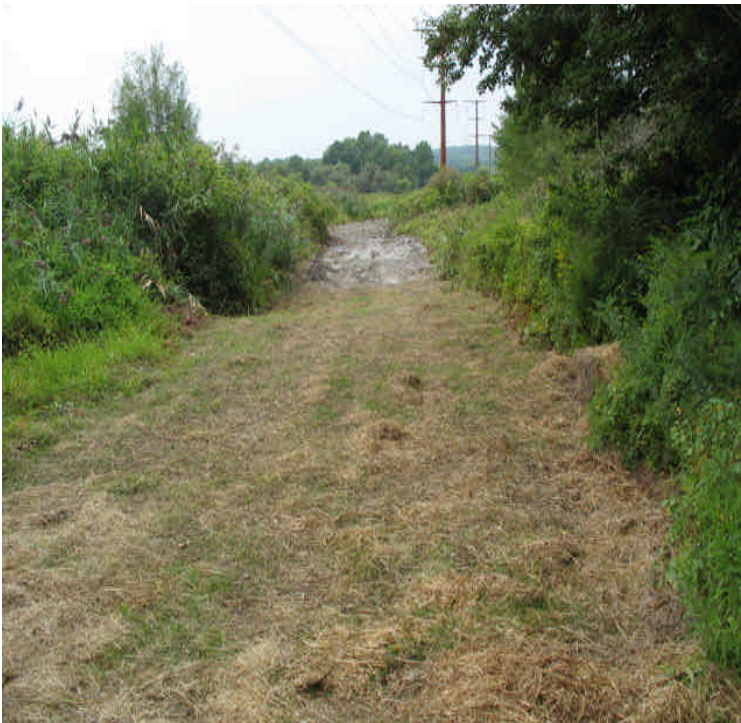
**Durham Rd: Final restoration complete within Durham Meadows. Check/add controls and monitor the area until stable. Areas out of the standing water were mulched and seeded.**

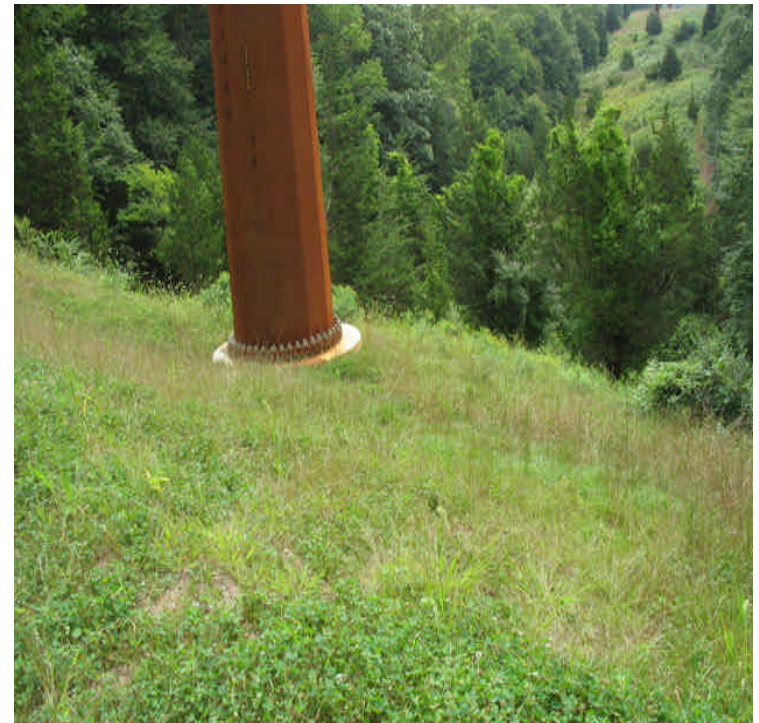
**Black Walnut Dr: Vegetation continues to grow along the slopes upgradient from Ball Brook. This segment is stable with at least 70% cover.**
