Docket No. 272 – Development and Management Plan Inspection

Segment 1b (Royal Oaks Bypass) Inspection

Date: January 7, 2008

Location: Segment 1b (Royal Oaks Bypass)

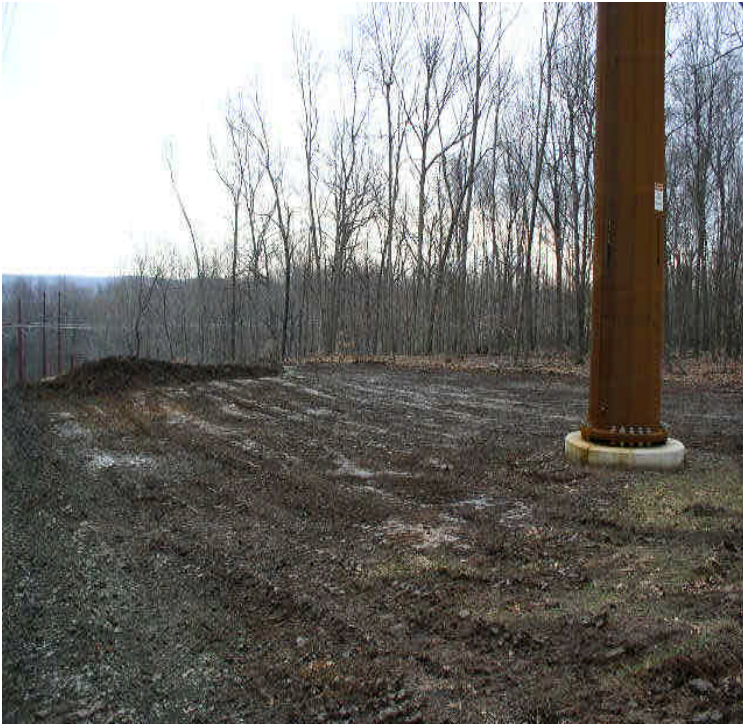
Recently reclaimed area near the Black Walnut Dr. entrance. Area should be temporarily stabilized with mulch for the winter.

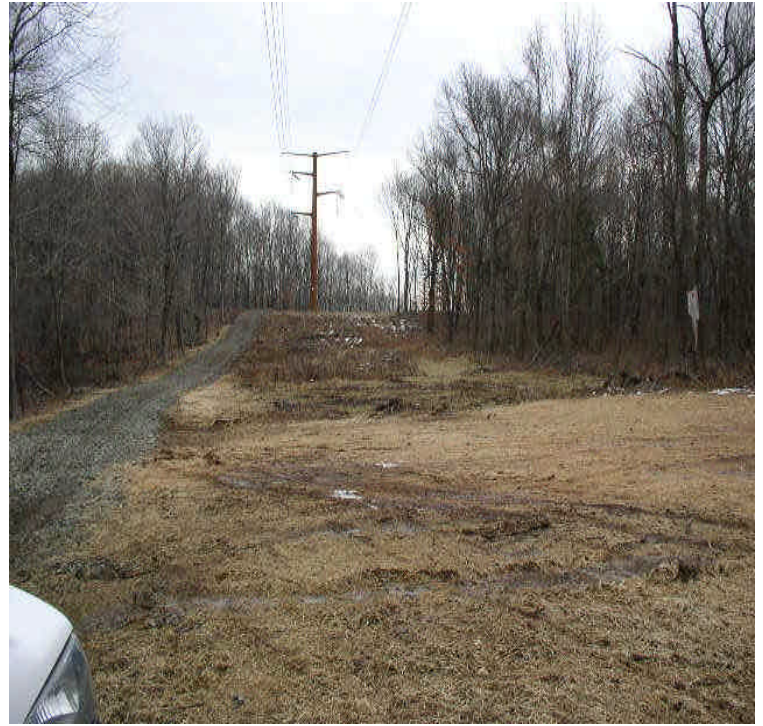
Recently reclaimed, seeded and mulched area off the Black Walnut Dr. entrance.

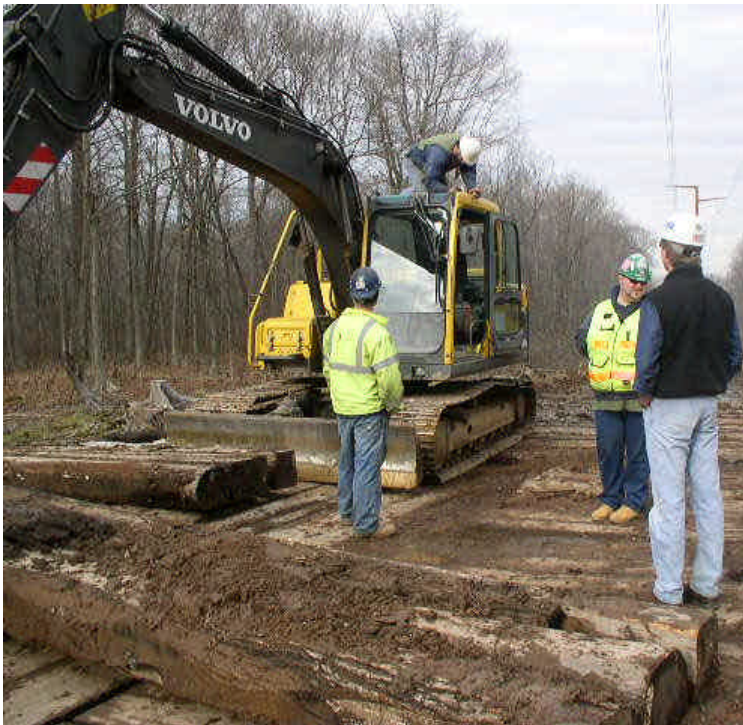
Timber mat removal underway within the wetlands off Rte 17 near Little Ln. Encourage vegetative cover as soon as feasible and provide mulch in adjacent upland areas.

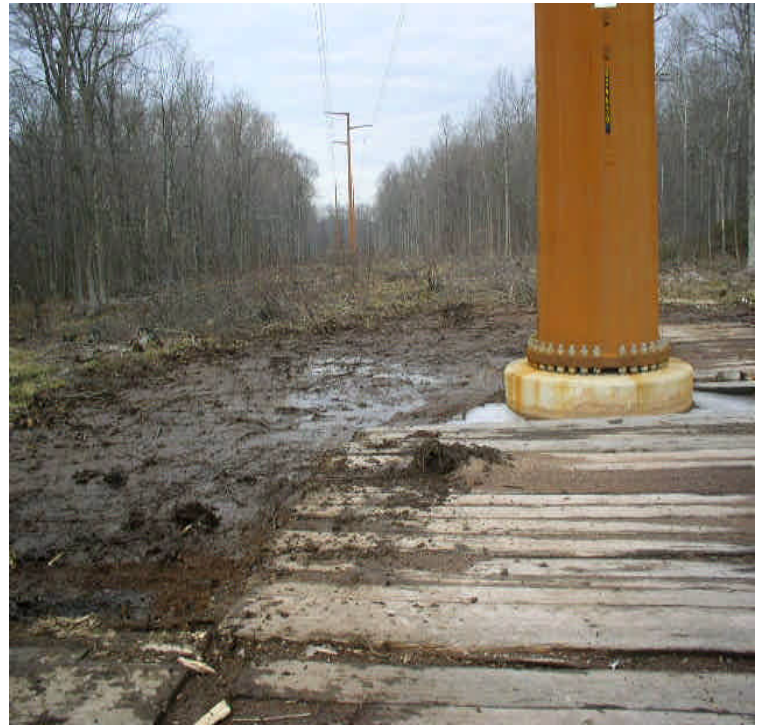
Disturbed area where pads were recently removed within the wetland off Rte 17 near Little Ln. Carefully restore contours upon completion of pad removal and encourage vegetative cover as soon as feasible.
