Docket No. 272 – Development and Management Plan Inspection

Segment 1b (Royal Oaks Bypass) Inspection

Date: January 22, 2008

Location: Segment 1b (Royal Oaks Bypass)

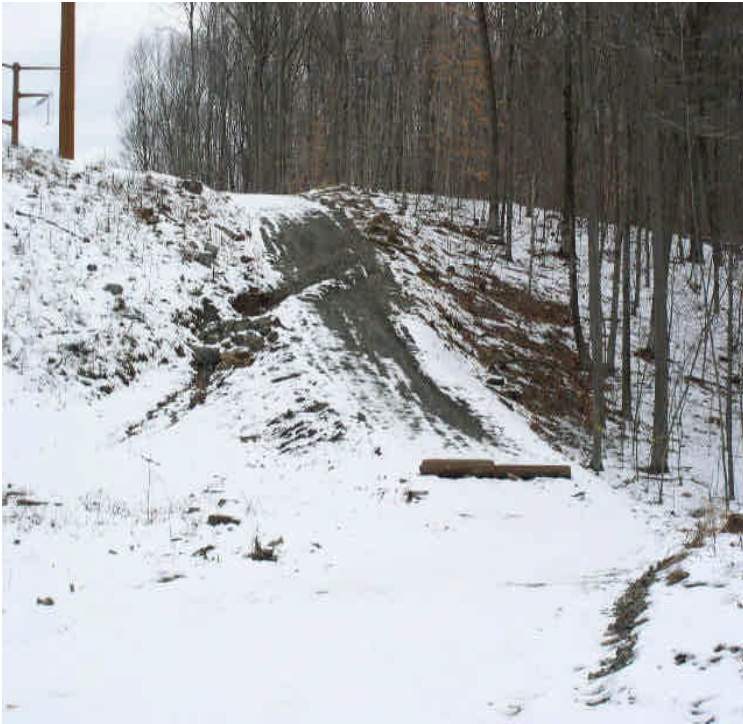
The slope off the Black Walnut Dr. entrance has a drainage ditch/water bar to divert run-off and an old wooden pole to prevent vehicles from driving over and damaging controls.

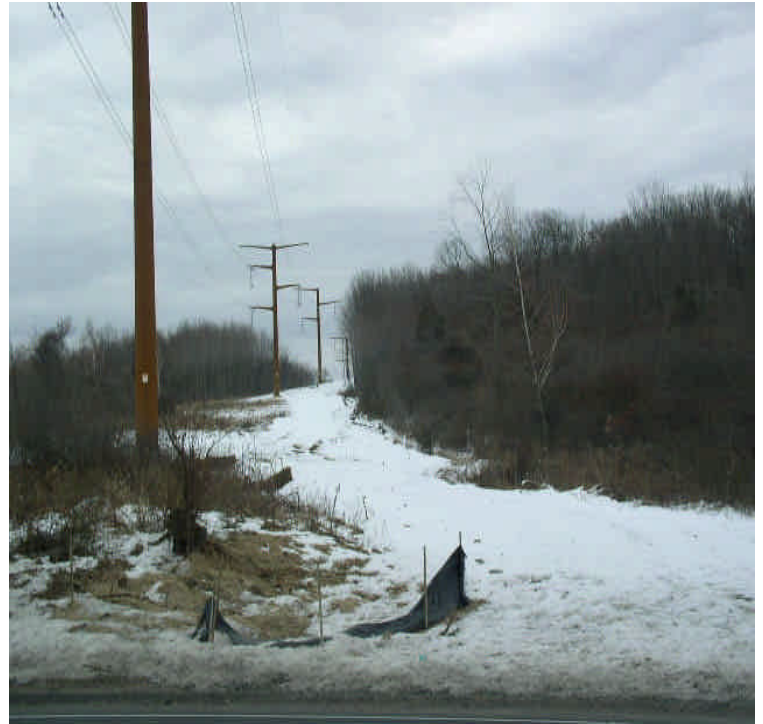
View from the Rt. 17 east entrance: Several areas have been reclaimed and mulch/seed are in place for temporary stabilization. Snow cover and freezing temperatures also help to stabilize.

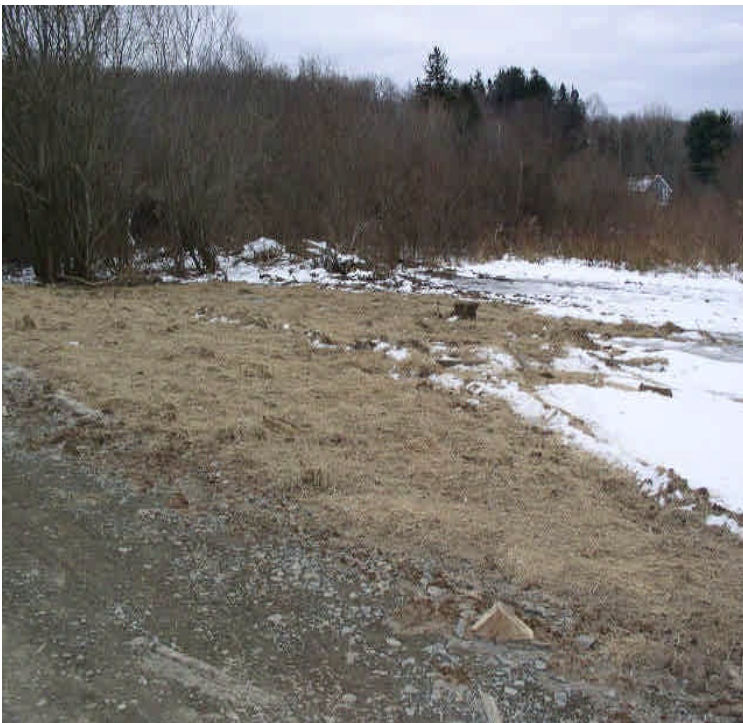
Contractor receiving yard. An old pad and storage site was graded and temporarily stabilized with hay mulch and seed.

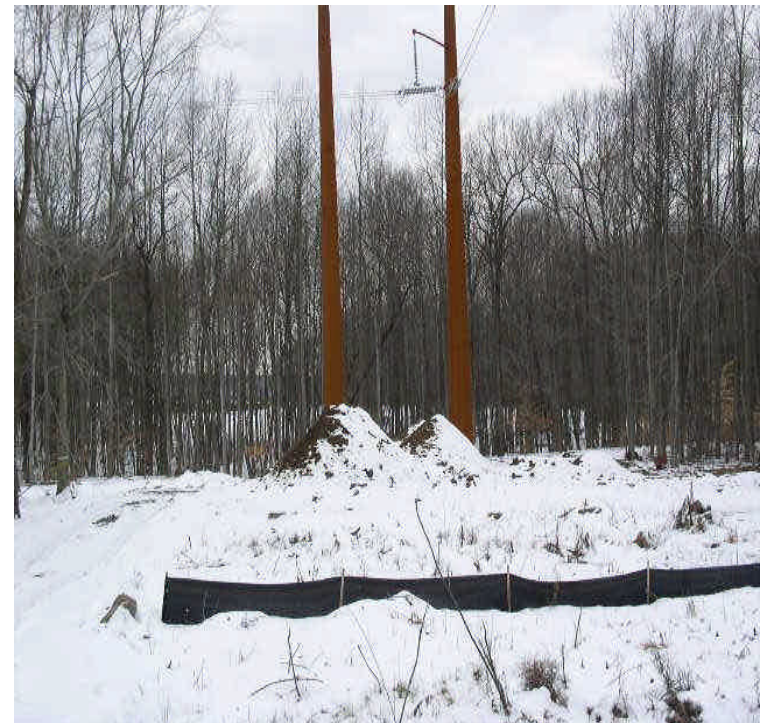
Areas of Inspection	Observation	Recommended Action	Corrected Action
	1/22/08 Most of the soil stockpiles noted along this segment have been removed. However, two stockpiles were noted at the edge of the wetlands near the receiving yard. 1/7-1/22/08	1/22/08 Monitor and add controls as needed. Ensure soil is no stockpiled with 100 feet of wetlands. See erosion control section. 1/7-1/22/08	The two stockpiles near wetlands need attention.
Additional Observations	None. 1/22/08	None. 1/22/08	NA

Soil stockpiles remain near the edge of the wetlands near the receiving yard. Ensure that controls are in place and stockpiles are not stored within 100 feet of wetlands where feasible.
