Docket No. 272 – Development and Management Plan Inspection

Segment 1b (Royal Oaks Bypass) Inspection

Date: January 28, 2008

Location: Segment 1b (Royal Oaks Bypass)

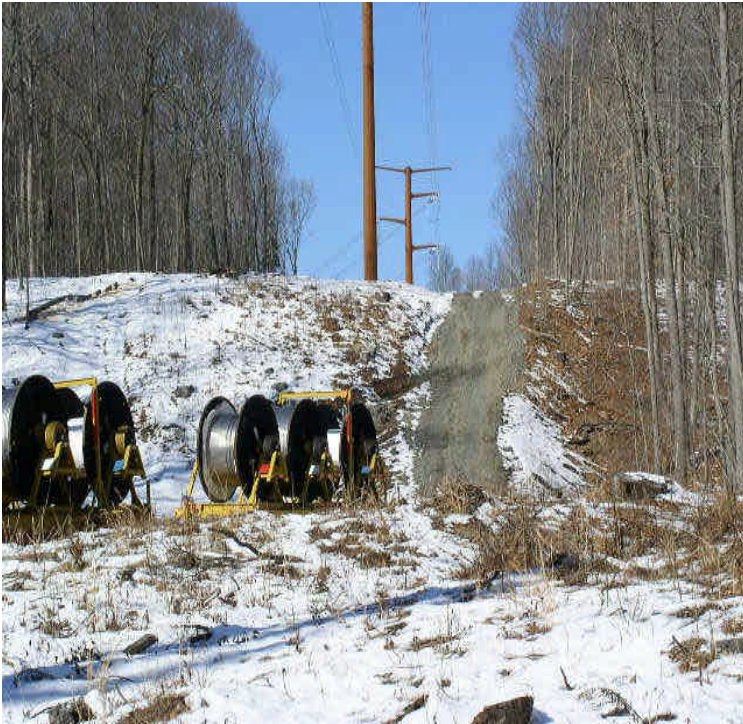
The slope off the Black Walnut Dr. entrance has a drainage ditch/water bar to divert run-off and an old wooden pole to prevent vehicles from driving over and damaging controls.

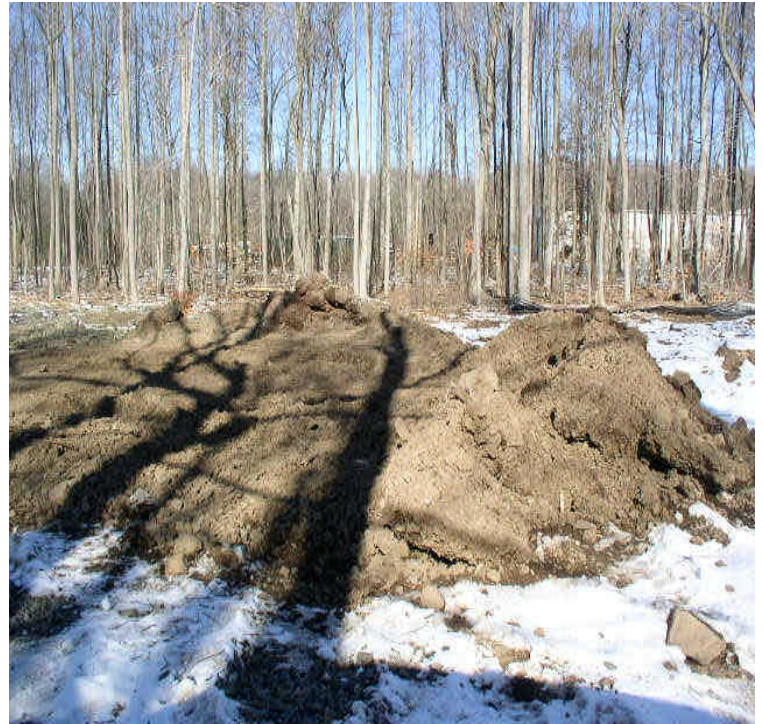
Areas of Inspection	Observation	Recommended Action	Corrected Action
	<p>have been removed. However, stockpiles were noted at the edge of the wetlands near the receiving yard. 1/7-1/28/08</p>	<p>not stockpiled with 100 feet of wetlands. See erosion control section. 1/7-1/28/08</p>	<p>attention.</p>
<p>Additional Observations</p>	<p>None. 1/28/08</p>	<p>None. 1/28/08</p>	<p>NA</p>

Soil stockpiles located at the turn in the ROW, accessed from the receiving yard.

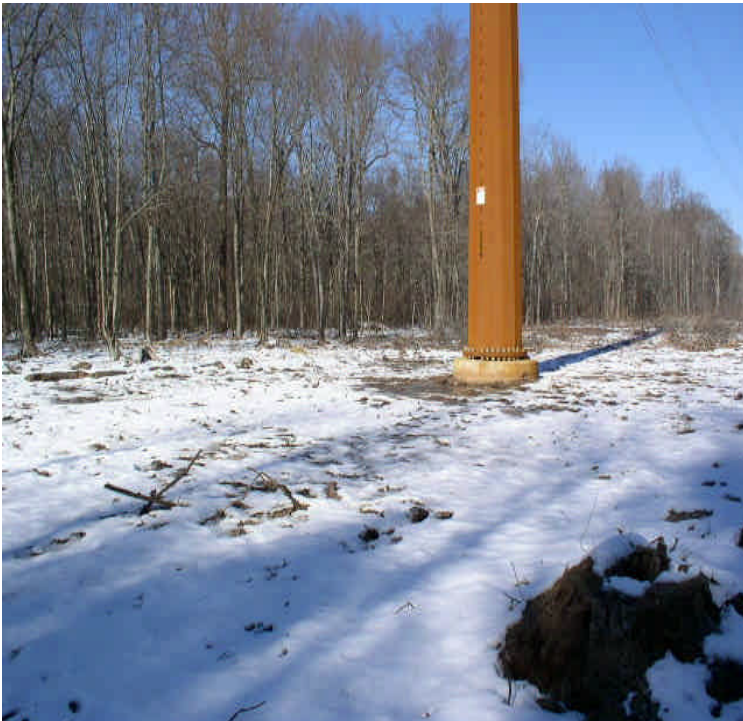
Timber mats have been removed from the Rte 17 access near Little Ln. Stabilization is needed when weather conditions permits.

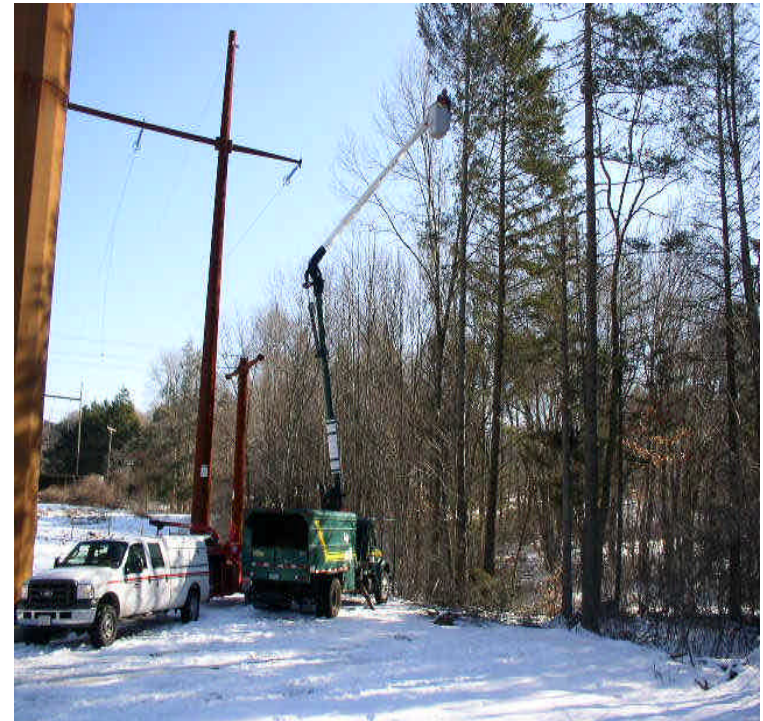
Little Lane: Minor tree trimming underway at the edge of the ROW.
