Docket No. 272 – Development and Management Plan Inspection

Segment 1b (Royal Oaks Bypass) Inspection

Date: February 25, 2008

Location: Segment 1b (Royal Oaks Bypass)

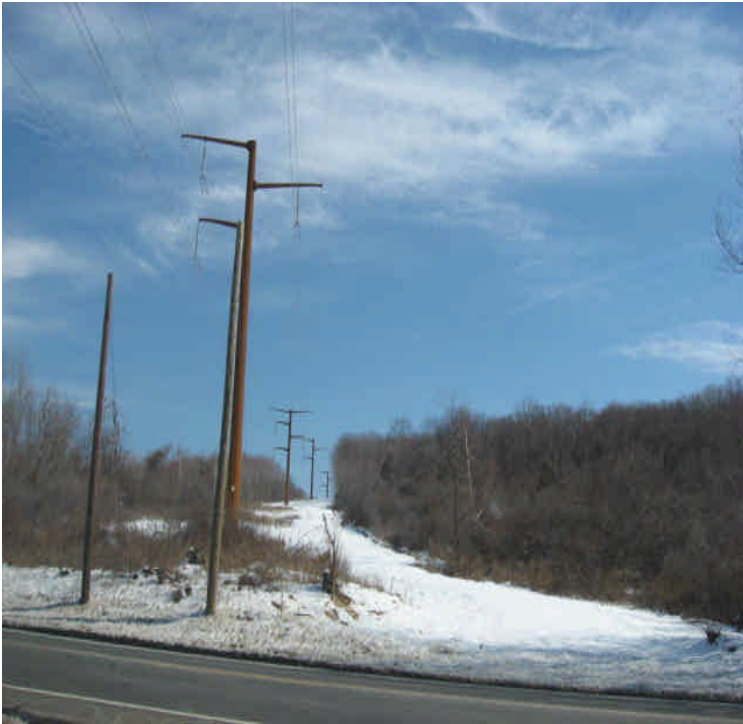
East of Rte 17: Snow cover has returned and slopes are frozen and temporarily stable.

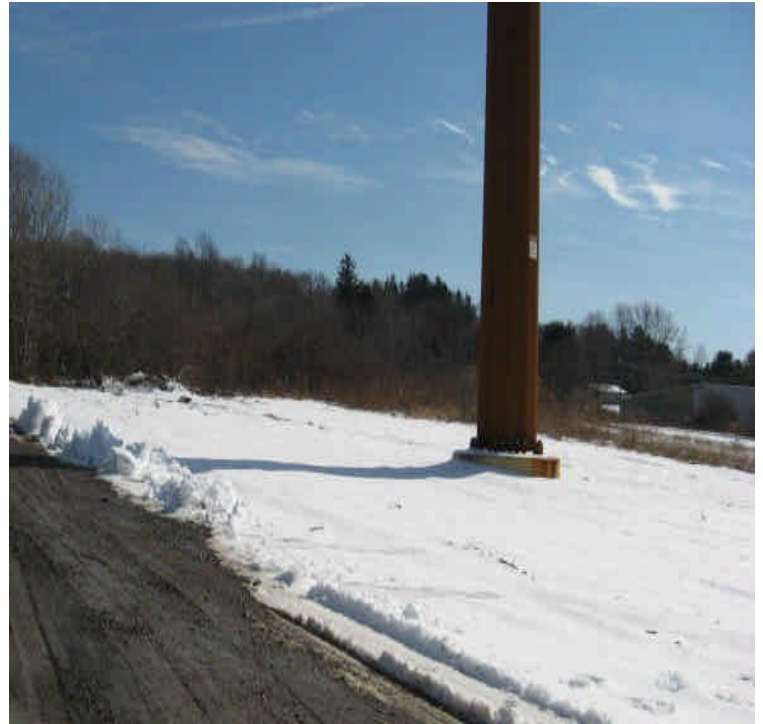
Prior to snow cover, exposed/reclaimed areas had been mulched and seeded west of Rte 17 in the receiving yard.

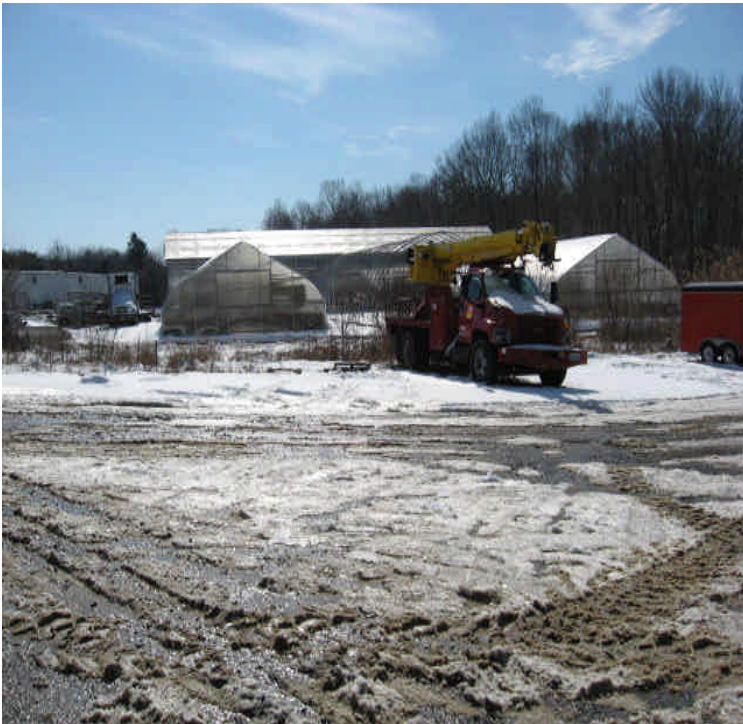
The sanitary facility previously observed upgradient from wetlands has been relocated and stored away from resource areas.

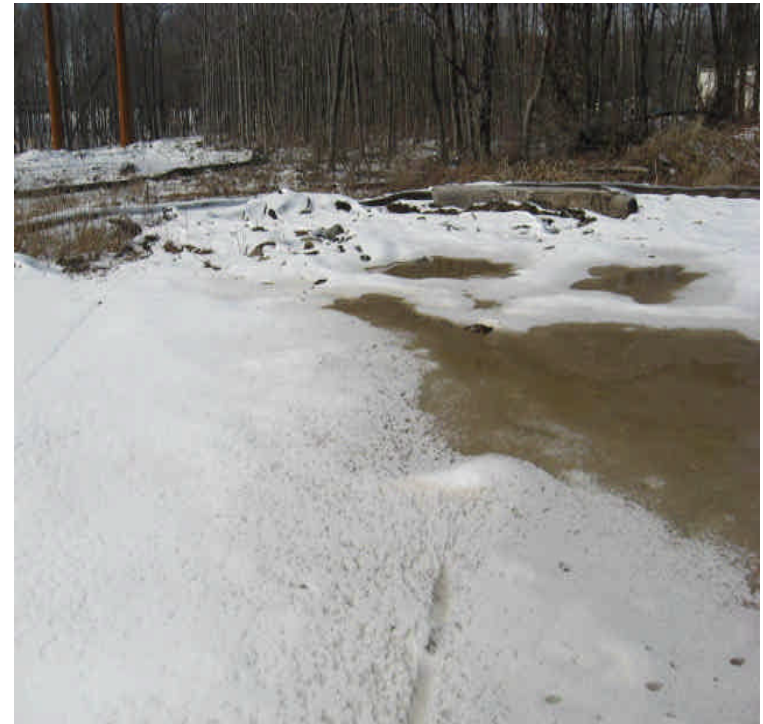
Turbid water is pooling at the edge of the receiving yard. However, it was observed filtering through controls before entering the wetland
