Docket No. 272 – Development and Management Plan Inspection

Segment 1b (Royal Oaks Bypass) Inspection

Date: March 3, 2008

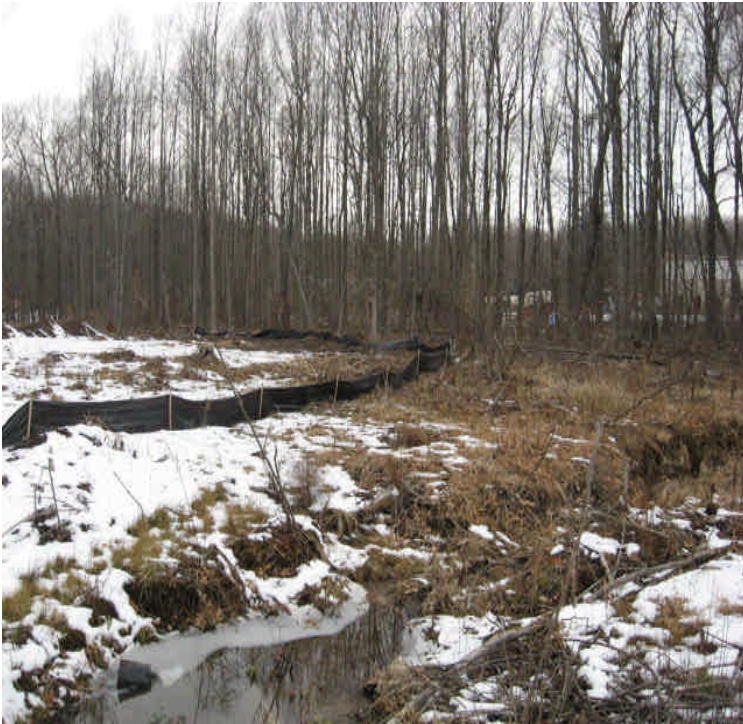
Controls remain around the old pull site. Stabilize/restore soils as soon as feasible.

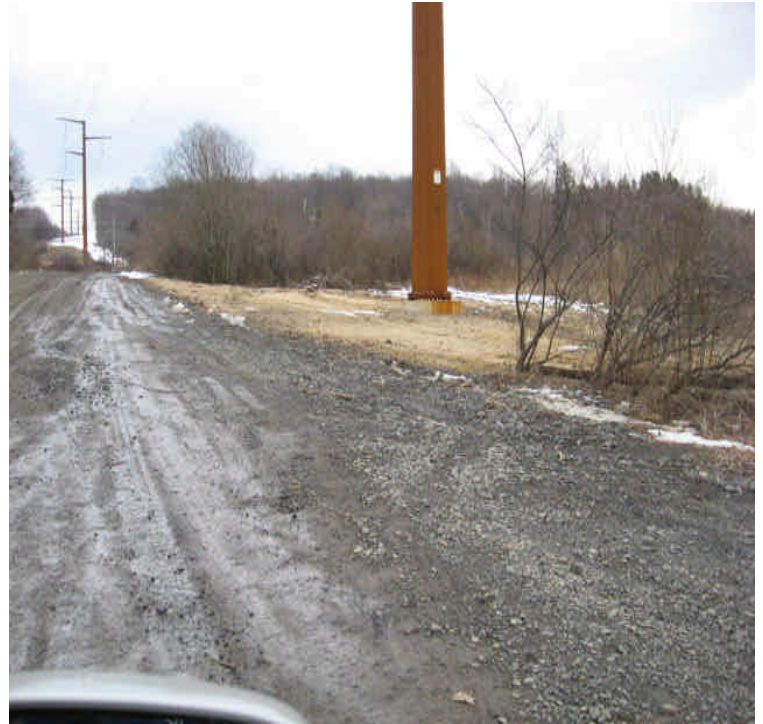
Exposed/reclaimed areas remain mulched and seeded west of Rte 17 in the receiving yard.

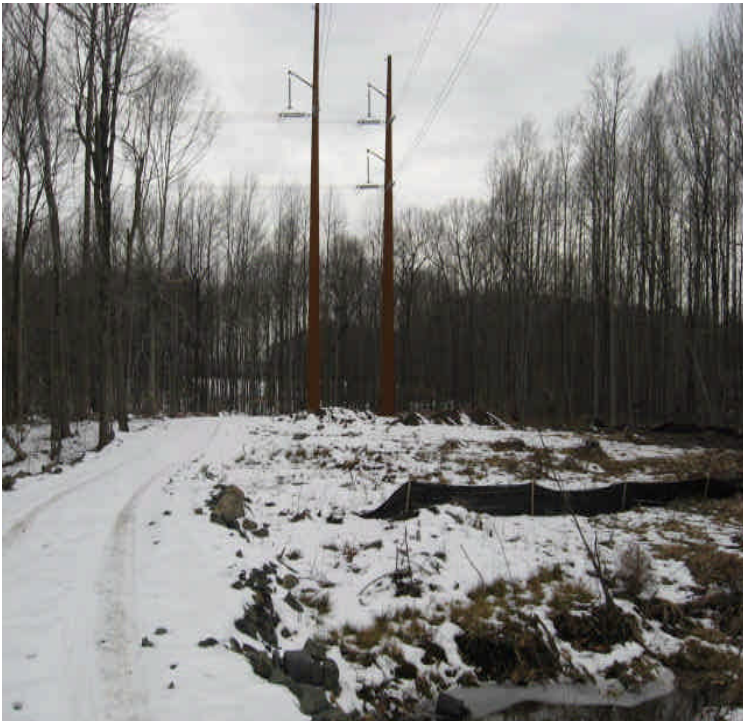
View of the exposed stockpiles. Topography here appears to reduce the potential of run-off to wetlands.

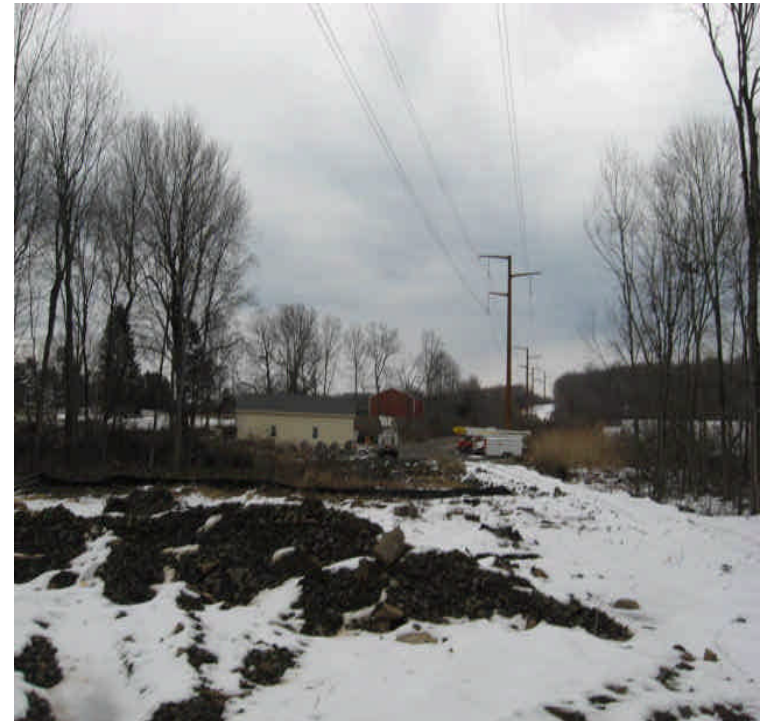
Access road from the receiving yard was still under snow cover. No run-off noted.
