**Docket No. 272 – Development and Management Plan Inspection**

**Segment 1b (Royal Oaks Bypass) Inspection**

**Date:** March 10, 2008

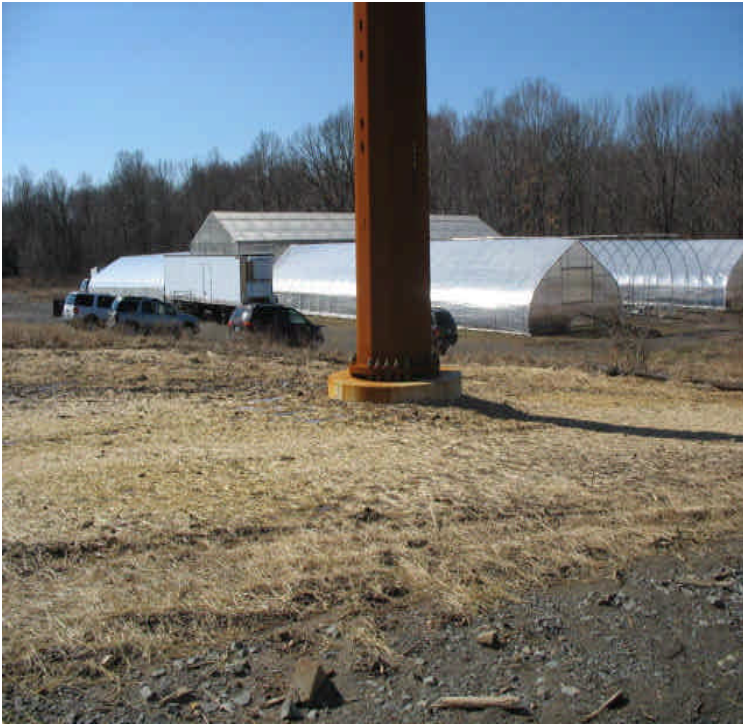
**Hay and mulch were applied at a reclaimed pad site within the the receiving yard . Fiber roll controls are installed downgradient from the exposed area.**

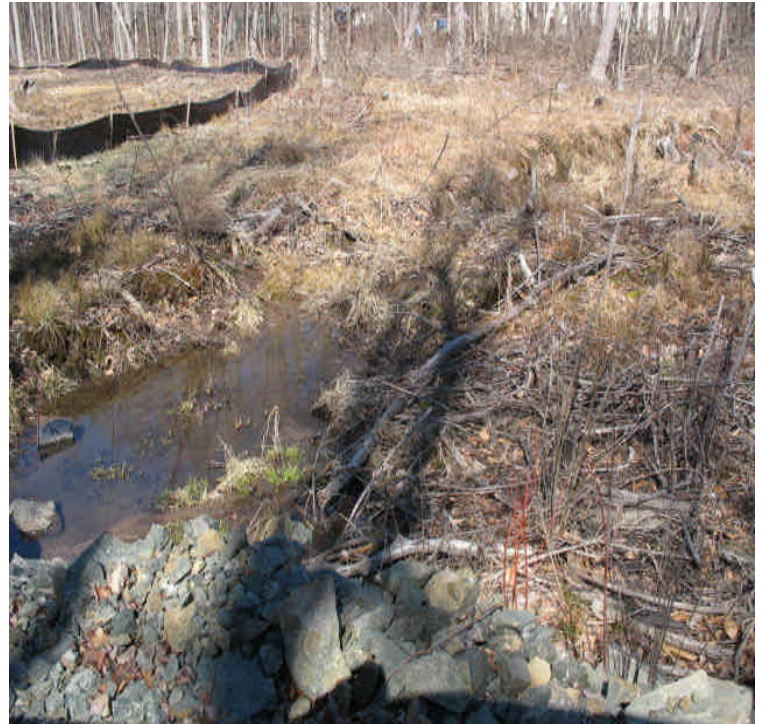
**Clear water was flowing in the stream adjacent to the receiving yard.**

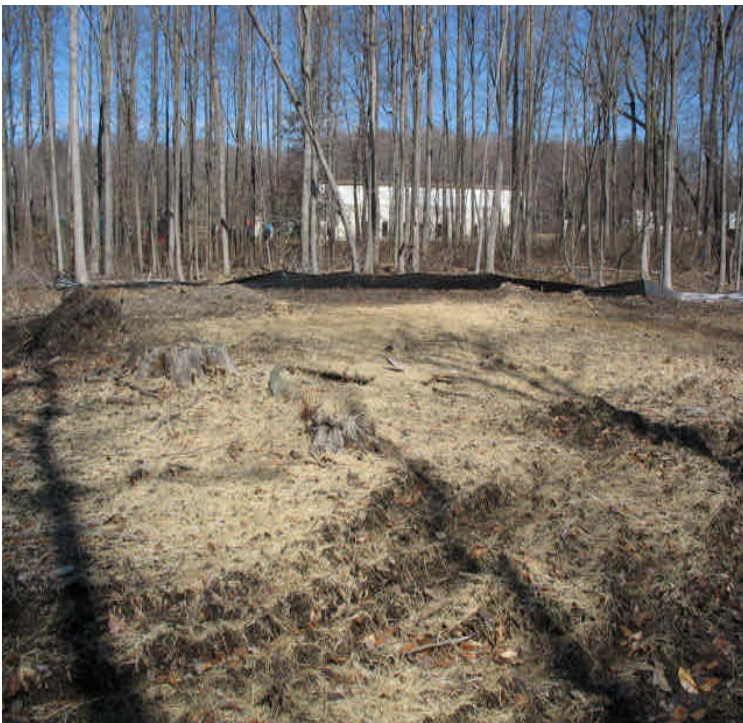
**Hay and seed were applied over the reclaimed pull site. Silt fence was installed adjacent to the wetland.**

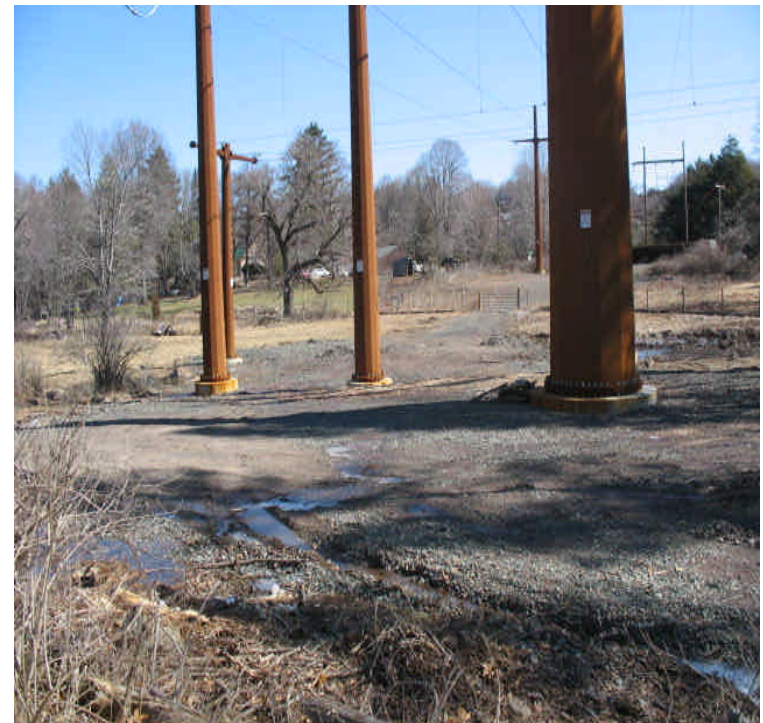
**View of the 1A and 1B intersection off Little Lane. Controls are in place. Reclaim the pad sites when feasible.**
