Docket No. 272 – Development and Management Plan Inspection

Segment 1b (Royal Oaks Bypass) Inspection

Date: March 18, 2008

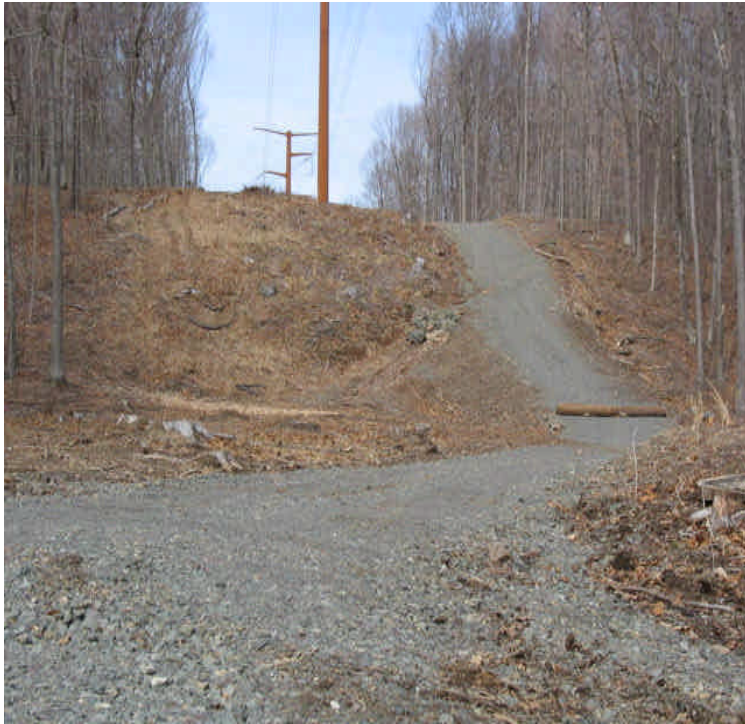
View of site entrance off Black Walnut Drive with water bar controls.

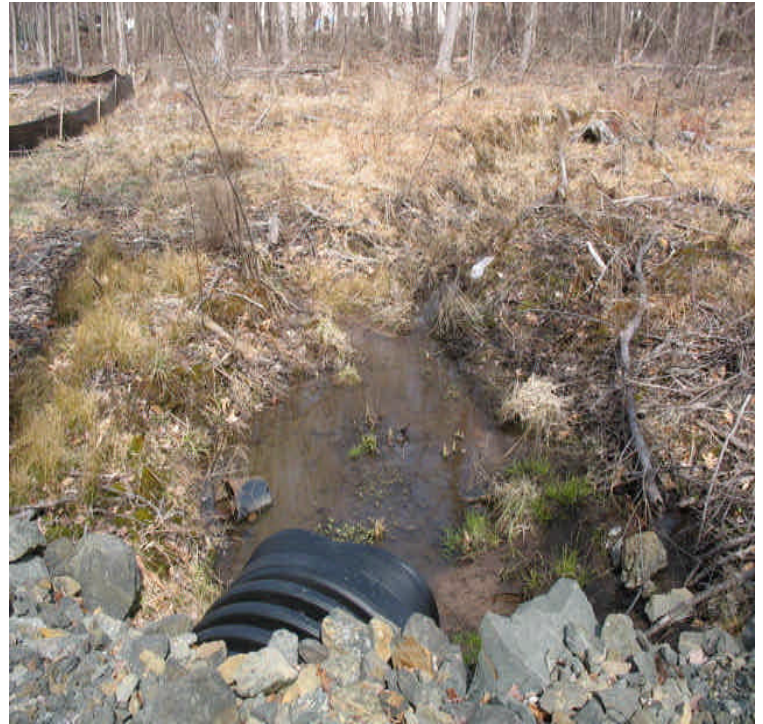
Clear water was flowing in the stream adjacent to the receiving yard.

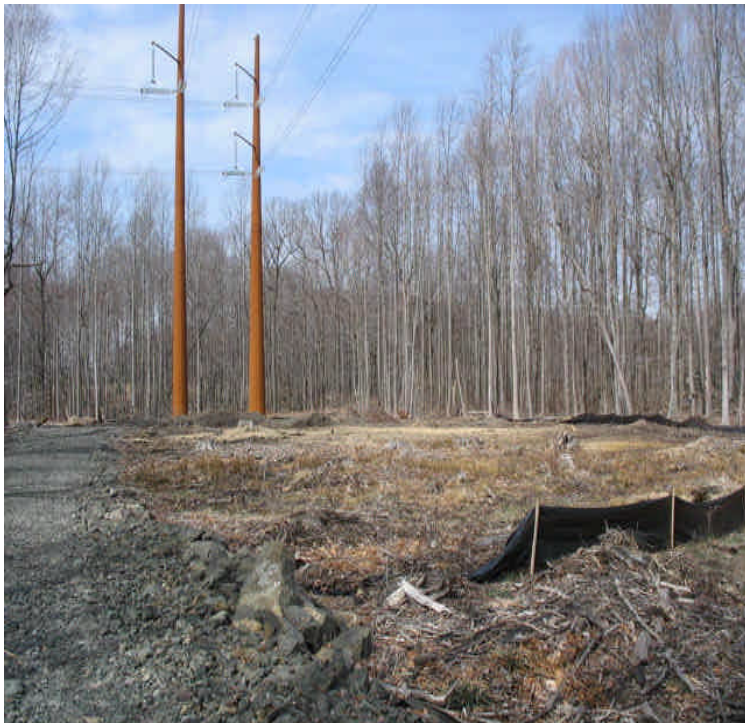
Hay and seed were applied over the reclaimed pull site. Silt fence remains in place adjacent to the wetland.

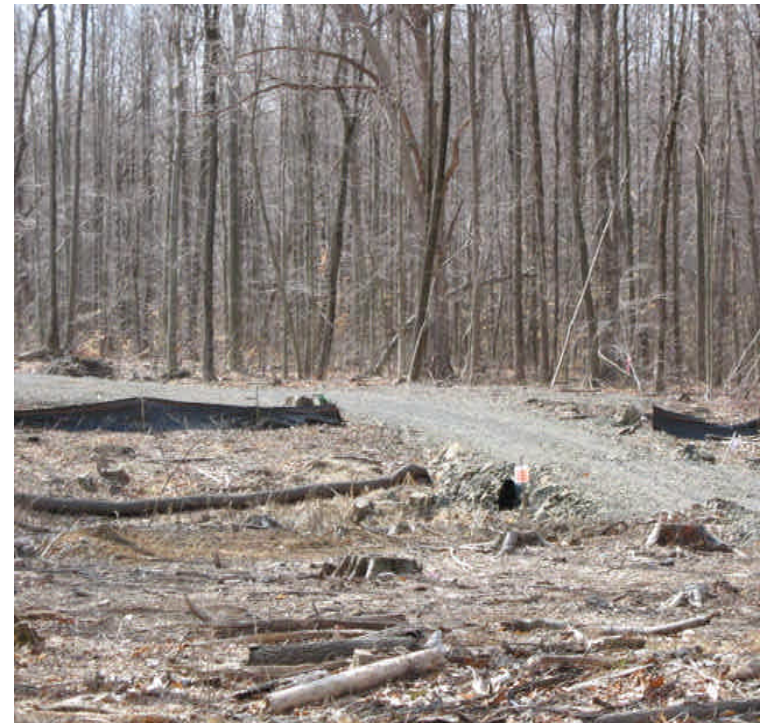
View of the stream crossing on the access road from the receiving yard. Controls are in place.
