**Docket No. 272 – Development and Management Plan Inspection**

**Segment 1b (Royal Oaks Bypass) Inspection**

**Date:** March 24, 2008

**Location:** Segment 1b (Royal Oaks Bypass)

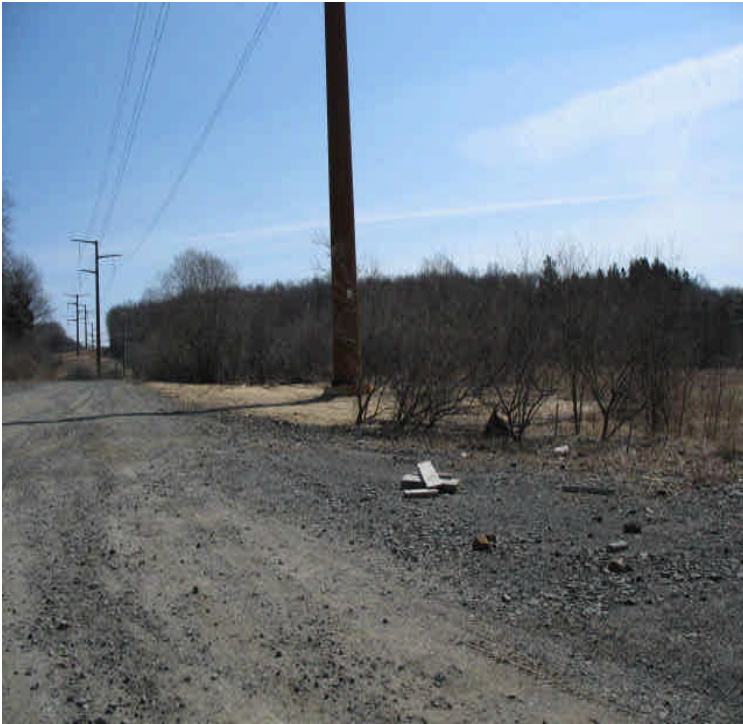
**View of mulch and seed over the exposed area within the receiving yard.**

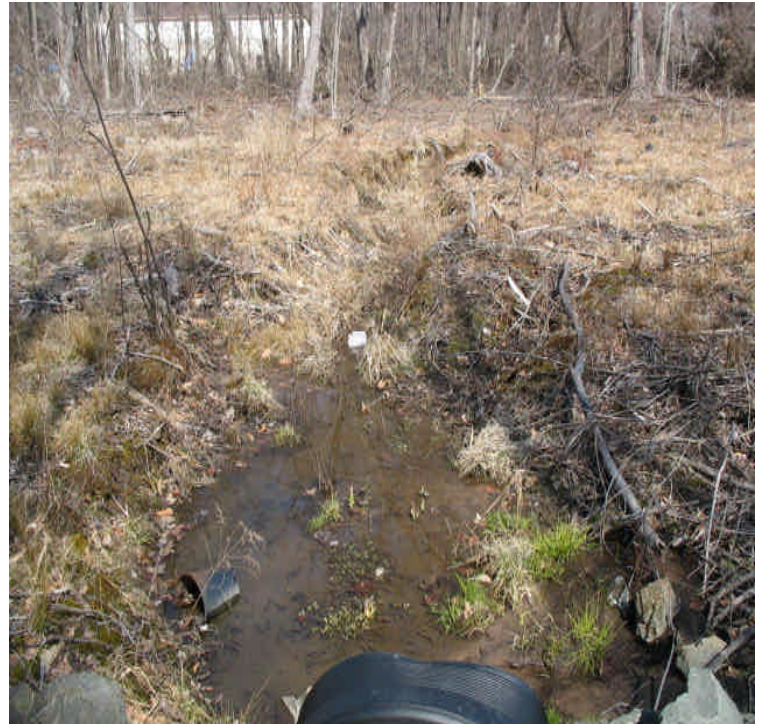
**Clear water was flowing in the stream adjacent to the receiving yard.**

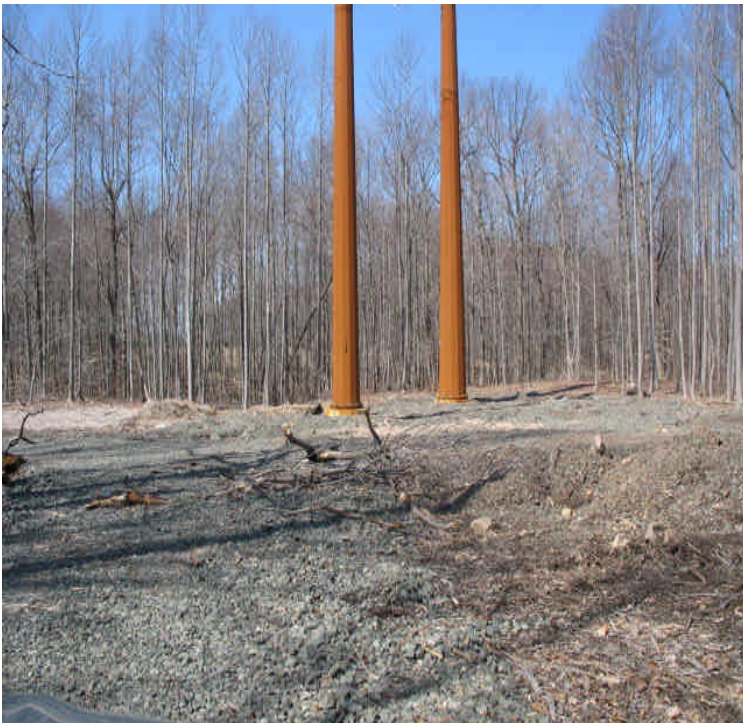
**Final reclamation is still needed from the turn in the ROW at the receiving yard to Little Ln.**

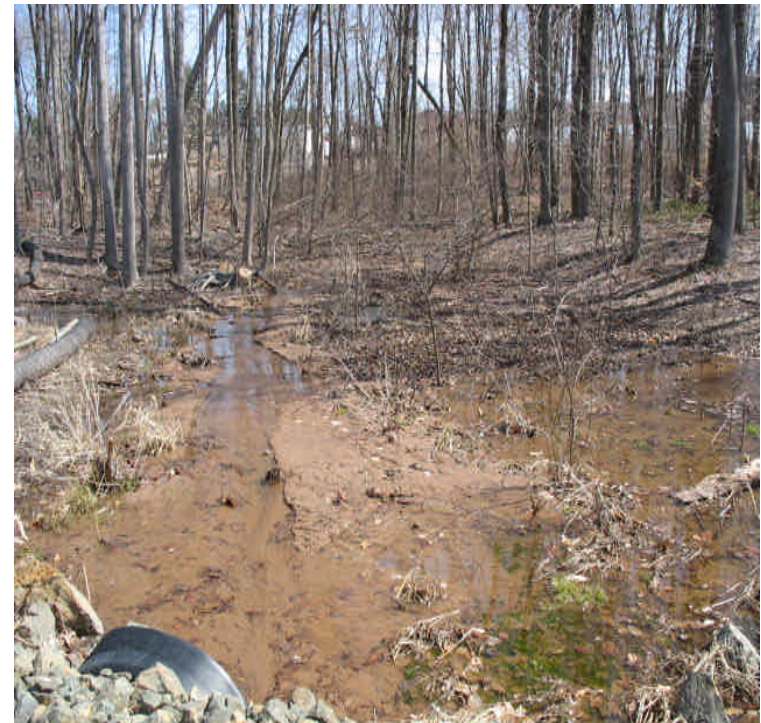
**Controls remain in place at the access road stream crossing from the receiving yard. It appears that some sediment from the pond has settle accumulated within the wetlands. It is likely that sediment in the pon is due to the landowner and not project activities. However, consider carefully removing the sediment at this location.**
