Docket No. 272 – Development and Management Plan Inspection

Segment 1b (Royal Oaks Bypass) Inspection

Date: March 31, 2008

Location: Segment 1b (Royal Oaks Bypass)

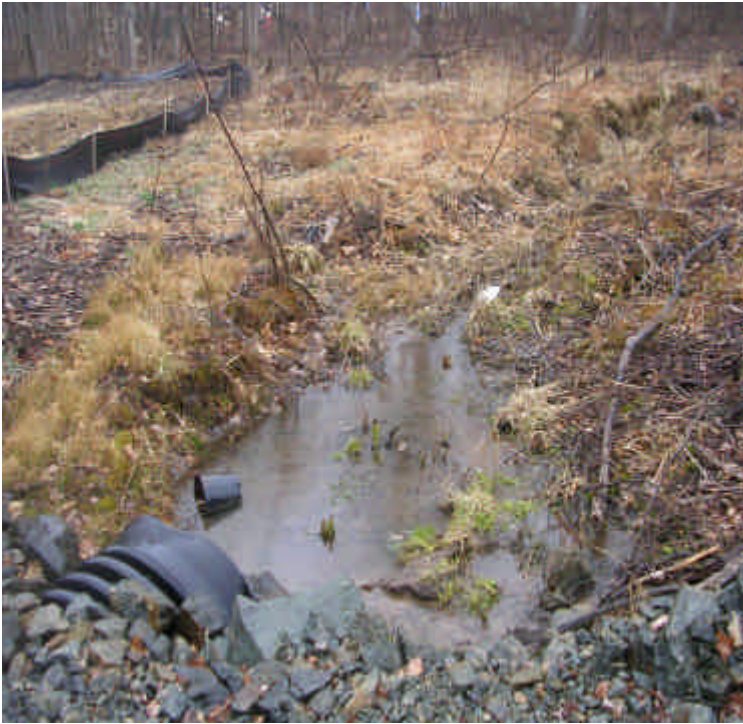
Clear water flowing in the stream adjacent to the receiving yard.

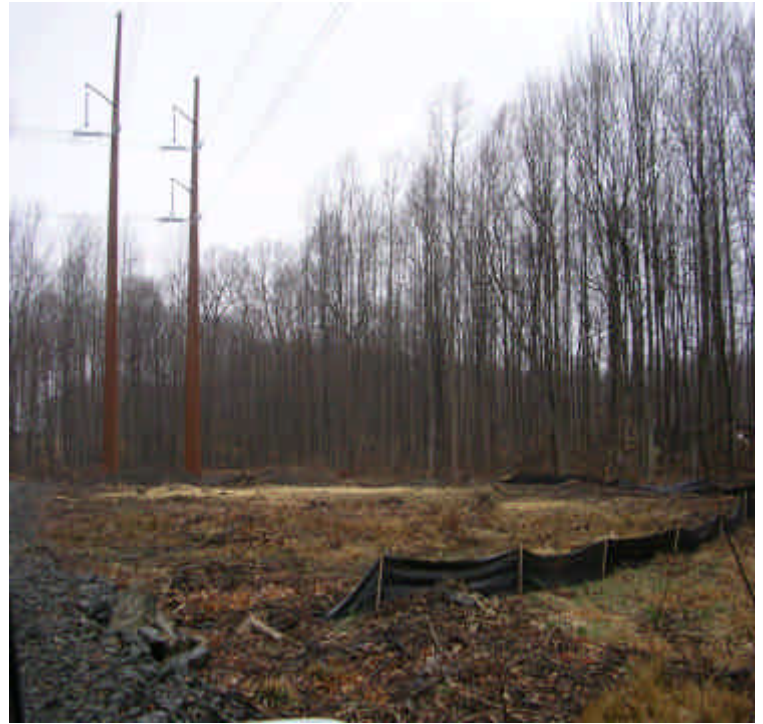
CSC approved line-pulling area. Stone was pulled back from wetland and stockpiled. Controls remain in place along with hay/seed.

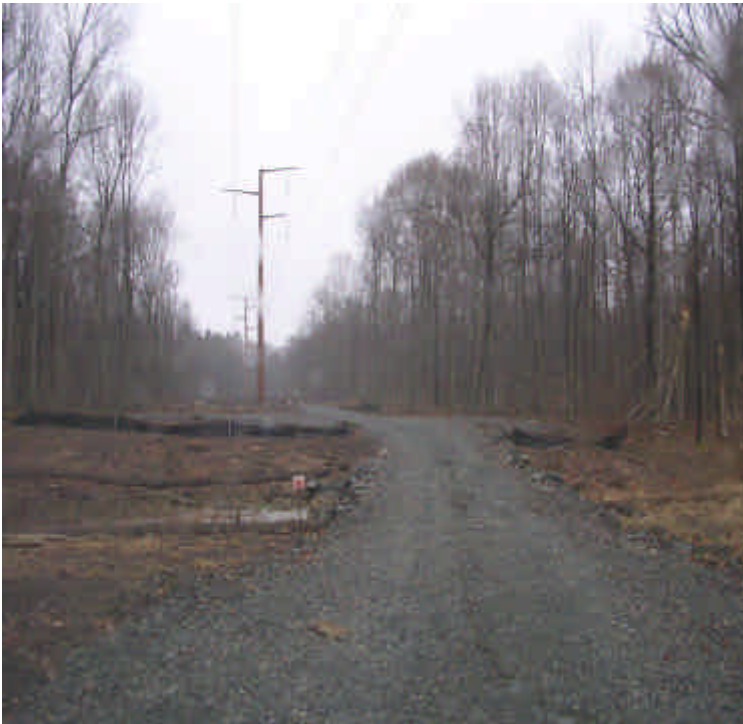
Wetland crossings and final pad sites awaiting reclamation within the watershed.

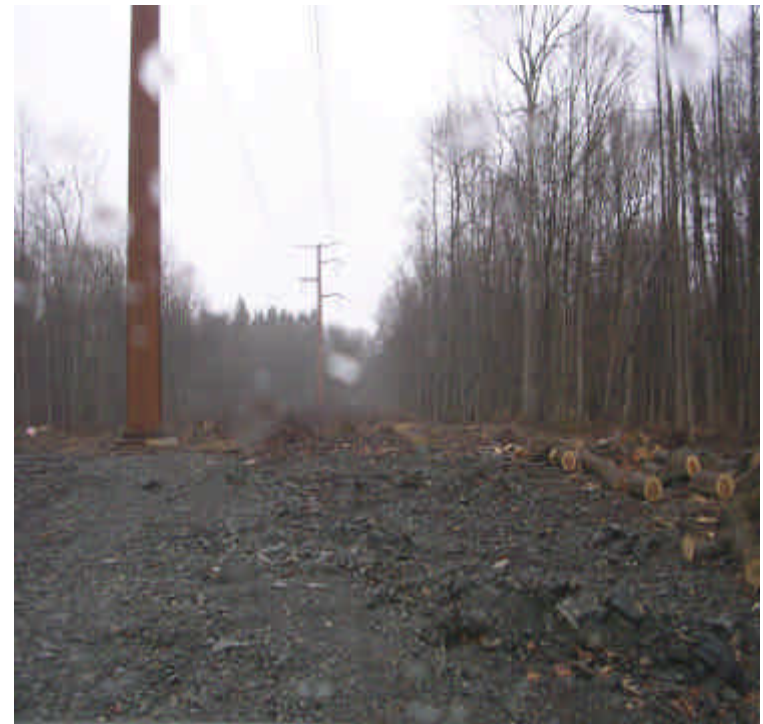
View of the final pad before the no access area looking toward Little Lane.
