Docket No. 272 – Development and Management Plan Inspection

Segment 1b (Royal Oaks Bypass) Inspection

Date: April 7, 2008

Location: Segment 1b (Royal Oaks Bypass)

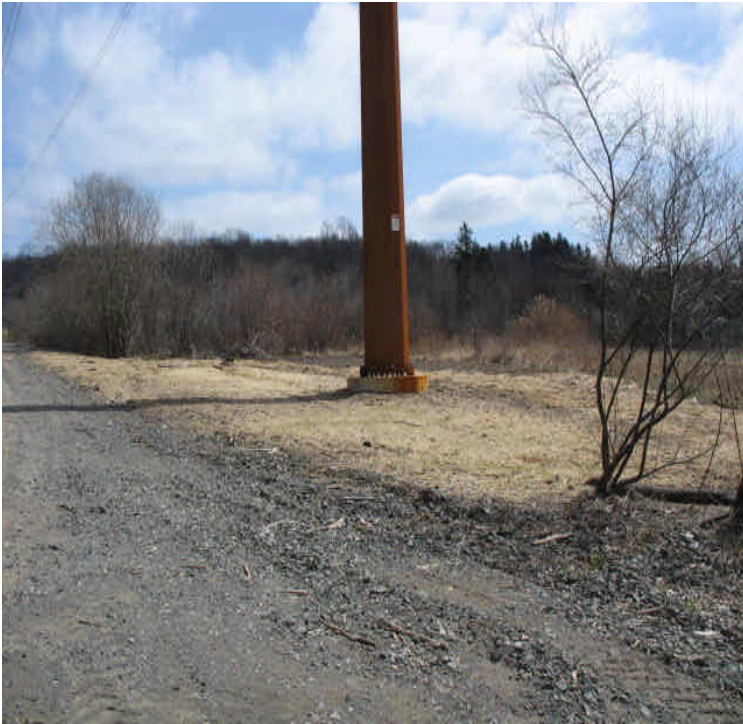
View of reclaimed pad within the receiving yard.

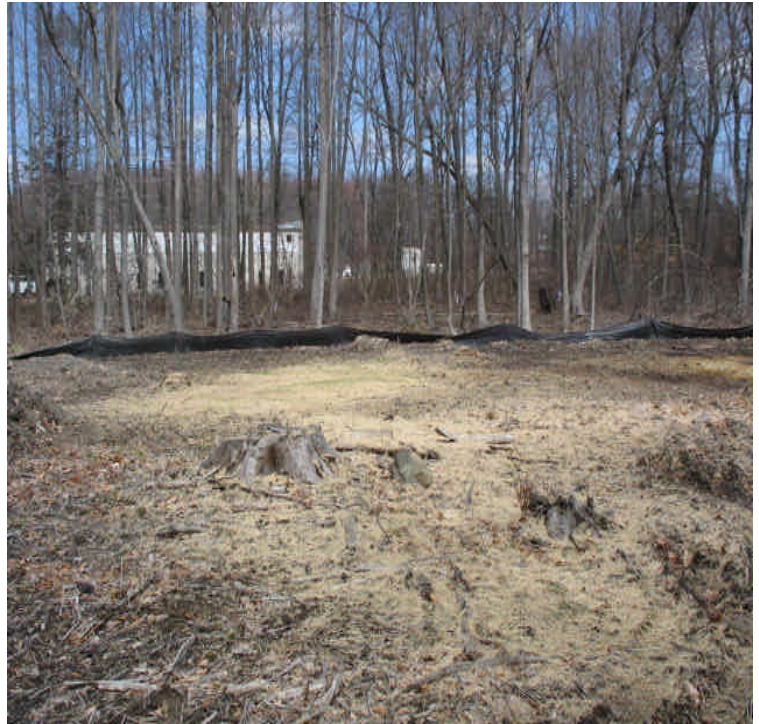
View of the CSC approved line-pulling area. Stone was pulled back from wetlands and stockpiled. Controls remain in place along with hay/seed

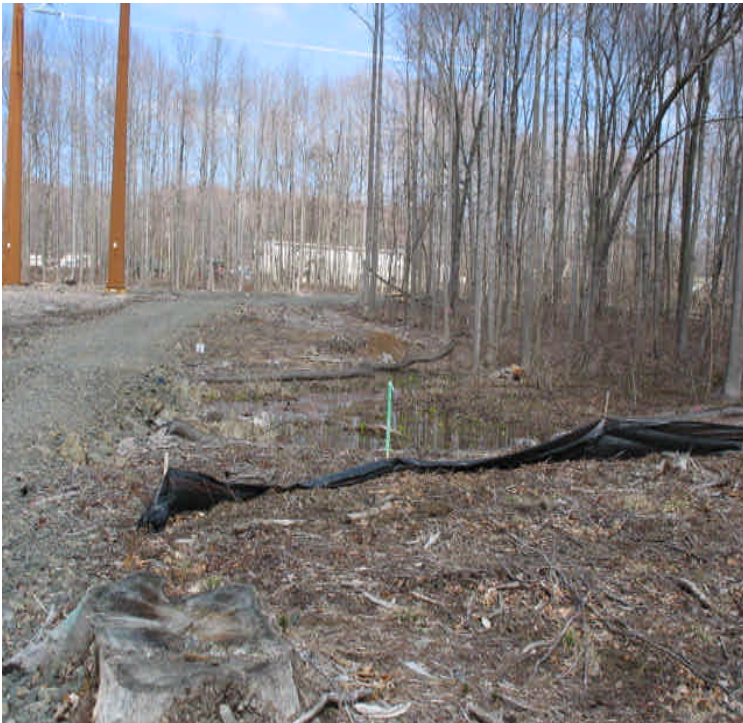
Wetland crossing and pad sites are awaiting reclamation within the watershed

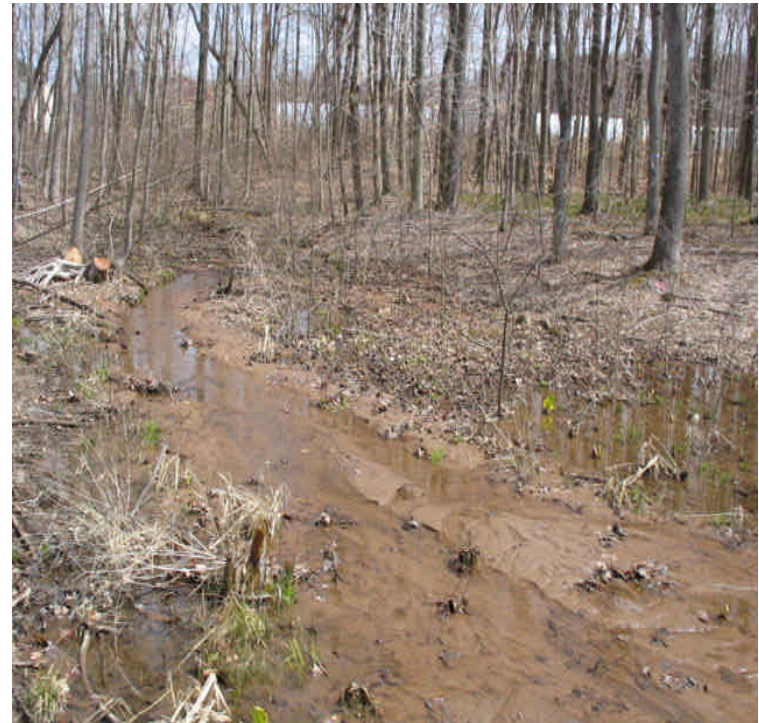
Areas of Inspection	Observation	Recommended Action	Corrected Action
<p>encroachment and mitigation</p>	<p>receiving yard wetlands. Three streams were crossed with culverts. Controls and mulch are in place adjacent to the roads. 4/7/08</p> <p>One of the streams has a considerable amount of sediment accumulation in the wetlands at the culvert, likely from turbidity from the pond. 3/24-4/7/08</p> <p>In accordance with the D&M Plan, all work occurring in and around wetlands should be expedited to minimize potential adverse impacts to wetlands and reduce disturbances to wetland soils. This includes attending to restoration in adjacent upland areas when work is complete. Reclamation has occurred several areas. Wetland areas within the watershed are waiting for reclamation. 4/7/08</p>	<p>controls as needed to prevent road run-off. Wetland crossings are temporary and material will have to be removed when work is complete. 4/7/08</p> <p>Although turbidity in the pond appears to be landowner related, consider carefully removing the sediment accumulation in the wetlands to improve conditions. 3/24-4/7/08</p> <p>Final stabilization and reclamation efforts should occur in completed areas in and around wetlands. Any additional work needed in and around wetlands should be expedited to allow for final stabilization procedures to commence. 4/7/08</p>	<p>Needs evaluation and consideration.</p> <p>Reclamation has occurred in several areas. Continue to evaluate.</p>

Controls remain in place at the access road stream crossing from the receiving yard. It appears that some sediment from the pond has settled accumulated within the wetlands. It is likely that sediment in the pond is due to the landowner and not project activities. However, consider carefully removing the sediment at this location.
