Docket No. 272 – Development and Management Plan Inspection

Segment 1b (Royal Oaks Bypass) Inspection

Date: April 14, 2008

Location: Segment 1b (Royal Oaks Bypass)

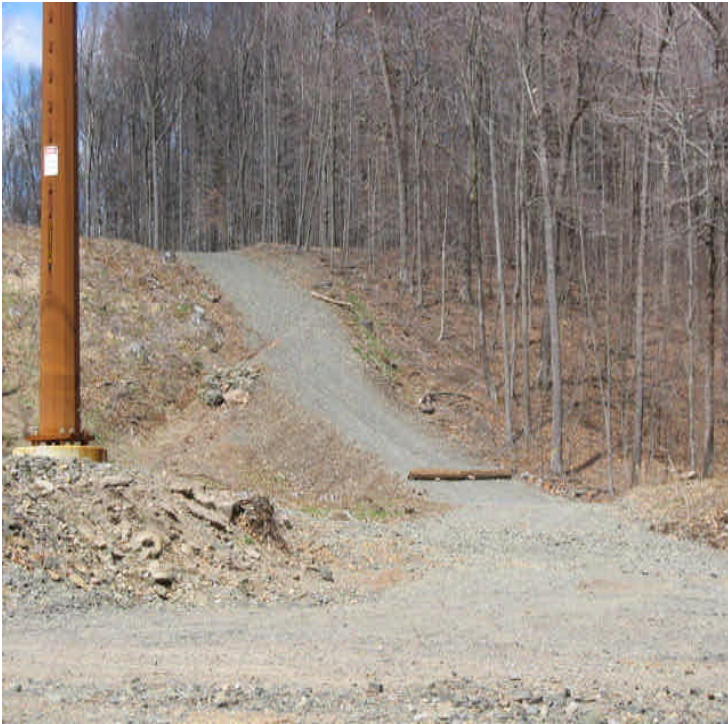
Site entrance off Black Walnut Drive, still closed to vehicles.

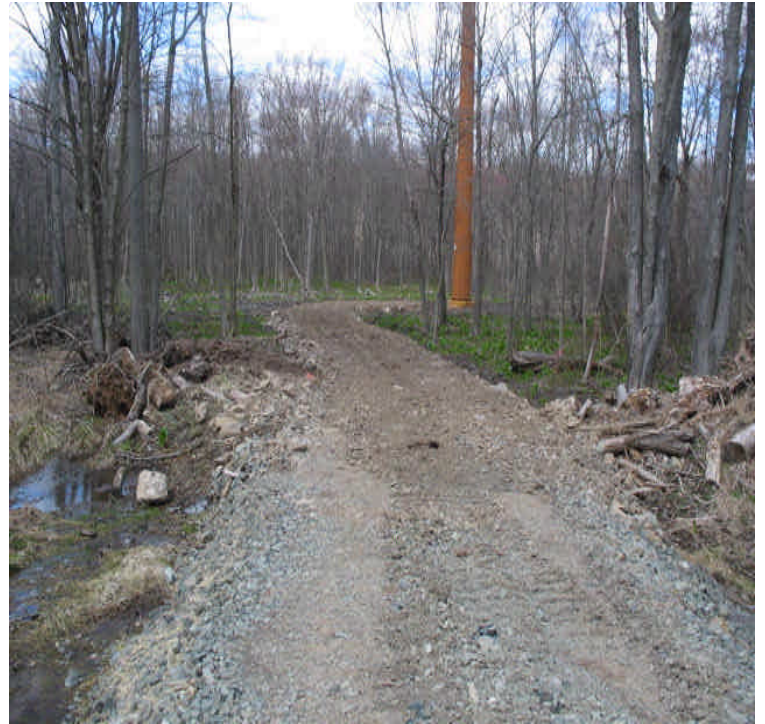
New stone access road installed west off Rte 17 between the receiving yard and north of Little Lane, in order to maintain access to structure #24580.

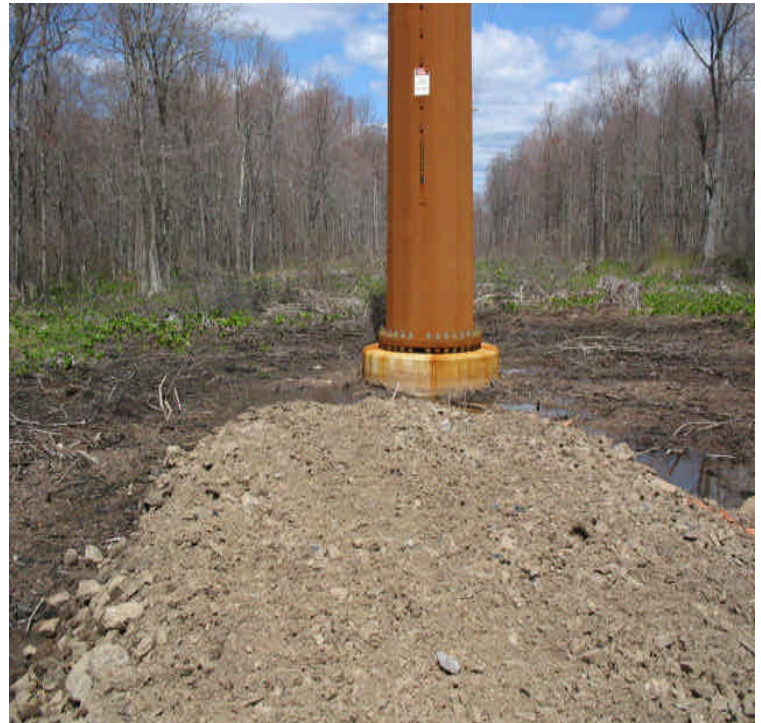
End of the new access road at structure #24580. Exposed area of soils noted from timber mat removal. Amphibians were noted within a small pool at the end of the access road near the new structure. Final stabilization/restoration still needed here.
