**Docket No. 272 – Development and Management Plan Inspection**

**Segment 1b (Royal Oaks Bypass) Inspection**

**Date:** April 29, 2008

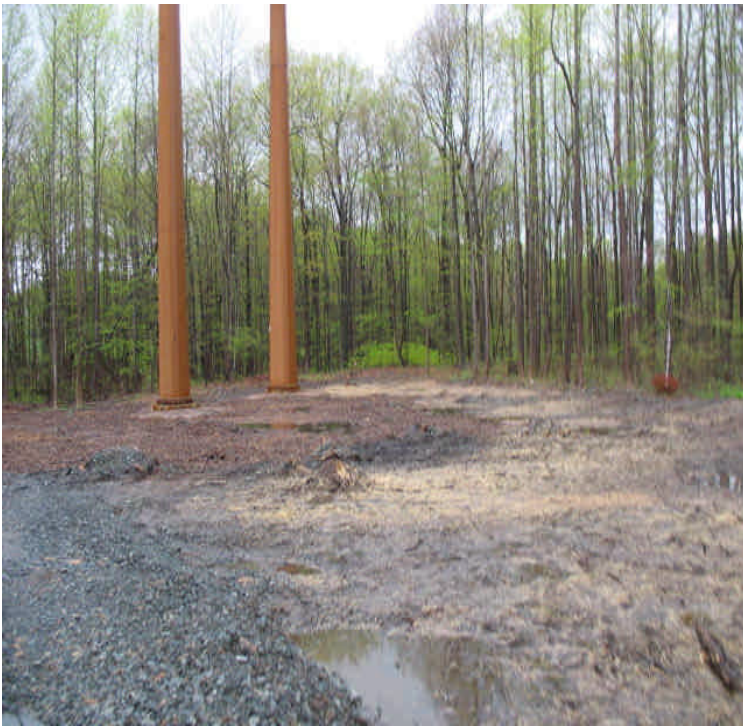
**Small stockpiles have been removed from the upland adjacent to the contractor yard.**

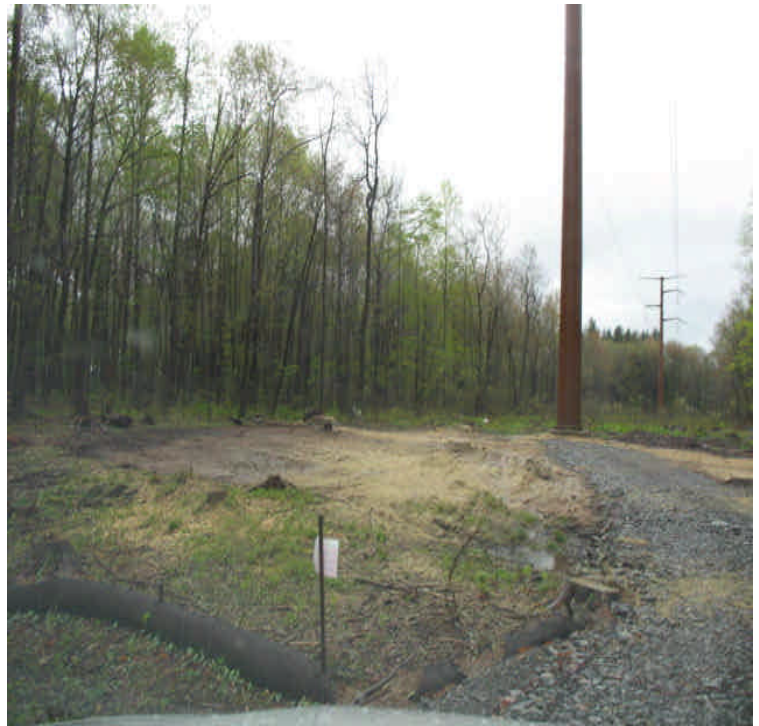
**Stone pad was removed, graded and hay and seed applied at structure #24531.**

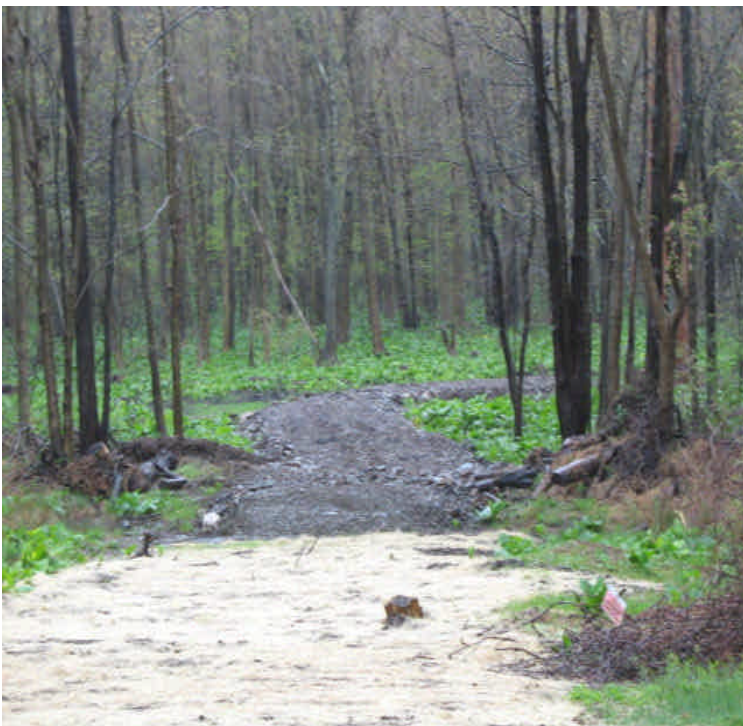
| Areas of Inspection | Observation | Recommended Action | Corrected Action |
|---|---|---|---|
| | <p>structure #24530) where timber mats had been removed. The access road bisects a small channel and a culvert was not installed. This area is flooding and forming a new channel around the access road. 4/14-4/29/08</p> <p>The area from Rte 17 to the edge of the wetlands remains reclaimed with mulch and seed. A gate is in place off Rt 17. 4/29/08</p> <p>The timber mats, pads, and access roads located from Rte 17 to Little Ln were removed, graded, and seeded. 4/29/08</p> | <p>maintain the hydrology in the currently bisected channel. 4/14-4/29/08</p> <p>Contractors will be evaluating this and may wait to make repairs/improvements during low flow. 4/29/08</p> <p>Continue to monitor for final stabilization and vegetative cover. Access through here may still be needed in order to maintain hydrology at the crossing. 4/21-4/29/08</p> <p>Monitor this area for run-off and add controls as needed until stable. 4/29/08</p> | <p>Contractors are evaluating this area.</p> <p>Monitor for stabilization.</p> <p>Restoration is complete. Monitor for stabilization.</p> |

**Water levels were higher at the channel bisected by the new access road. Either reduce the grade or install a culvert to maintain flow/hydrology in this area. Contractors will be evaluating this area but improvements will likely wait until a low flow period.**

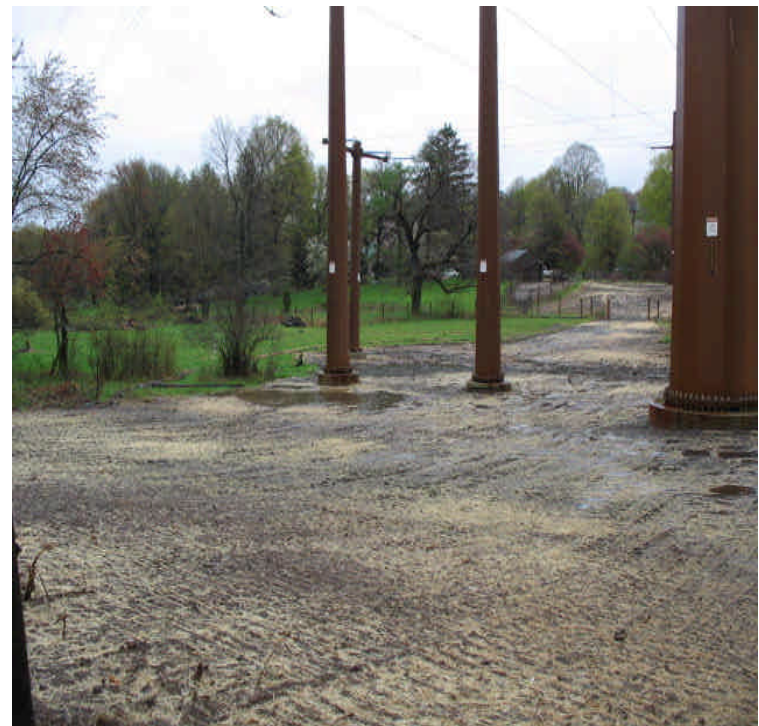
**Timber mat removal and final grading from Rte 17 to Little Ln is complete. Monitor for final stabilization with vegetative cover.**
