Docket No. 272 – Development and Management Plan Inspection

Segment 1b (Royal Oaks Bypass) Inspection

Date: May 5, 2008

Location: Segment 1b (Royal Oaks Bypass)

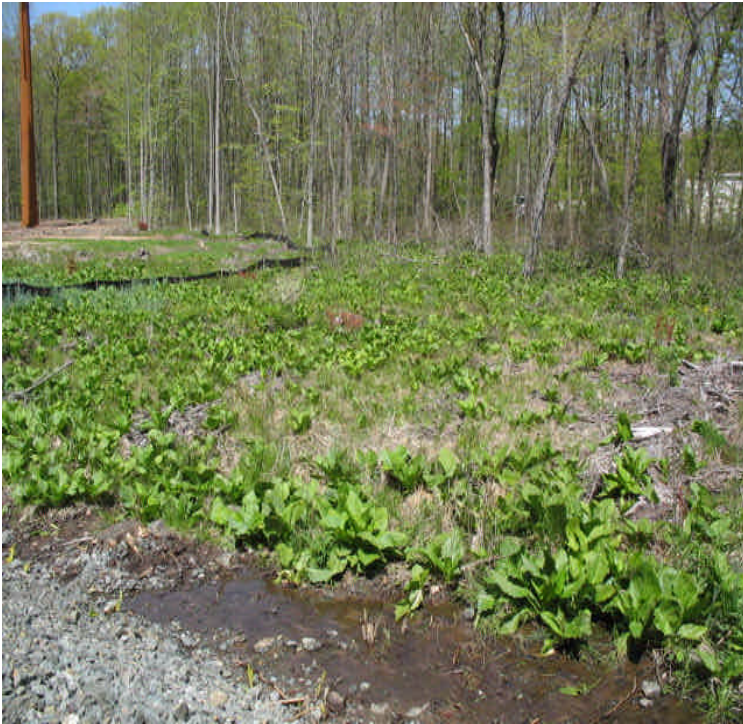
Clear water and new vegetative growth noted in the wetlands adjacent to the contractor yard.

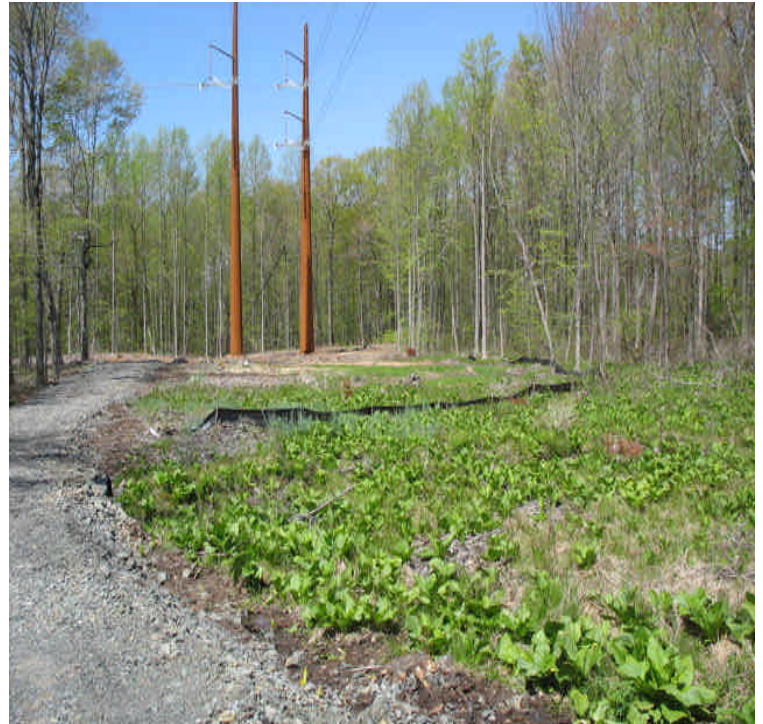
Stock piles and pad were removed/reclaimed at the CSC approved pull site. Controls will remain until final stabilization with vegetative cover occurs.

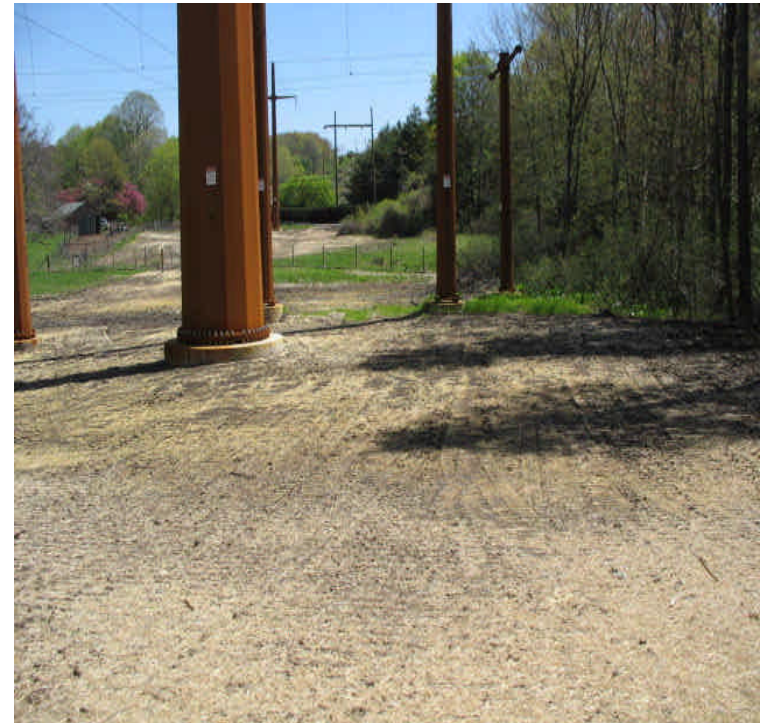
Timber mat removal and final grading from Rte 17 to Little Ln is complete. Monitor for final stabilization with vegetative cover.
