Docket No. 272 – Development and Management Plan Inspection

Segment 1b (Royal Oaks Bypass) Inspection

Date: May 19, 2008

Location: Segment 1b (Royal Oaks Bypass)

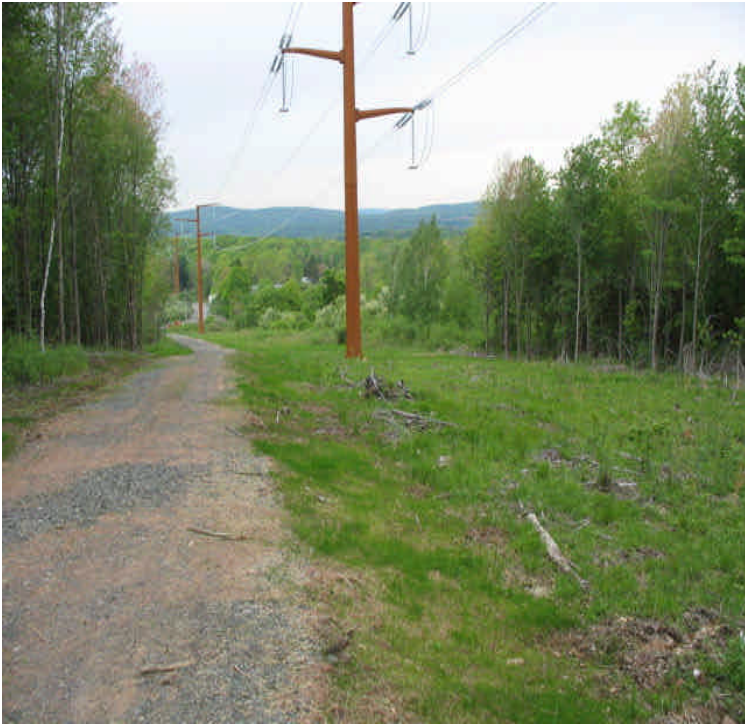
Grass and vegetative growth noted along the slopes east of the contractor yard to Black Walnut Drive.

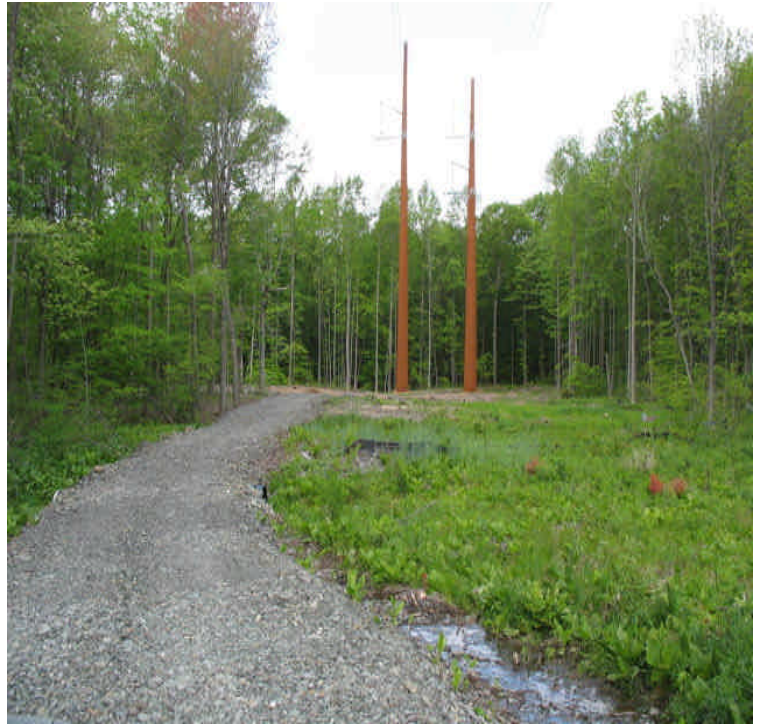
View of wetland crossing from the contractor yard. Re-growth of vegetative cover is well underway.

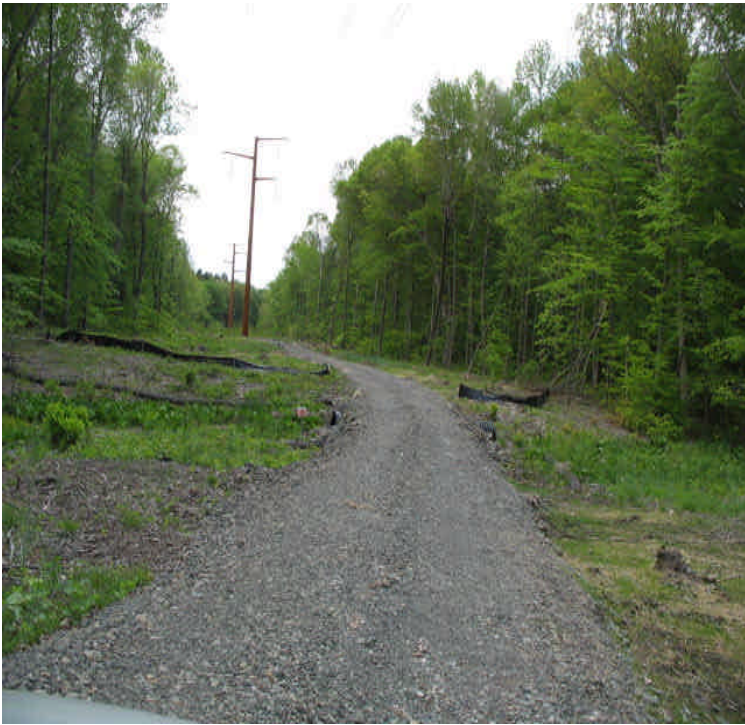
View of permanent wetland crossings looking north toward Little Ln.

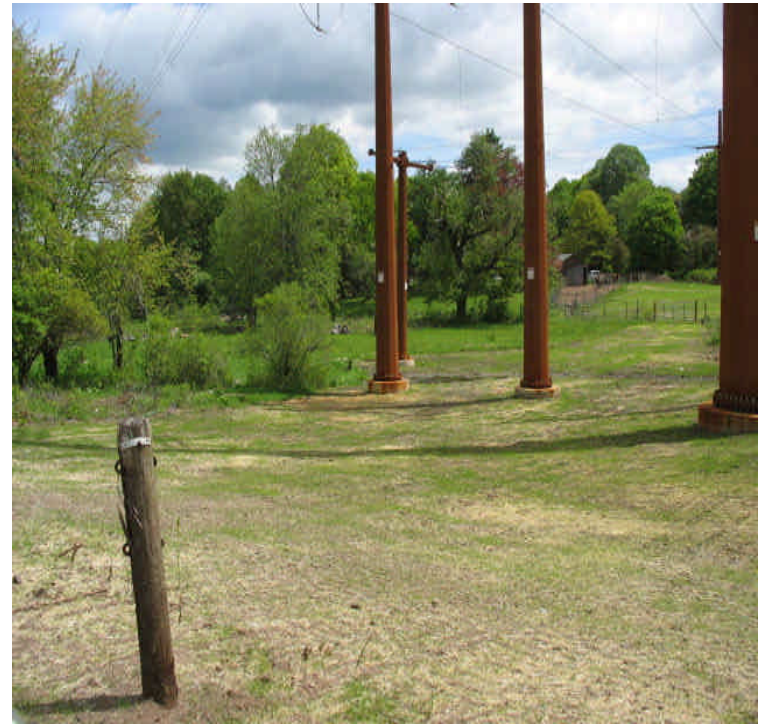
Some grass growth noted at the reclaimed final pad site off Little Lane
