Docket No. 272 – Development and Management Plan Inspection

Segment 1b (Royal Oaks Bypass) Inspection

Date: June 2, 2008

Location: Segment 1b (Royal Oaks Bypass)

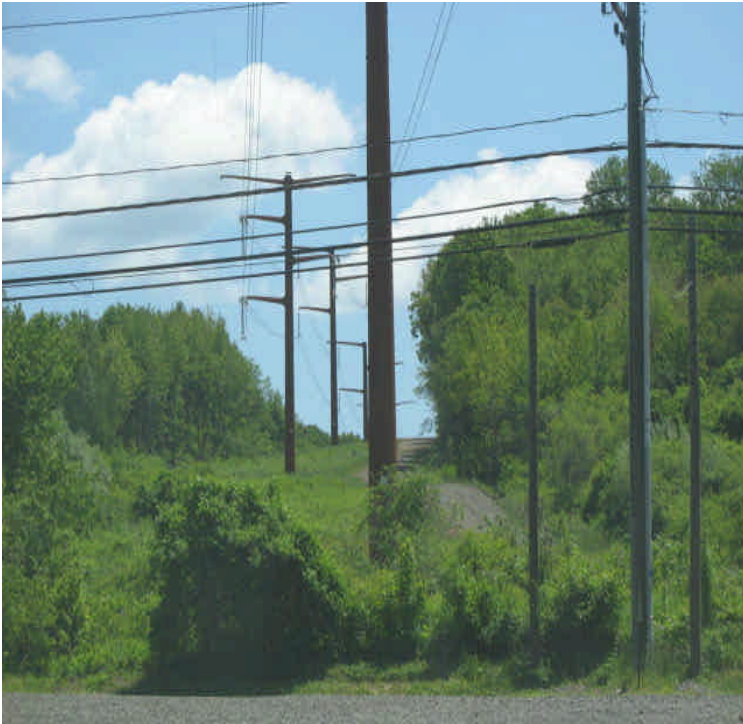
Grass growth noted at previously seeded area across from the receiving yard.

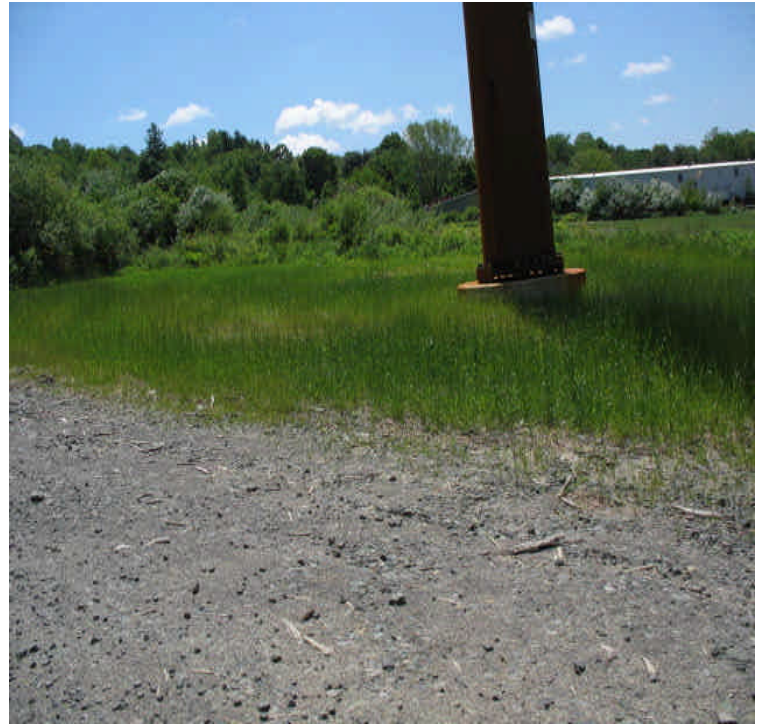
Grass is established at the structure within the receiving yard.

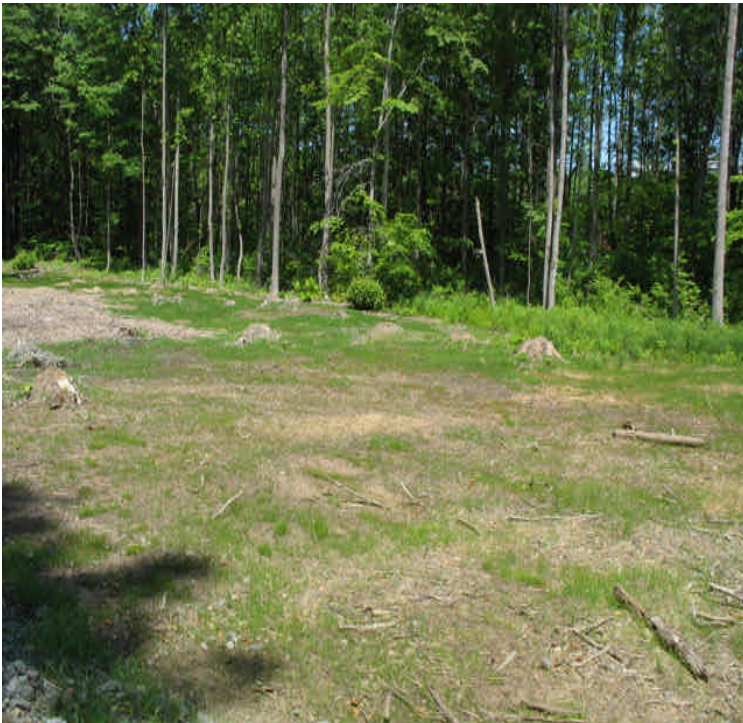
Grass germination starting to occur at the old line pulling site near the receiving yard.

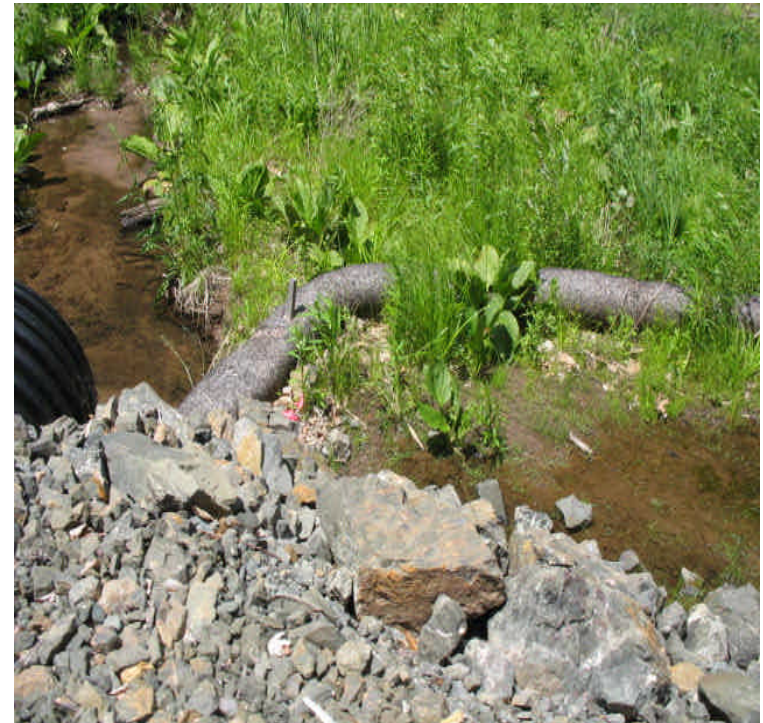
Controls remain in place during and after restoration activities.
