Docket No. 272 – Development and Management Plan Inspection

Segment 1b (Royal Oaks Bypass) Inspection

Date: June 16, 2008

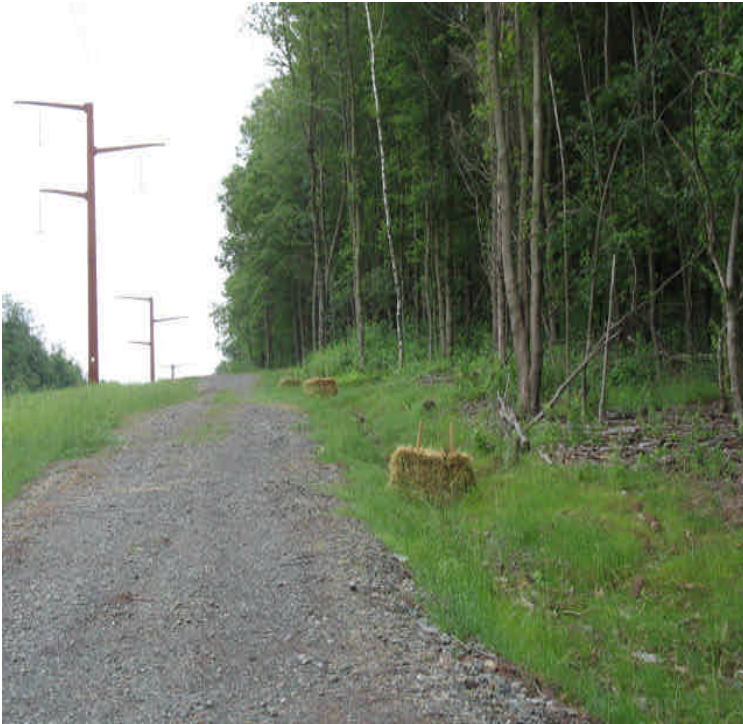
Grass growth noted at previously seeded areas along the access road across from the receiving yard.

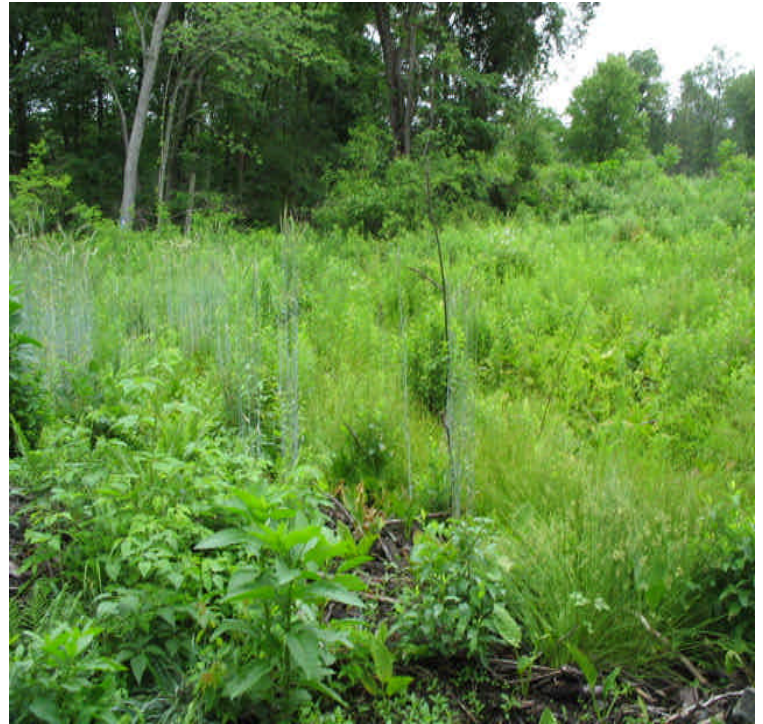
Vegetation is established at first wetland crossing connected to the pond.

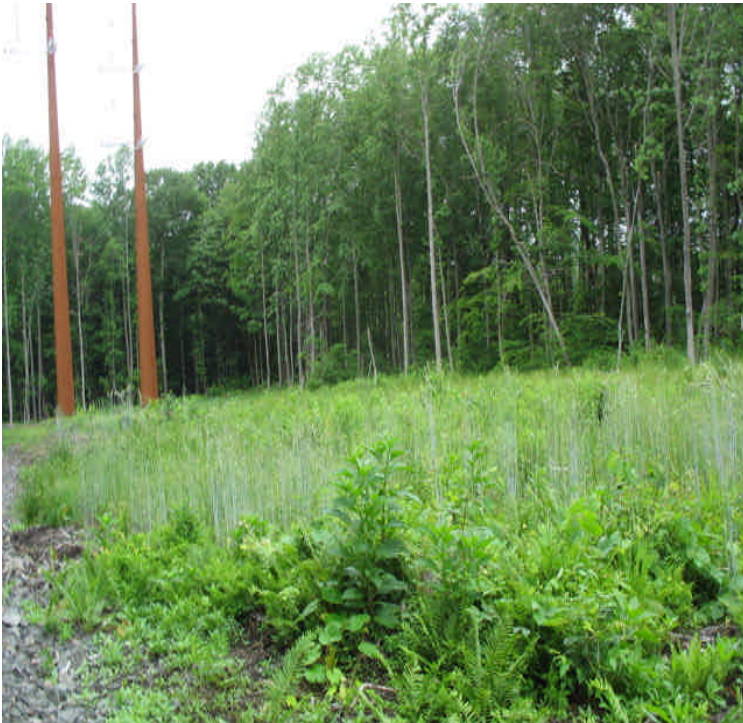
Previously seeded areas along the ROW have good vegetative cover. Remove any remaining silt fence where applicable.

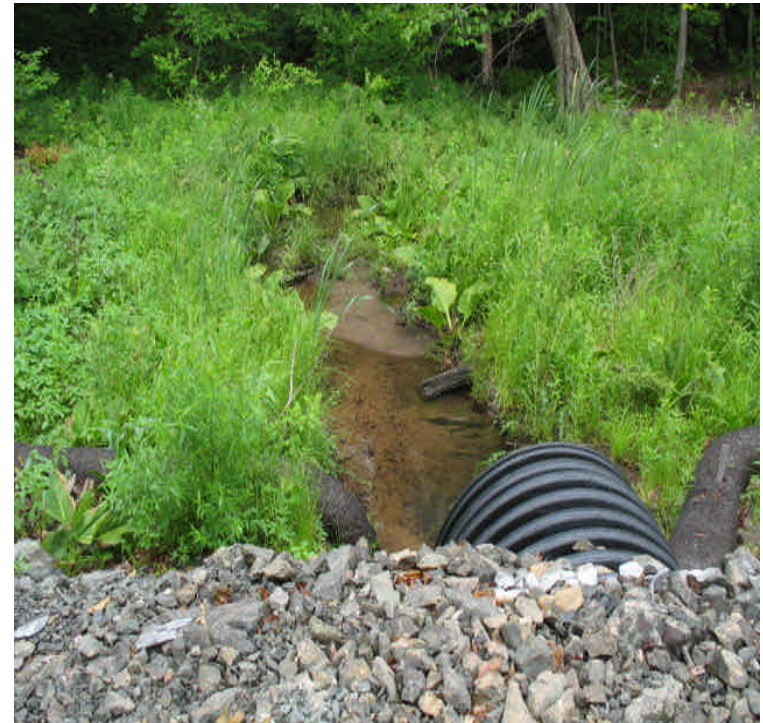
Clear water with tadpoles noted at the second culverted crossing past the receiving yard.
