Docket No. 272 – Development and Management Plan Inspection

Segment 1b (Royal Oaks Bypass) Inspection

Date: June 23, 2008

Location: Segment 1b (Royal Oaks Bypass)

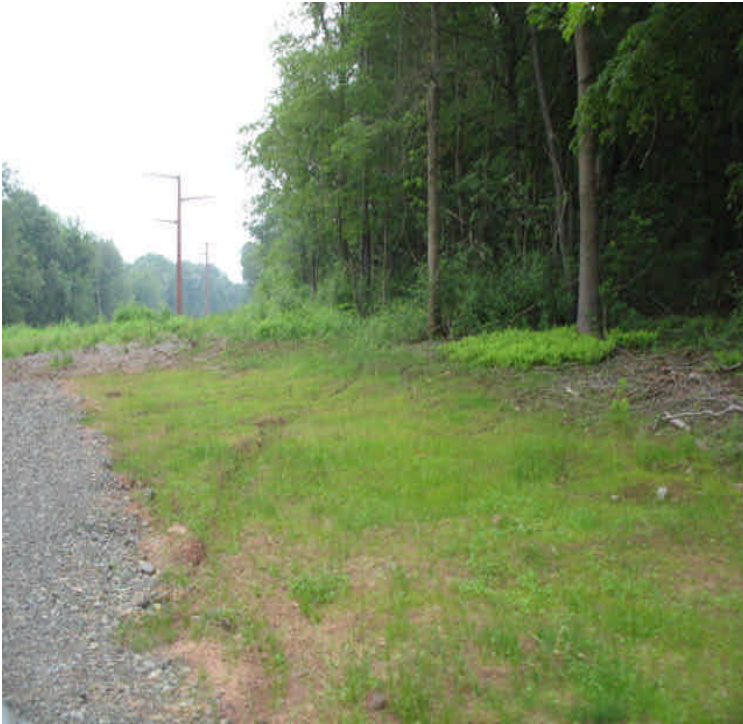
Grass growth noted at previously seeded area along the access road across from the receiving yard.

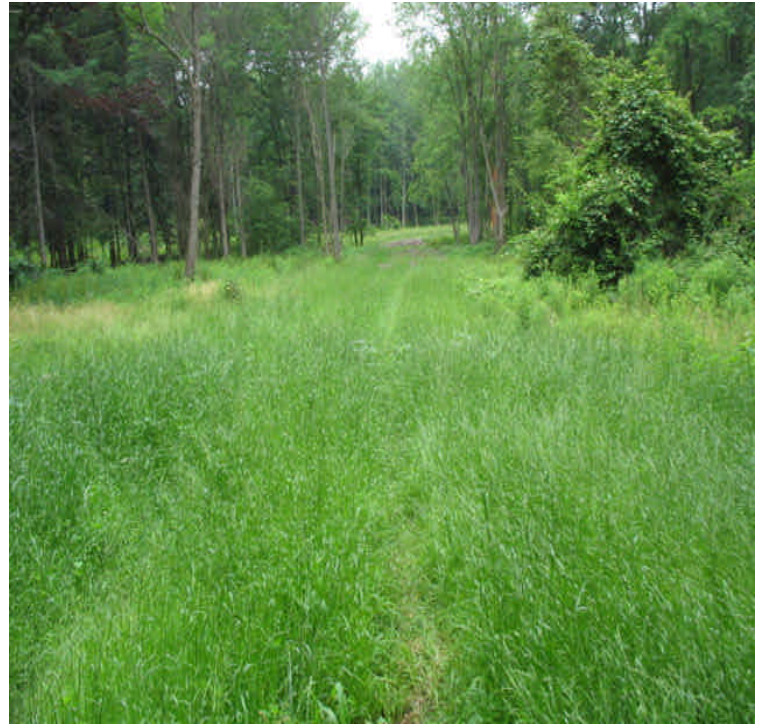
Grass is well established on the access road to Structure #24530. Minimal impacts were noted from culvert installation. Area is stable.

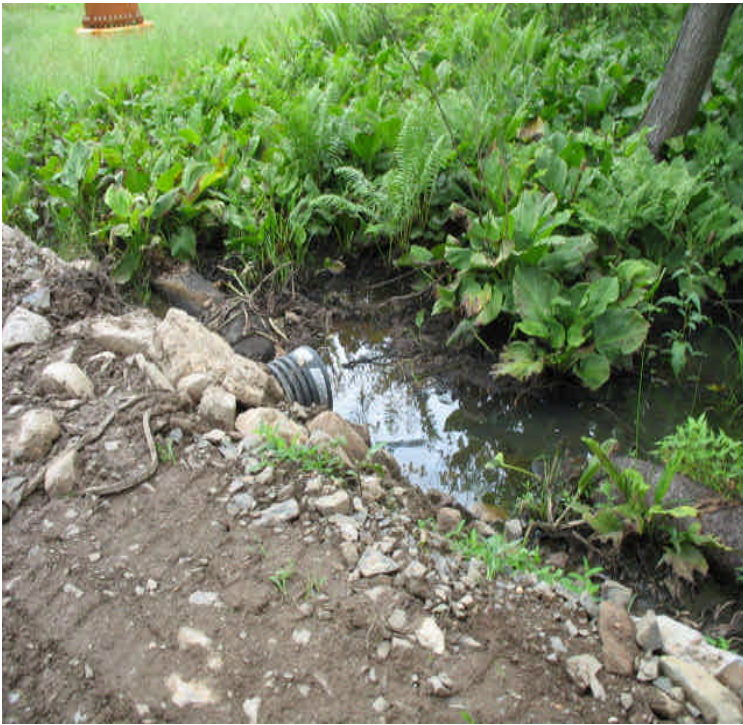
Culvert installed at the bisected channel crossing to Structure #24530. Continue to monitor to ensure hydrology is intact.

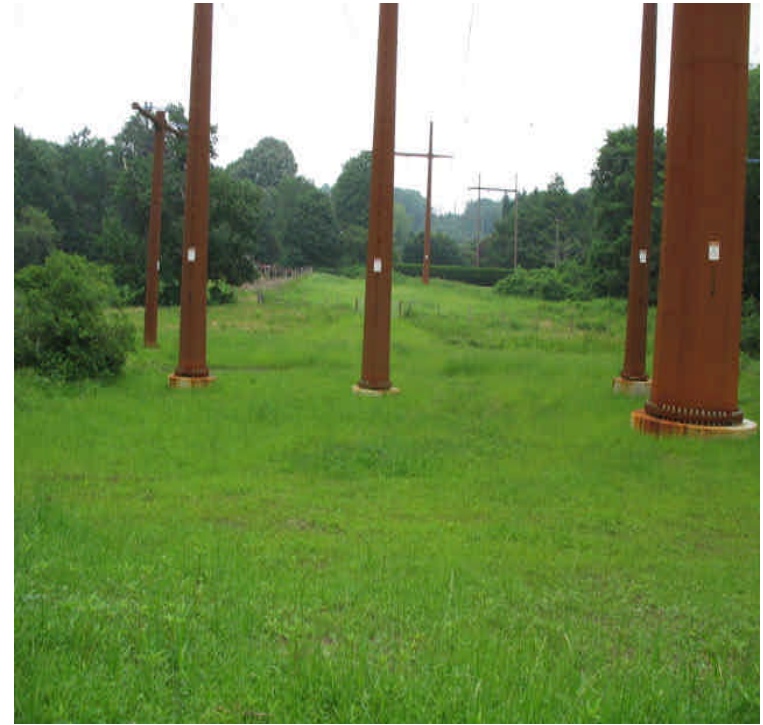
Vegetation established in the grazing field from Rte 17 to Little Lane. Area is stable.
