Docket No. 272 – Development and Management Plan Inspection

Segment 1b (Royal Oaks Bypass) Inspection

Date: June 30, 2008

Location: Segment 1b (Royal Oaks Bypass)

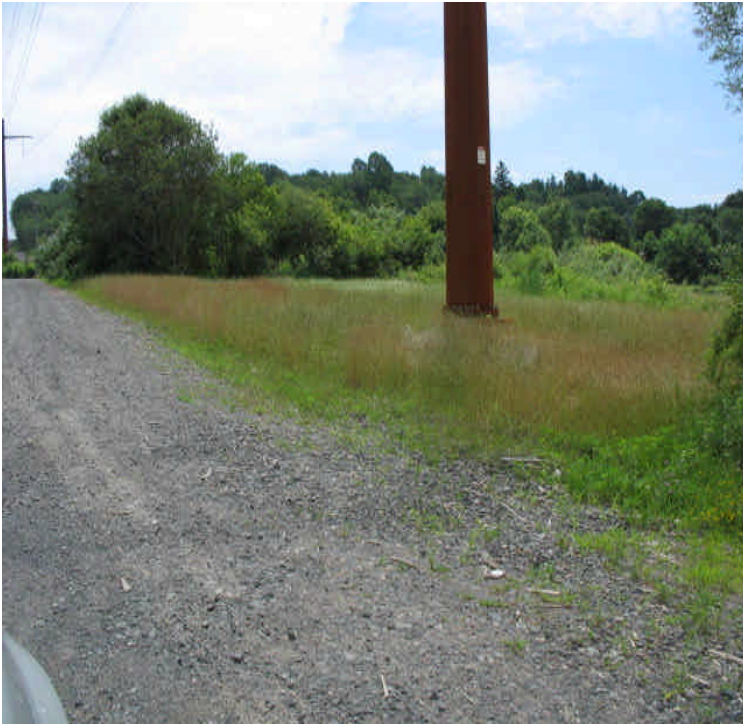
Grass growth noted at the pad site within the receiving yard.

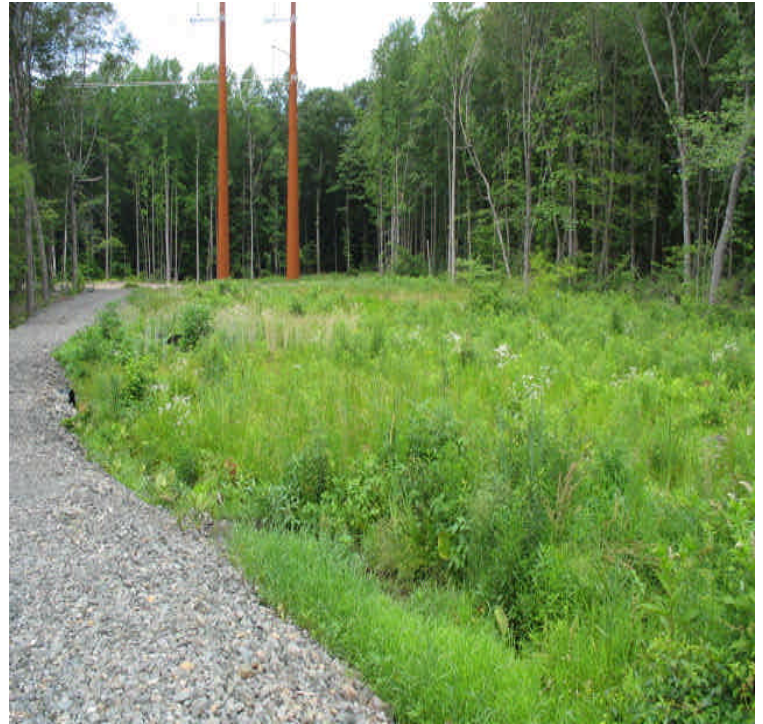
Wetland crossing at the edge of the receiving yard is stable with good vegetative cover.

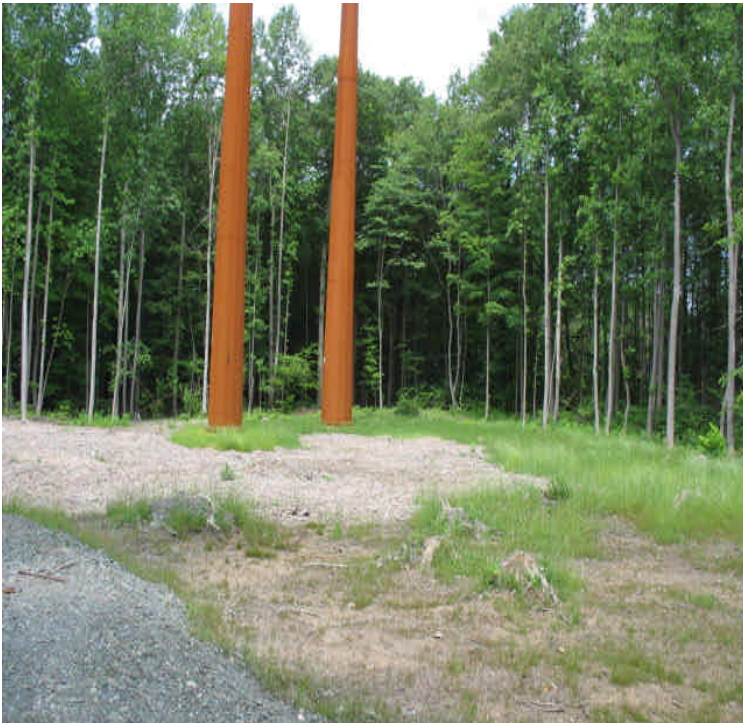
Areas of Inspection	Observation	Recommended Action	Corrected Action
Vegetative clearing or stabilization	<p>Restoration completed from Black Walnut Dr. to Little Lane. Vegetative growth/cover continues to increase in restored areas. 6/30/08</p> <p>One pad near the turn towards Little Ln off the receiving yard has some sparse cover due to thick mulch/chips. 6/30/08</p>	<p>Monitor restored areas for stabilization and add controls as needed. 6/30/08</p> <p>Continue to monitor and rake out the mulch and re-seed if necessary. 6/30/08</p>	<p>Vegetative cover established in most restored areas.</p> <p>NA at this time.</p>
Dewatering	Active work associated with dewatering was no longer necessary. 6/30/08	NA 6/30/08	NA
Blasting	No blasting is proposed at this time. 6/30/08	None	NA
Spills, soils and material storage	<p>Contractor receiving yard is set up near Rte. 17 in Middletown for 1A & 1B work. Stockpile is located upgradient from wetlands in the receiving yard. 6/30/08</p> <p>Monitor equipment closely for future work within the Laurel Brook watershed protection area. Any refueling and equipment maintenance should be done outside of the protected area. 6/30/08</p>	<p>Continue to use and restock materials as needed. Move stockpile away from wetlands. See 1A report. 6/30/08</p> <p>In general, if a leak is observed, contain it and remove equipment from water department property. Proactively check equipment for leaks when working in the protected area. 6/30/08</p>	<p>See 1A report for details.</p> <p>NA at this time.</p>

The pad at the turn towards Little Lane off the Receiving Yard has thick mulch/chips that are inhibiting vegetative growth.

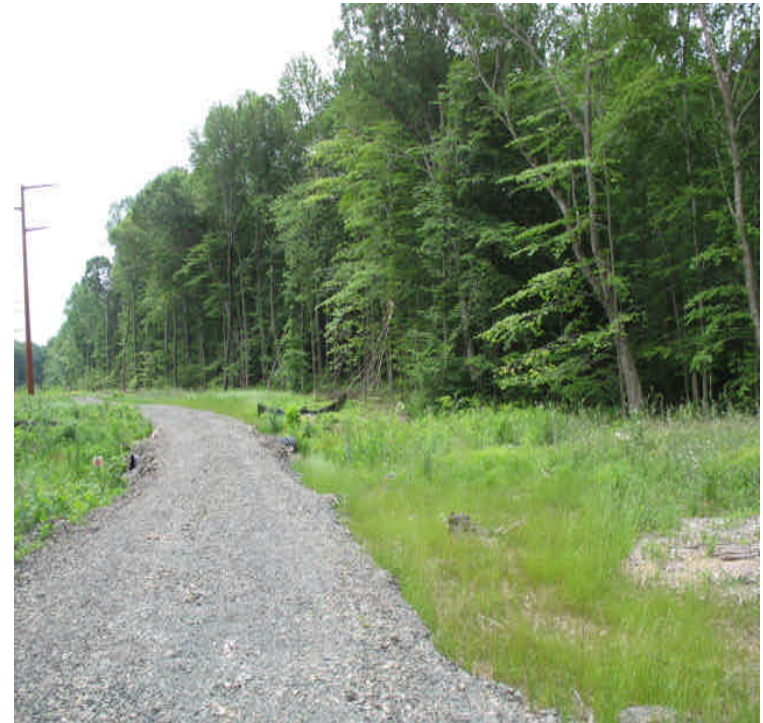
The majority of the ROW is stable with vegetation.
