Docket No. 272 – Development and Management Plan Inspection

Segment 1b (Royal Oaks Bypass) Inspection

Date: July 7, 2008

Location: Segment 1b (Royal Oaks Bypass)

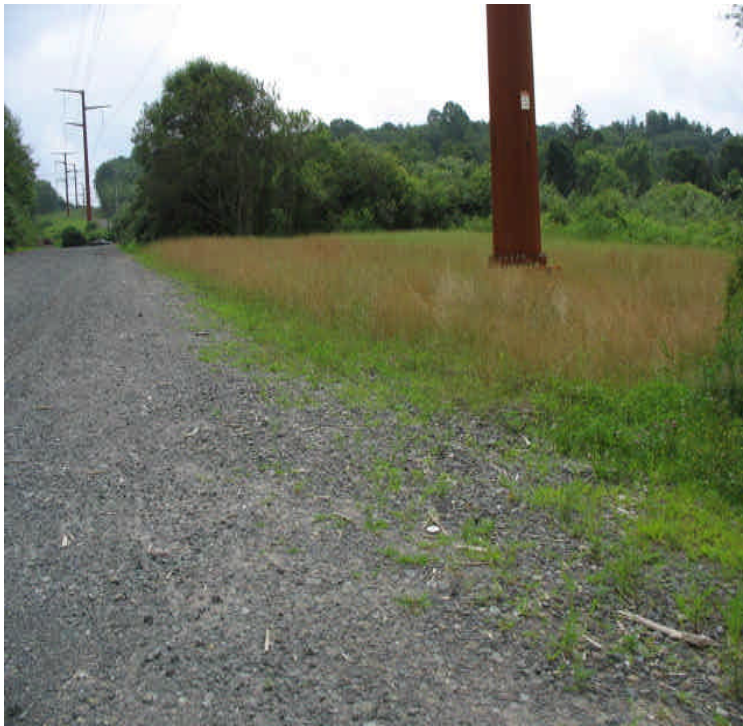
Grass growth noted at the pad site within the receiving yard.

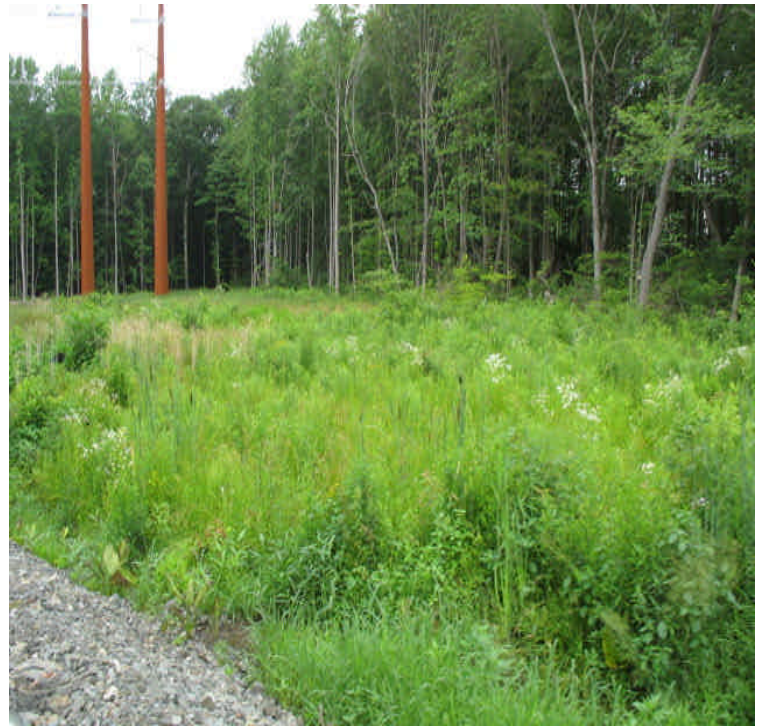
Wetland crossing at the edge of the receiving yard is stable with good vegetative cover.

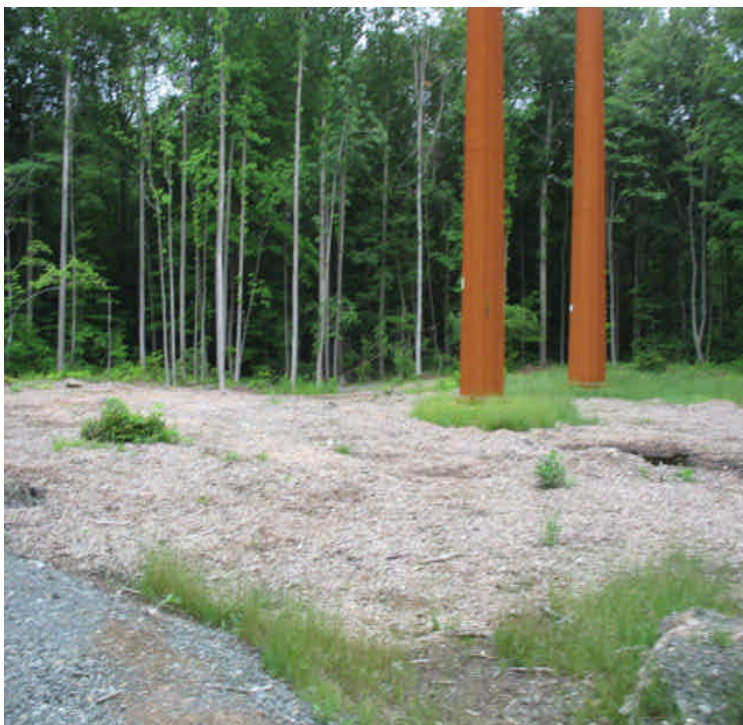
Areas of Inspection	Observation	Recommended Action	Corrected Action
Vegetative clearing or stabilization	<p>Restoration completed from Black Walnut Dr. to Little Lane. Vegetative growth/cover continues to increase in restored areas. 7/7/08</p> <p>One pad near the turn towards Little Ln off the receiving yard has some sparse cover due to thick mulch/chips. 6/30-7/7/08</p>	<p>Monitor restored areas for stabilization and add controls as needed. 7/7/08</p> <p>Continue to monitor and rake out the mulch and re-seed if necessary. 6/30-7/7/08</p>	<p>Vegetative cover established in most restored areas.</p> <p>NA at this time.</p>
Dewatering	Active work associated with dewatering was no longer necessary. 7/7/08	NA 7/7/08	NA
Blasting	No blasting is proposed at this time. 7/7/08	None	NA
Spills, soils and material storage	<p>Contractor receiving yard is set up near Rte. 17 in Middletown for 1A & 1B work. Stockpile is located upgradient from wetlands in the receiving yard. 7/7/08</p> <p>Monitor equipment closely for future work within the Laurel Brook watershed protection area. Any refueling and equipment maintenance should be done outside of the protected area. 7/7/08</p>	<p>Continue to use and restock materials as needed. Move stockpile away from wetlands. See 1A report. 7/7/08</p> <p>In general, if a leak is observed, contain it and remove equipment from water department property. Proactively check equipment for leaks when working in the protected area. 7/7/08</p>	<p>See 1A report for details.</p> <p>NA at this time.</p>

The pad at the turn towards Little Lane off the Receiving Yard has thick mulch/chips that are inhibiting vegetative growth.

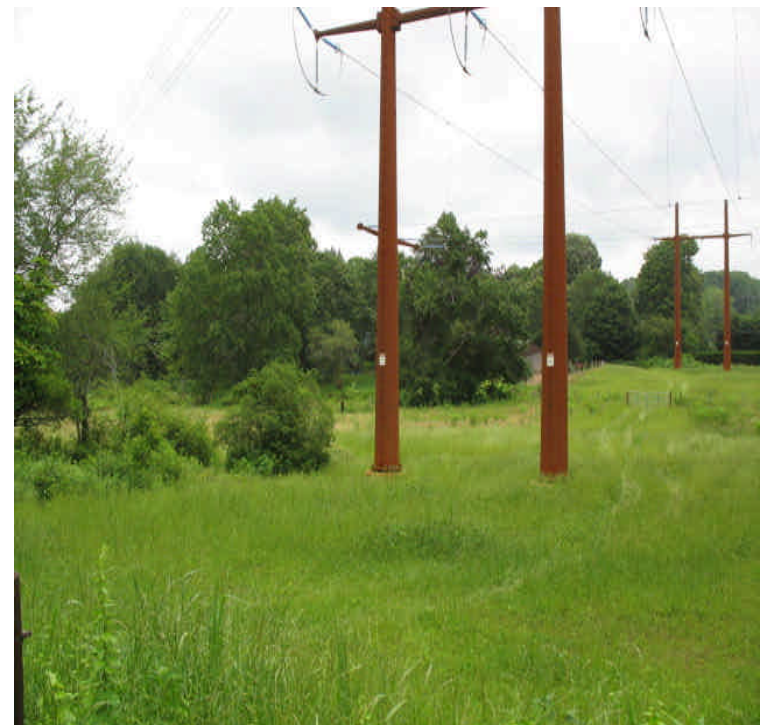
View of the intersections of 1A and 1B at Little Lane. Area is fully stabilized.
