Docket No. 272 – Development and Management Plan Inspection

Segment 1b (Royal Oaks Bypass) Inspection

Date: July 14, 2008

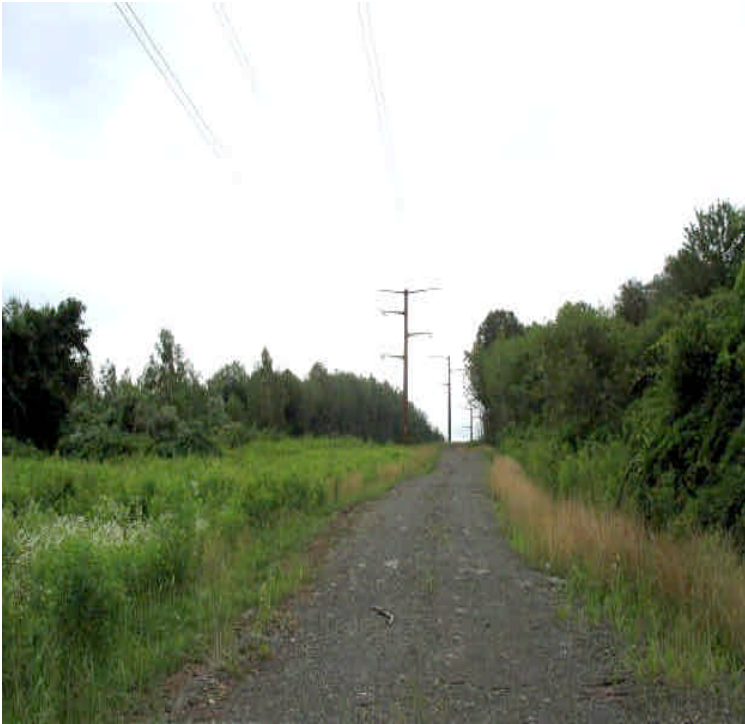
Grass growth noted along the ROW across from the receiving yard.

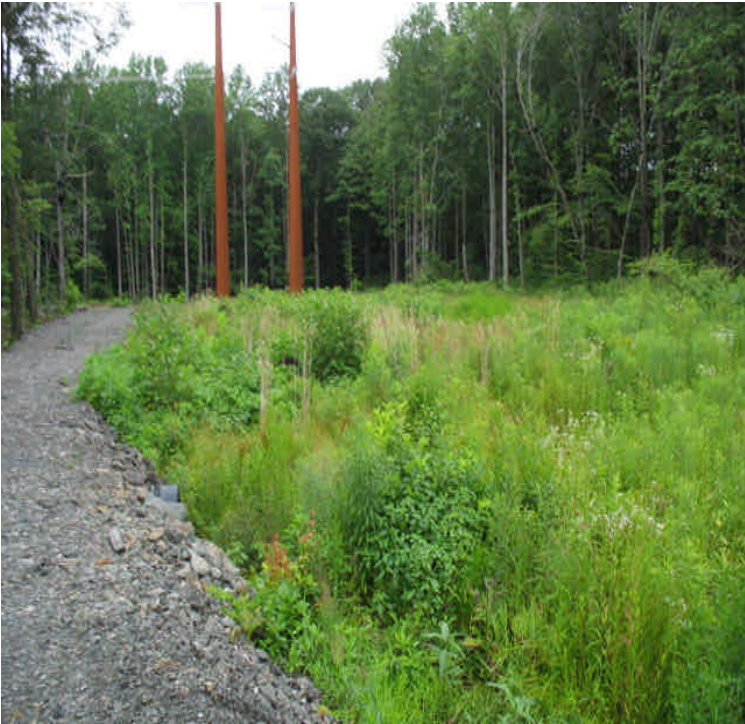
Wetland crossing at the edge of the receiving yard is stable.

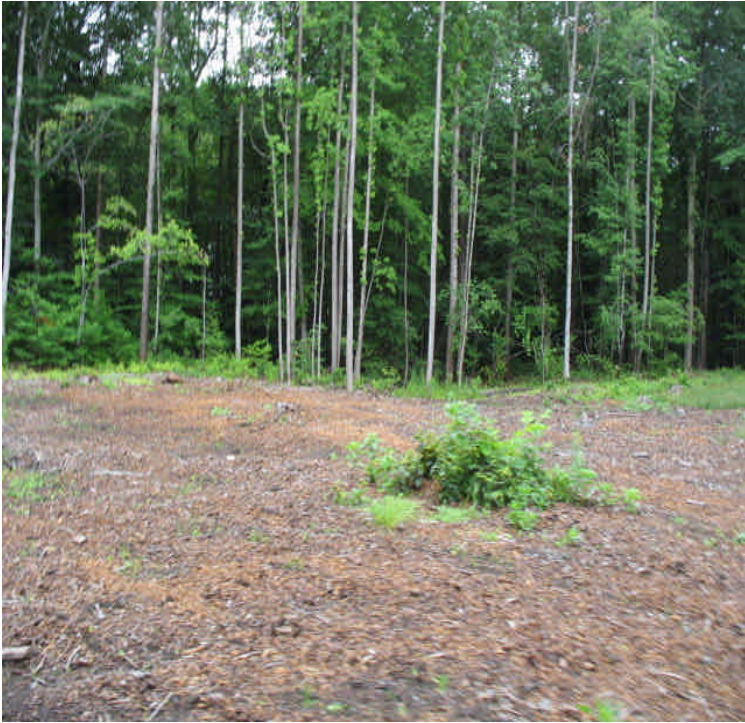
Areas of Inspection	Observation	Recommended Action	Corrected Action
Vegetative clearing or stabilization	<p>Restoration completed from Black Walnut Dr. to Little Lane. Vegetative growth/cover continues to increase in restored areas. 7/14/08</p> <p>One pad near the turn towards Little Ln off the receiving yard has some sparse cover due to thick mulch/chips. 6/30-7/14/08</p>	<p>Monitor restored areas for stabilization and add controls as needed. 7/14/08</p> <p>Continue to monitor and rake out the mulch and re-seed if necessary. 6/30-7/14/08</p>	<p>Vegetative cover established in most restored areas.</p> <p>NA at this time.</p>
Dewatering	Active work associated with dewatering was no longer necessary. 7/14/08	NA 7/14/08	NA
Blasting	No blasting is proposed at this time. 7/14/08	None	NA
Spills, soils and material storage	<p>Contractor receiving yard is set up near Rte. 17 in Middletown for 1A & 1B work. Stockpile is located upgradient from wetlands in the receiving yard. 7/14/08</p> <p>Monitor equipment closely for future work within the Laurel Brook watershed protection area. Any refueling and equipment maintenance should be done outside of the protected area. 7/14/08</p>	<p>Continue to use and restock materials as needed. Move stockpile away from wetlands. See 1A report. 7/14/08</p> <p>In general, if a leak is observed, contain it and remove equipment from water department property. Proactively check equipment for leaks when working in the protected area. 7/14/08</p>	<p>See 1A report for details.</p> <p>NA at this time.</p>

The pad at the turn towards Little Lane off the Receiving Yard has thick mulch/chips that are inhibiting vegetative growth.

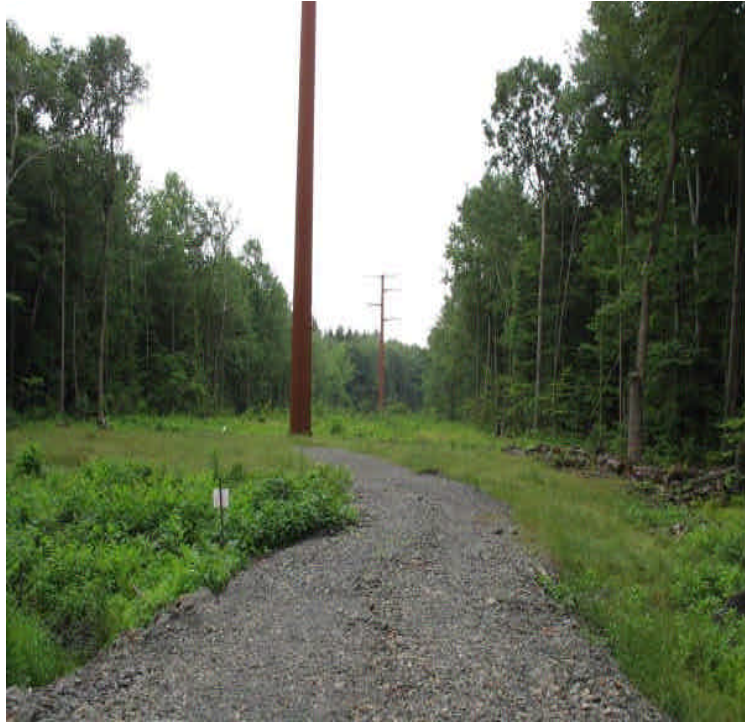
End of the access road from the receiving yard looking south.
