Docket No. 272 – Development and Management Plan Inspection

Segment 1b (Royal Oaks Bypass) Inspection

Date: July 21, 2008

Location: Segment 1b (Royal Oaks Bypass)

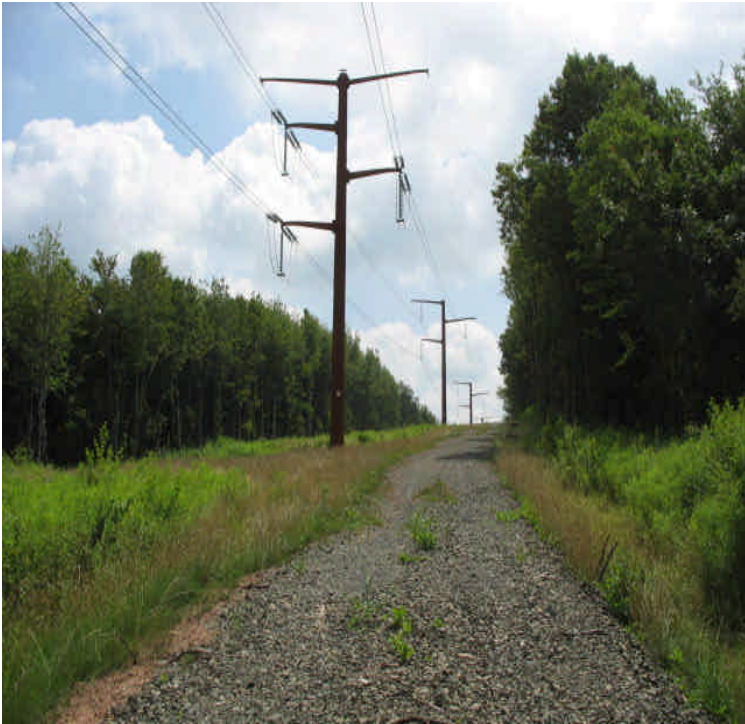
Grass cover noted along the ROW across from the receiving yard.

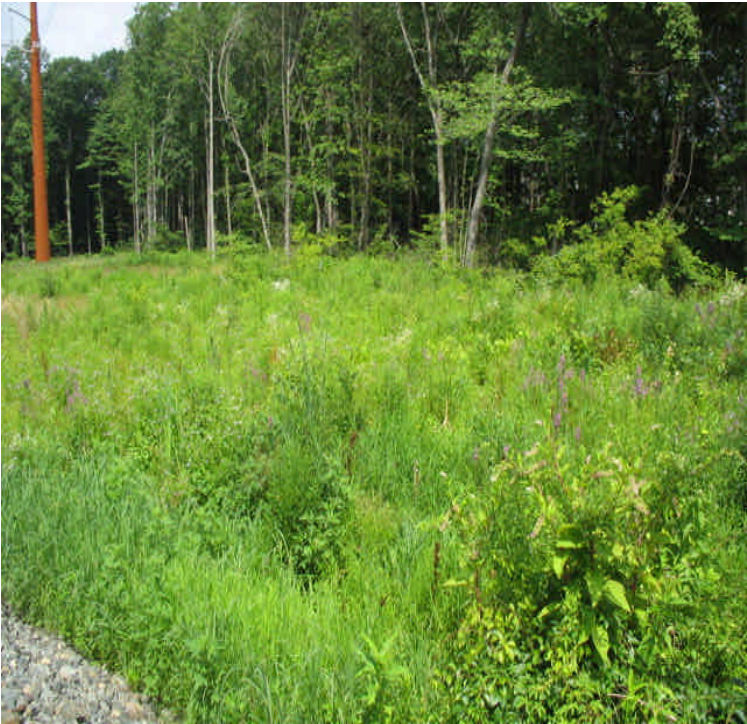
Wetland crossing at the edge of the receiving yard is stable with most native wetland species.

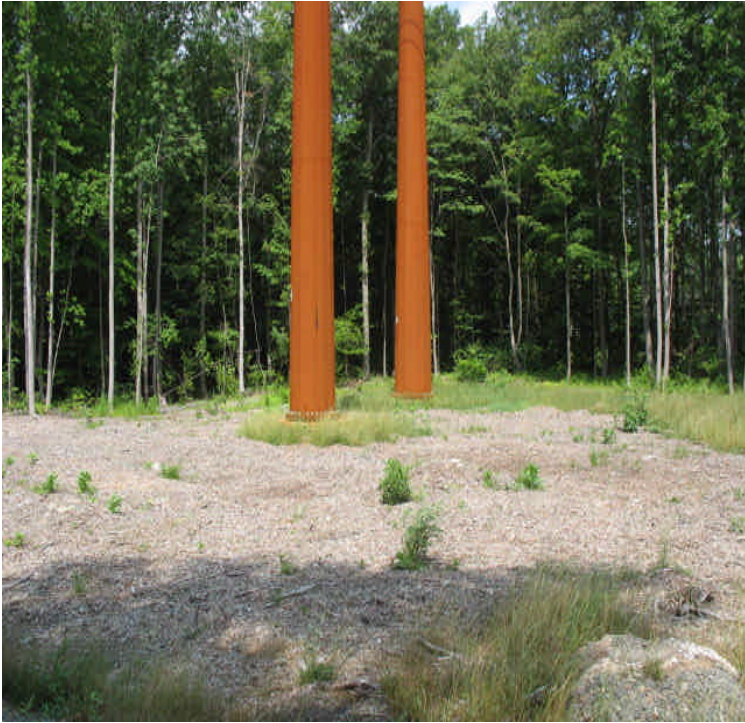
Although the area is stable, the pad at the turn off the Receiving yard towards Little Lane has thick mulch/wood chips slowing vegetative growth.

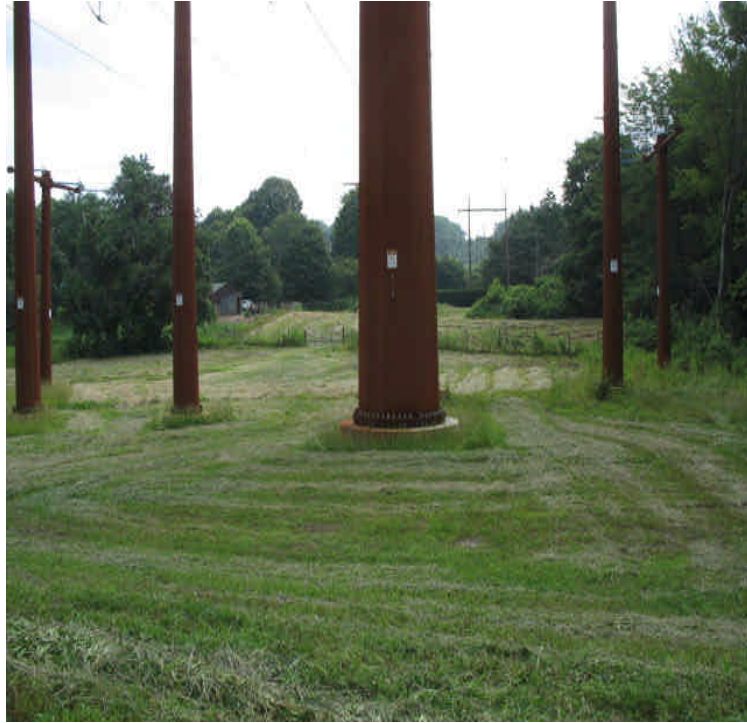
View of the 1A and 1B intersection off Little Lane. The field was fully restored and was being hayed.
