Docket No. 272 – Development and Management Plan Inspection

Segment 1b (Royal Oaks Bypass) Inspection

Date: July 28, 2008

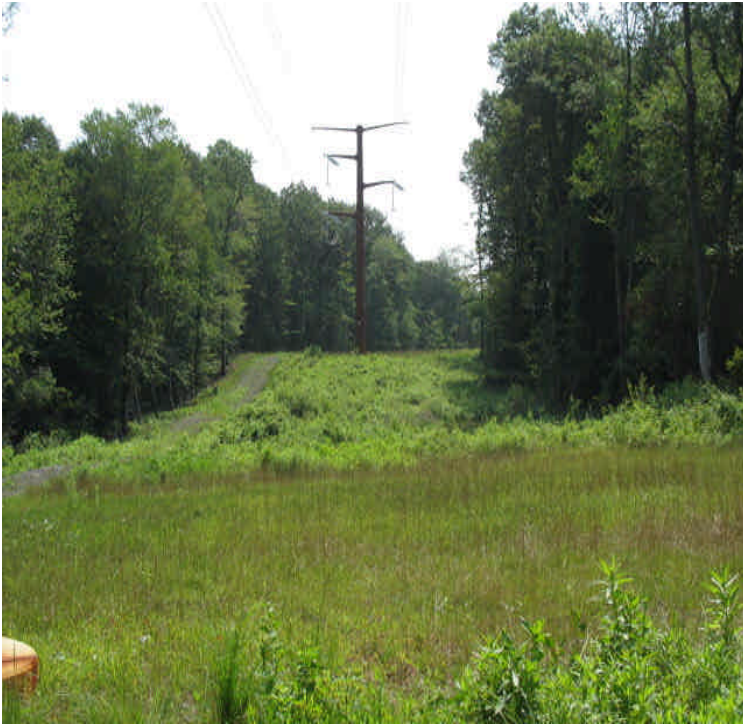
Vegetative cover noted along the ROW coming from the direction of Black Walnut Drive.

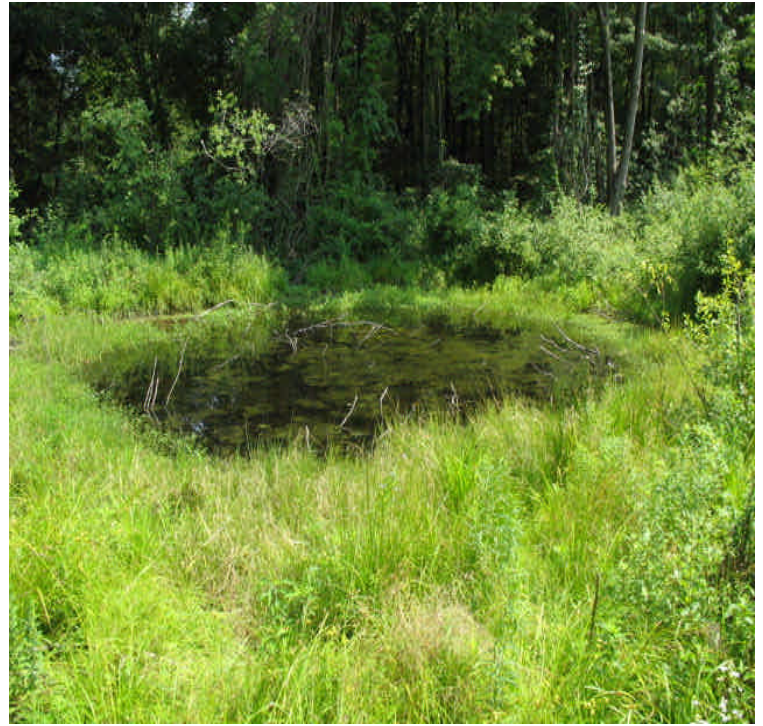
Small pond between Black Walnut Dr and the Contractor Yard. This area has good vegetative cover, consisting of native wetland plant species.

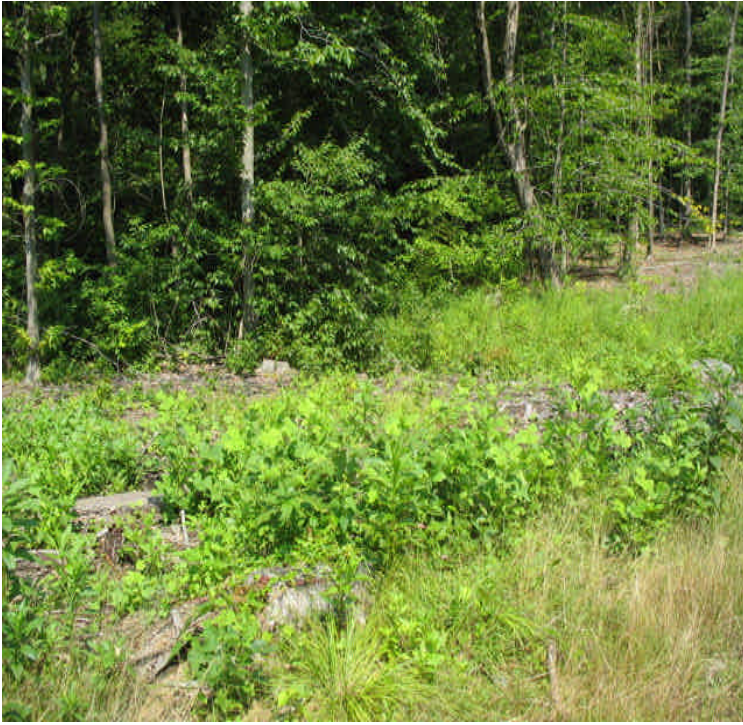
| Areas of Inspection | Observation | Recommended Action | Corrected Action |
|---|---|---|--|
| Vegetative clearing or stabilization | <p>Restoration completed from Black Walnut Dr. to Little Lane. Vegetative growth/cover continues to increase in restored areas. 7/28/08</p> <p>One pad near the turn towards Little Ln off the receiving yard has some sparse cover due to thick mulch/chips. 6/30-7/14/08</p> | <p>Restored areas are largely stable with over 70% cover. 7/28/08</p> <p>Continue to monitor and rake out the mulch and re-seed if necessary. 6/30-7/14/08</p> | <p>Vegetative cover established in most restored areas.</p> <p>NA at this time</p> |

View of the turn in the ROW towards Little Lane off the Receiving yard. Silt fence was removed where adjacent areas are stable. A line of fence remains near the pad with thick wood chips.

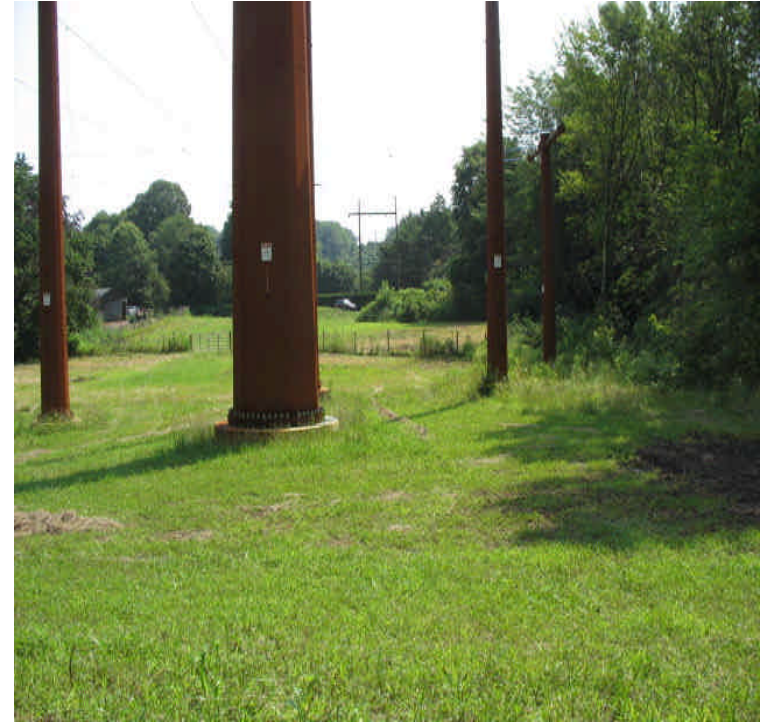
View of the fully stable 1A and 1B intersection off Little Lane.
