**Docket No. 272 – Development and Management Plan Inspection**

**Segment 1b (Royal Oaks Bypass) Inspection**

**Date:** August 5, 2008

**Location:** Segment 1b (Royal Oaks Bypass)

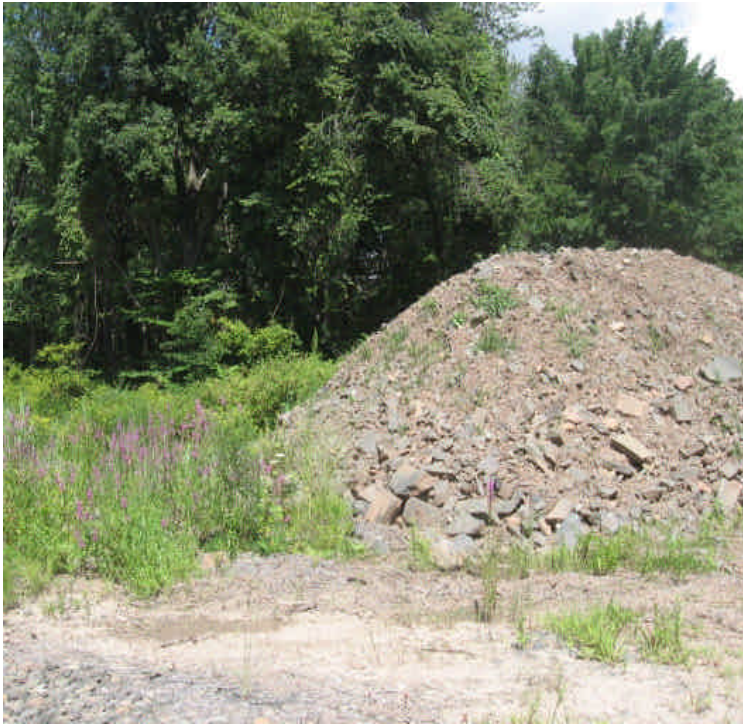
**View of the stone/soil stockpile remaining in the contractor yard. Controls are in place but the pile is located just upgradient from wetlands and should be relocated.**

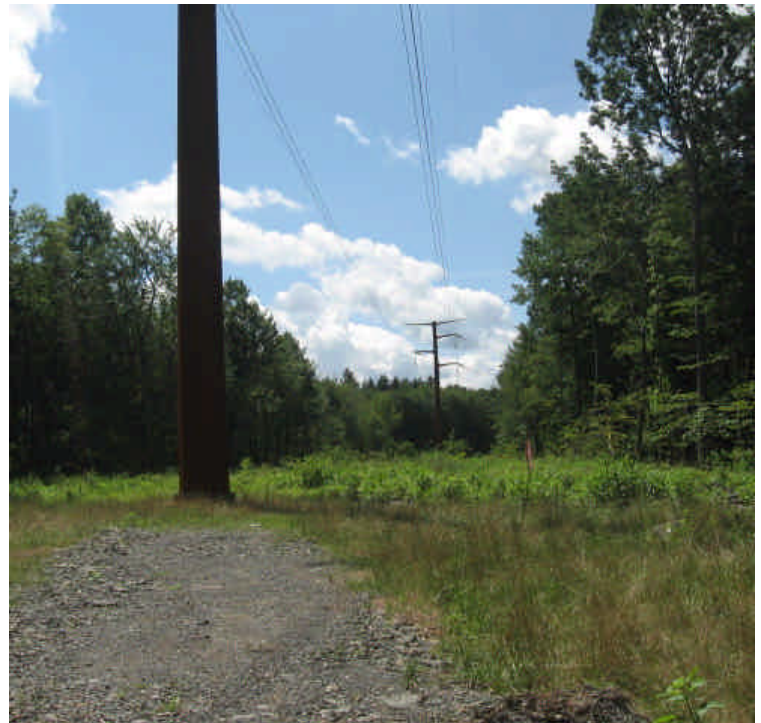
**View of the ROW and wetland crossing looking towards Little Lane. The area has good vegetative cover, consisting of native wetland plant species.**

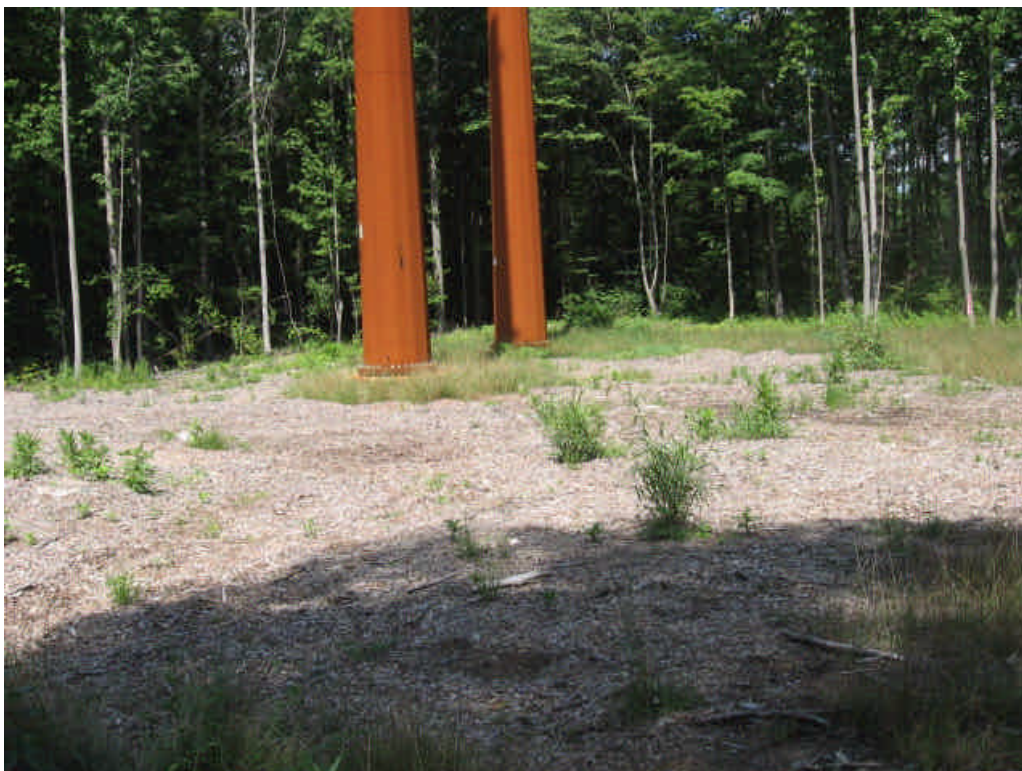
**View of the pad/angle structure at the turn in the ROW off the receiving yard. The area remains stable with thick wood chips but vegetation will not be able to establish fully. The contractor plans to remove the chips and seed the area when feasible.**
