Docket No. 272 – Development and Management Plan Inspection

Segment 1b (Royal Oaks Bypass) Inspection

Date: August 11, 2008

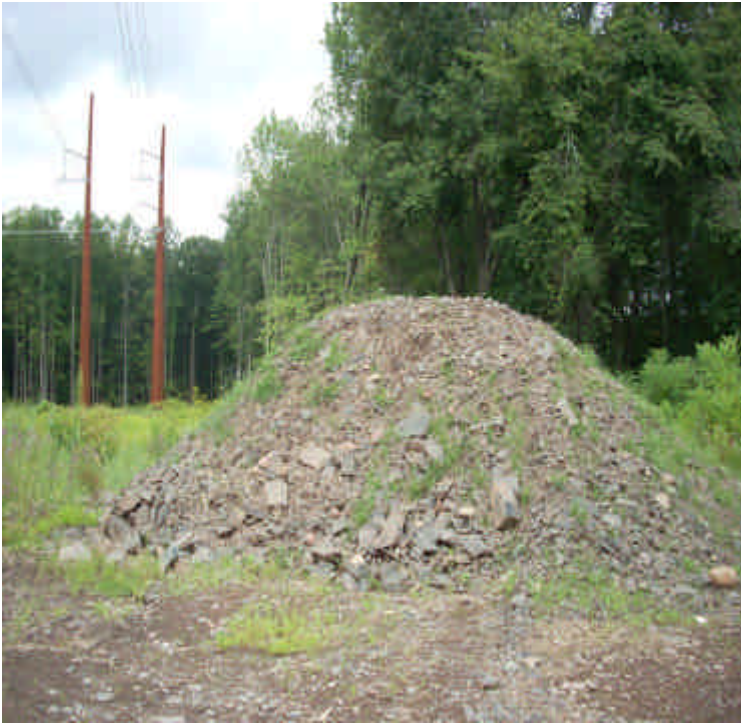
View of the stone/soil stockpile remaining in the contractor yard. Controls are in place but the pile is located just upgradient from wetlands and should be relocated.

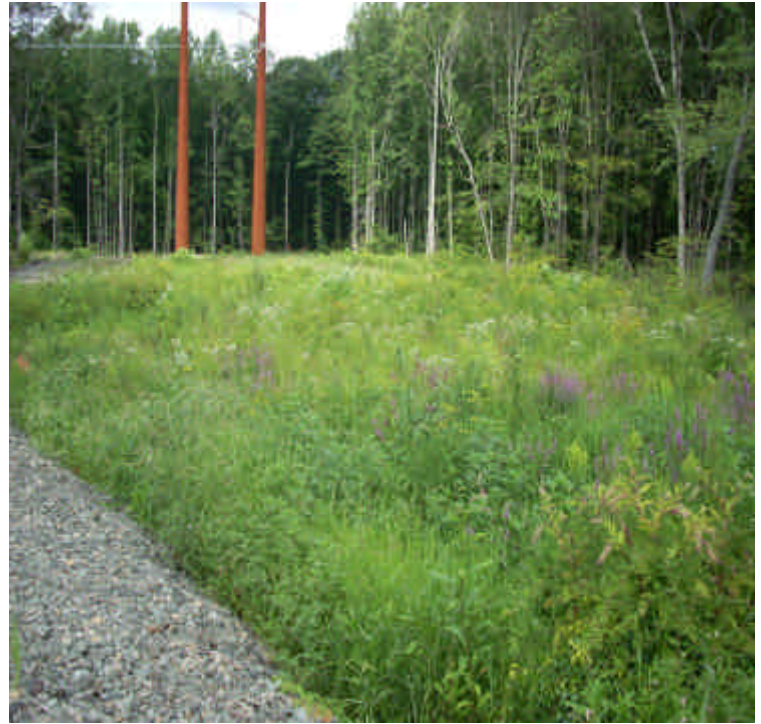
Well vegetated wetland crossing along the access road past the Contractor Yard.

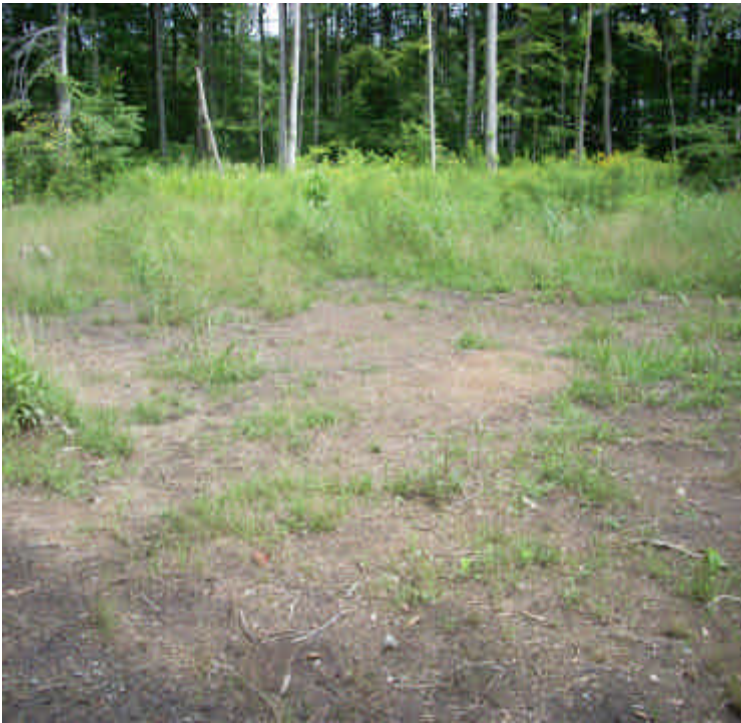
View of a small area of sparse vegetation located near the pad/angle structure at the turn in the ROW off the contractor yard.

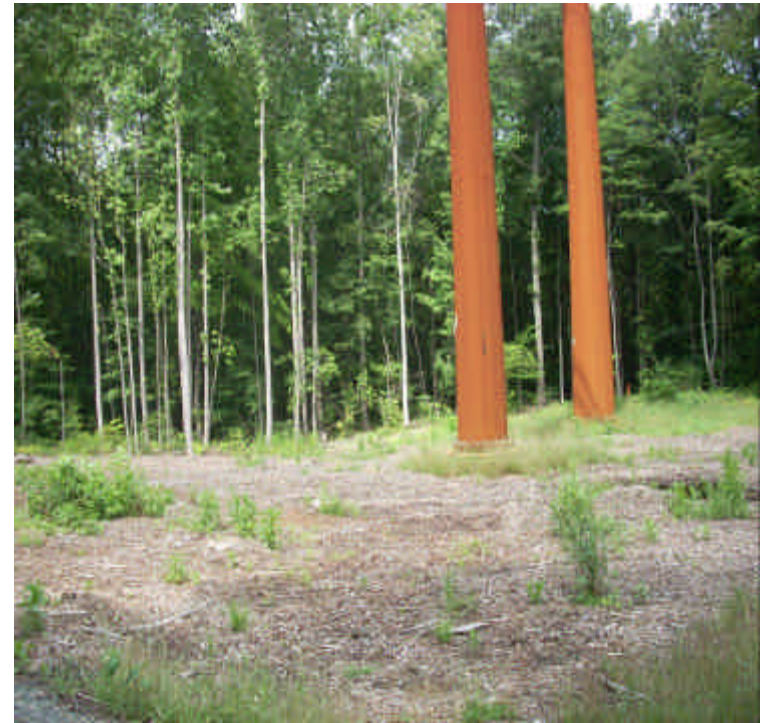
Another view of the pad/angle structure where vegetative cover is still sparse. The area remains stable with thick wood chips but vegetation will not be able to establish fully. The contractor plans to remove the chips and seed the area when feasible.
