**Docket No. 272 – Development and Management Plan Inspection**

**Segment 2a Inspection**

**Date:** January 22, 2008

**Location:** Segment 2a – Beseck Switching Station to Cheshire/Hamden Town Line

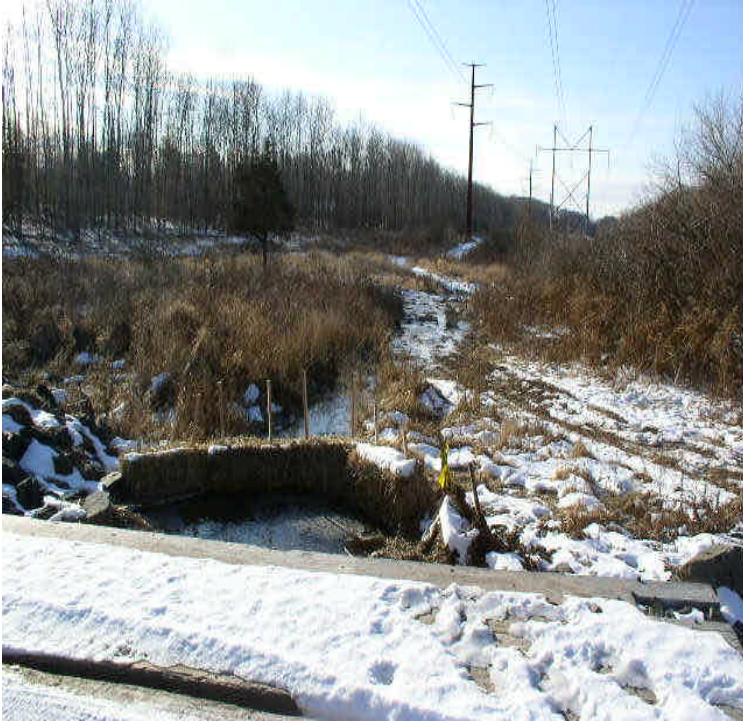
**Carpenter Lane: Haybales remain at the wetland outlet. ATVs continue to damage controls and leave tracks in wetlands.**

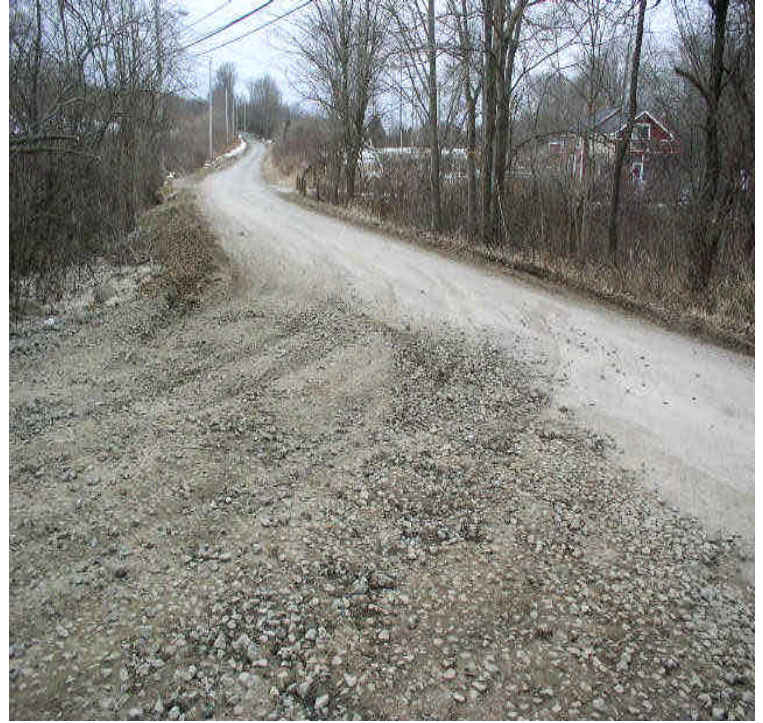
**Tamarack Swamp Rd: New access road installation is complete. Wetland crossings were noted via culverts with controls. Sediment tracking was noted on the roadway and needs regular attention.**

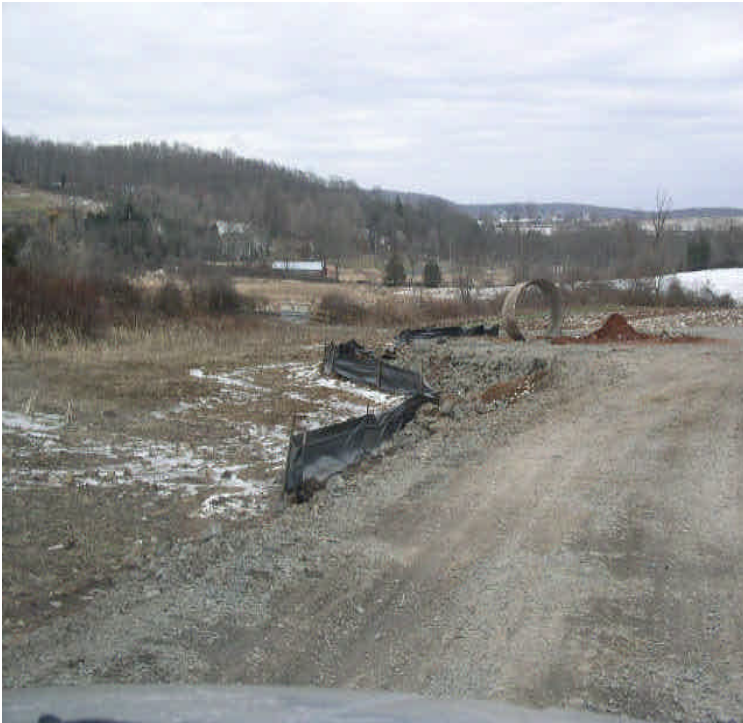
**Tamarack Swamp: Controls noted along the pad and access road at wetland crossings. Wetland crossings will need to be removed and restored when access needs are complete.**

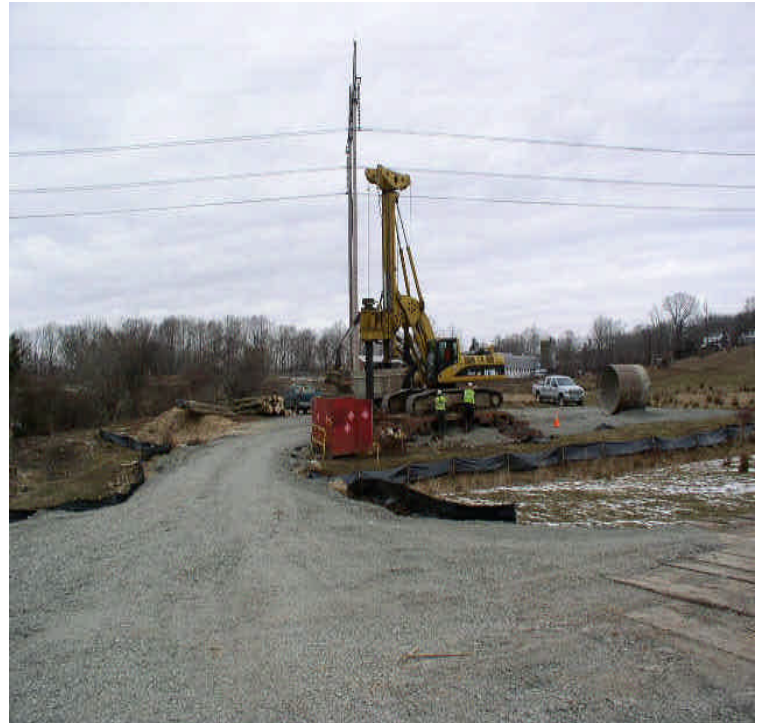
**Tamarack Swamp: Foundation drilling underway. Small stockpiles associated with drilling were noted. Controls are in place.**

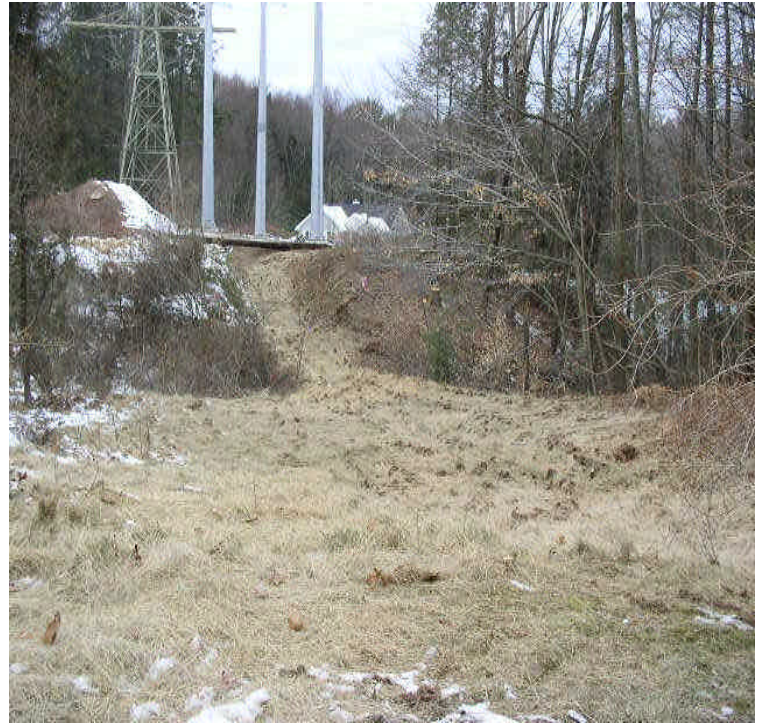
**Old Farms Rd: View of the recently cleared wetland crossing. Mulch and seed were used for stabilization**

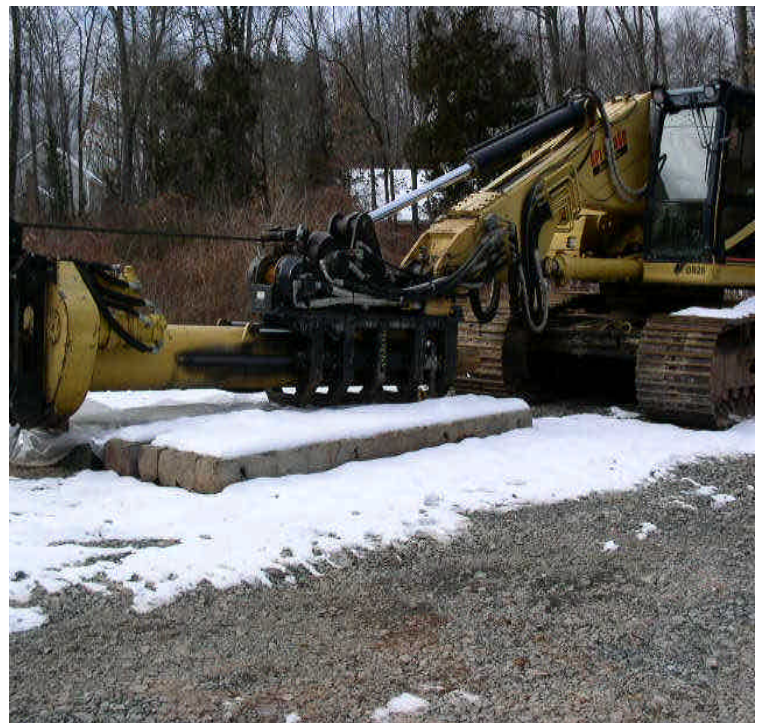
**Old Farms Rd: Leaking equipment has a plastic tarp to contain drips. However, fluid is still washing onto the ground off the tarp. Leak should be repaired as soon as possible.**
