**Docket No. 272 – Development and Management Plan Inspection**

**Segment 2a Inspection**

**Date:** February 5, 2008

**Location:** Segment 2a – Beseck Switching Station to Cheshire/Hamden Town Line

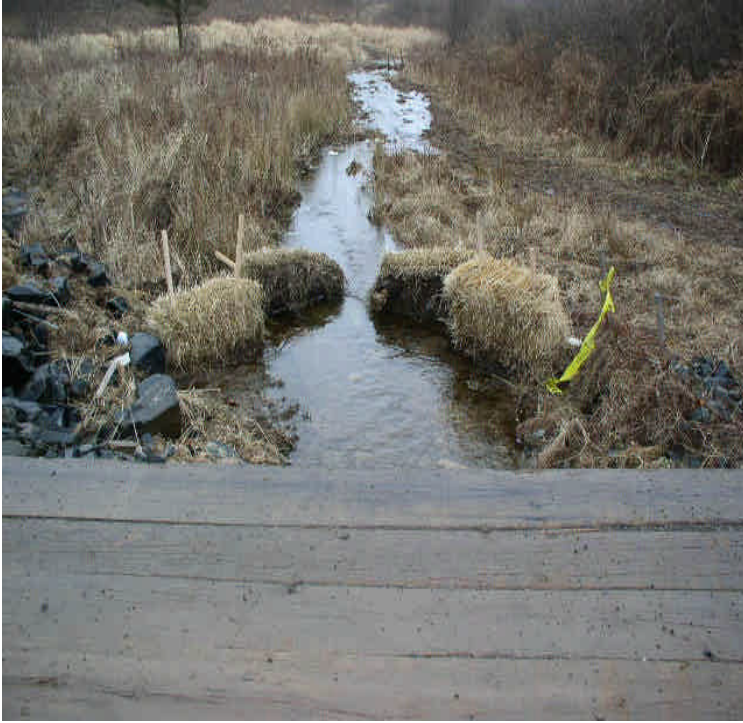
**Carpenter Lane: Haybales have been knocked over at the wetland Outlet and should be righted and restaked. ATVs continue to damage controls and leave tracks in the wetlands.**

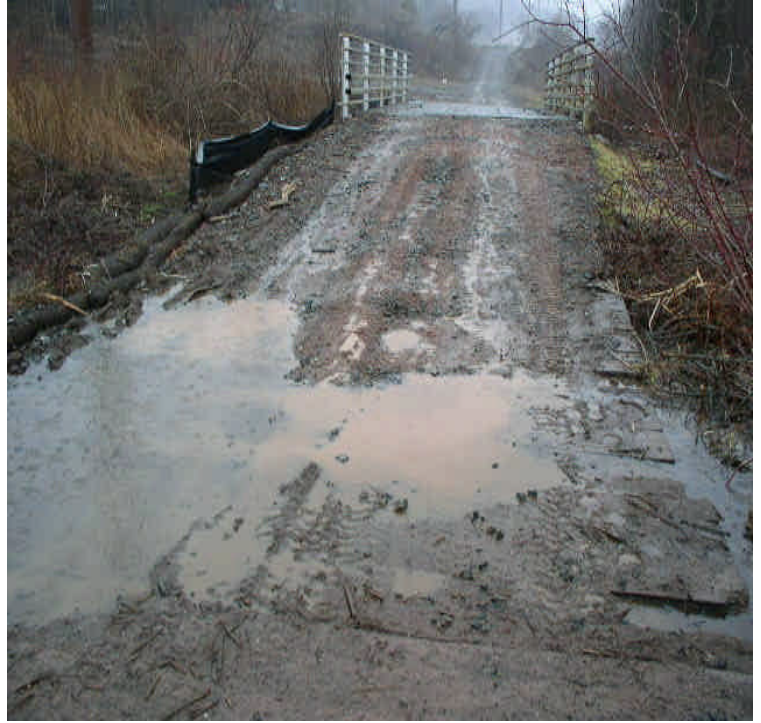
**Durham Rd: Some run-off was noted but it is being filtered by control. Additional controls may be needed as water levels have the potential to overflow/overwhelm them here.**

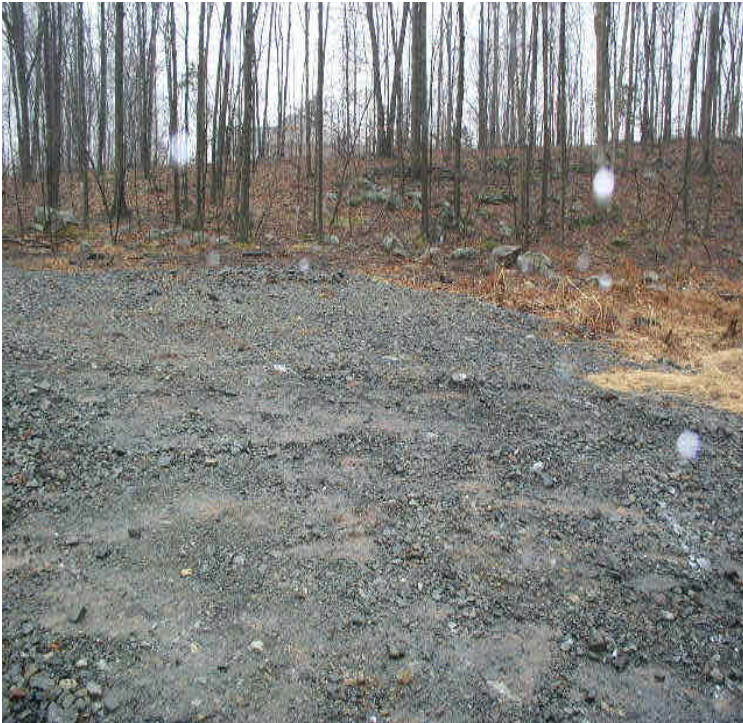
**Stony Brook: Pump truck and soil affected by the associated leaks have been removed from this area.**

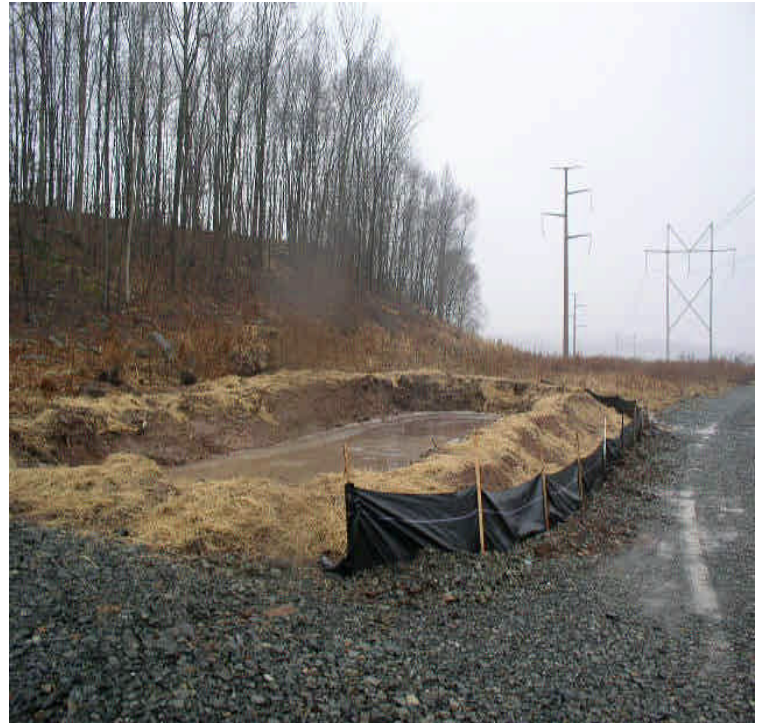
**Stony Brook: Slurry dewatering pit appears contained. Once drilling is complete, this area should be graded and stabilized.**

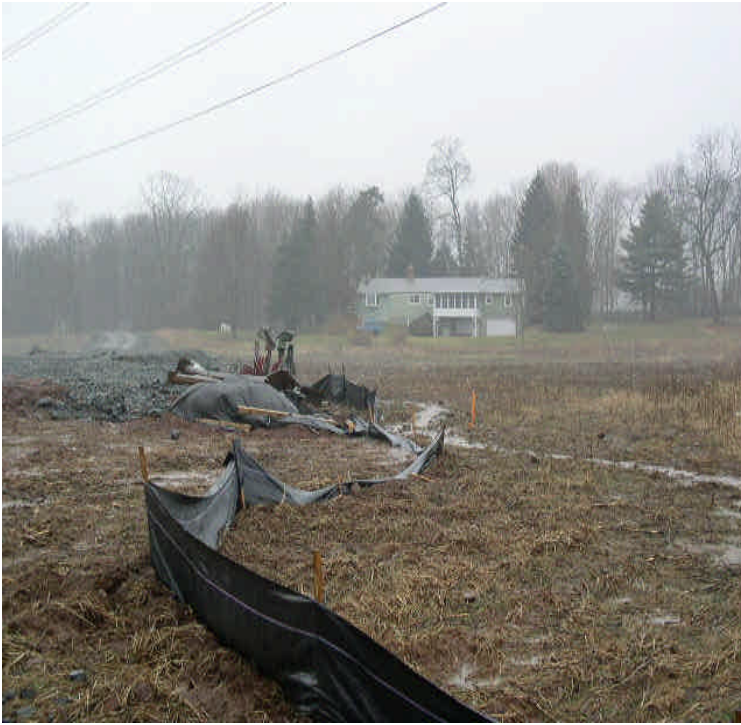
**Tamarack Swamp Rd (east): Small section of deteriorated silt fence needs repair.**

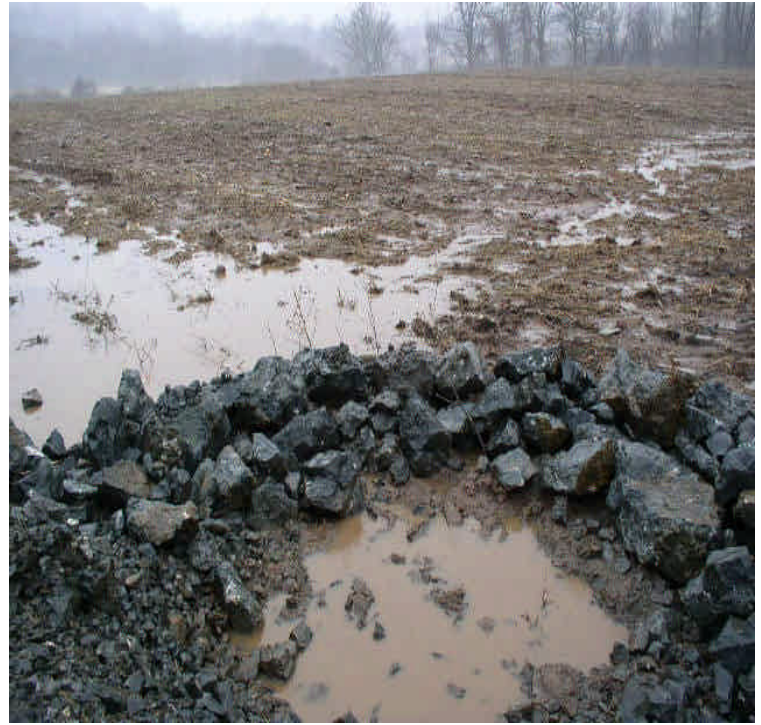
**Tamarack Swamp Rd (east): Turbid run-off was observed flowing from the exposed farm fields and into the project's existing controls. However, the turbid water is not associated with the project.**

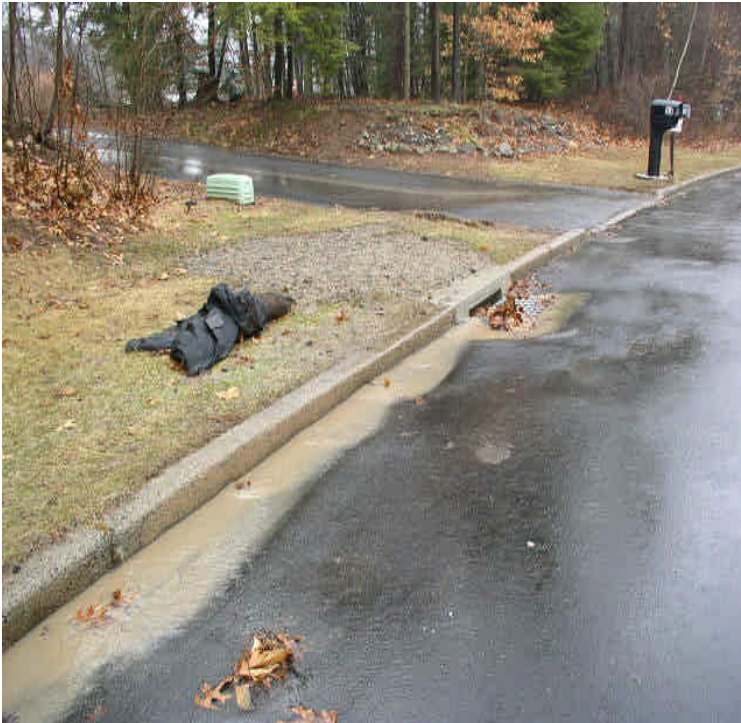
**Old Farms Rd: Turbid run-off from access driveway and driveway crossings was entering CBs that did not have controls in place.**

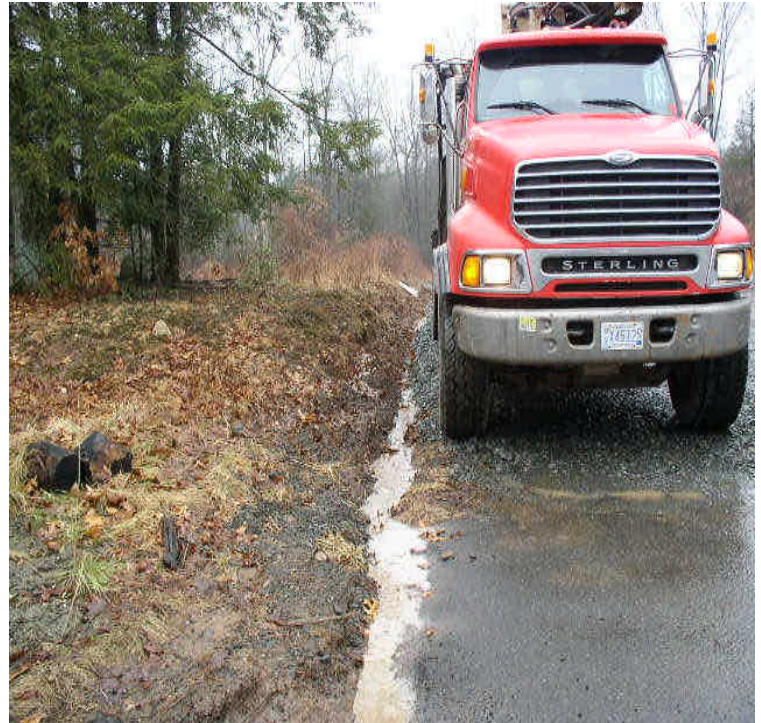
**Old Farms Rd: Turbid water noted flowing down the drainage channel at the saturated driveway crossing and onto the roadway. Evaluate alternatives such as haybale check dams.**
