Docket No. 272 – Development and Management Plan Inspection

Segment 2a Inspection

Date: February 20, 2008

Location: Segment 2a – Beseck Switching Station to Cheshire/Hamden Town Line

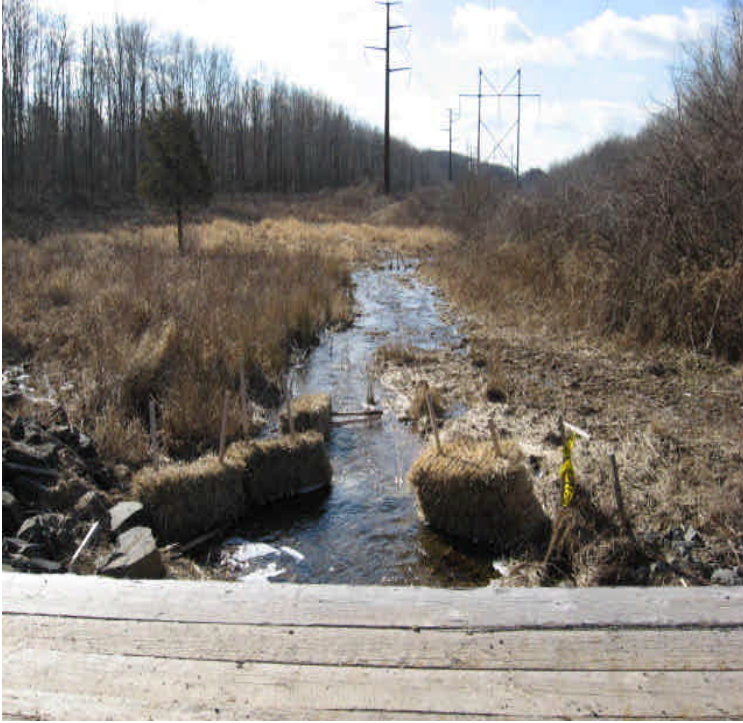
Carpenter Lane: Haybales have been knocked over at the wetland outlet due to high flow. ATVs continue to damage controls and leave tracks in wetlands.

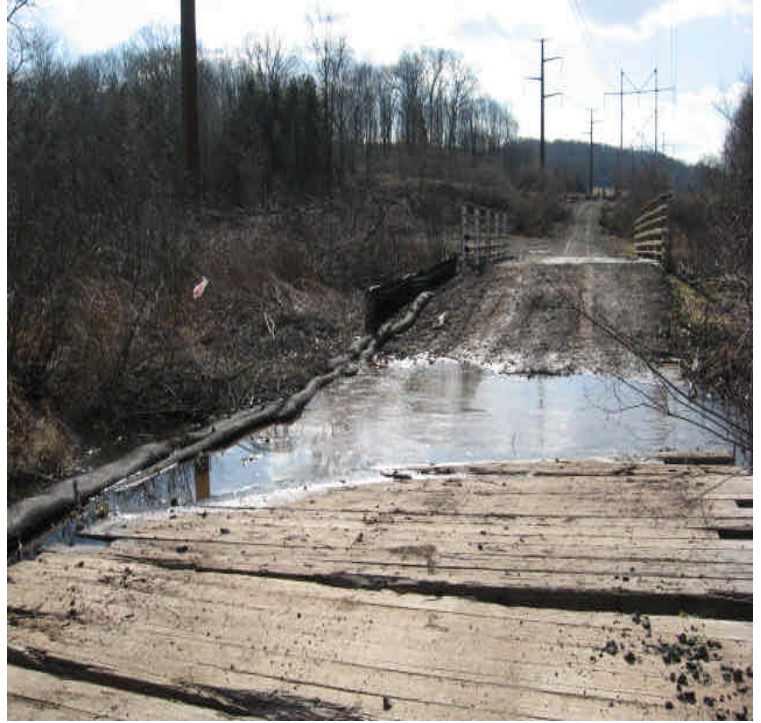
Durham Rd: Clear run-off noted across the access road and in the wetlands at the bridge over the Muddy River. Additional controls may be needed, especially when area is active.

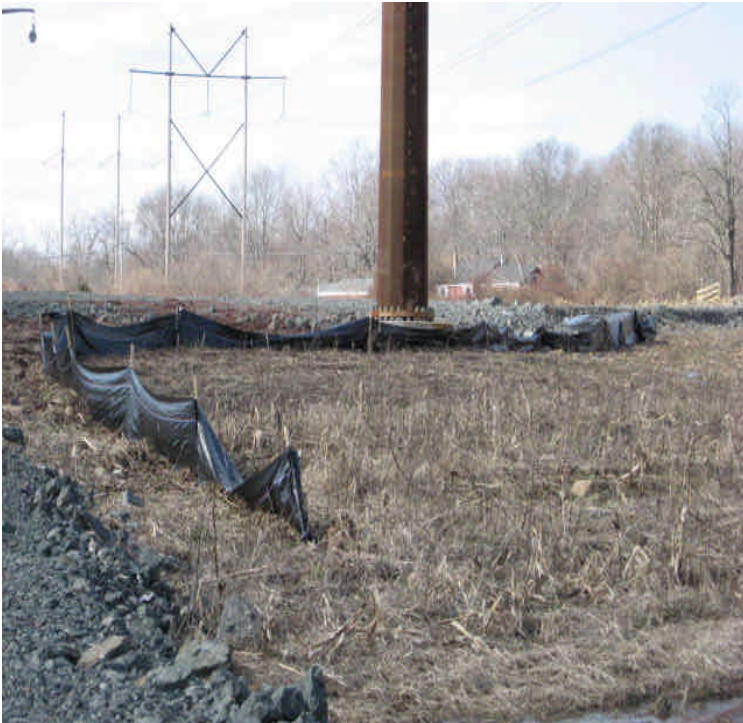
Tamarack Swamp Rd.: Silt fence has been repaired.

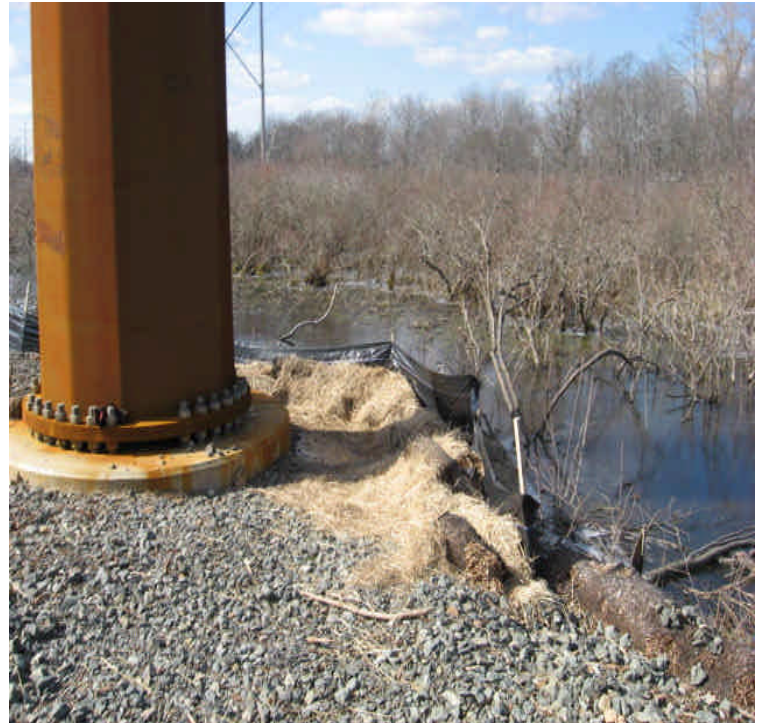
Tamarack Swamp Rd: Hay was added at foundation within the wetland.

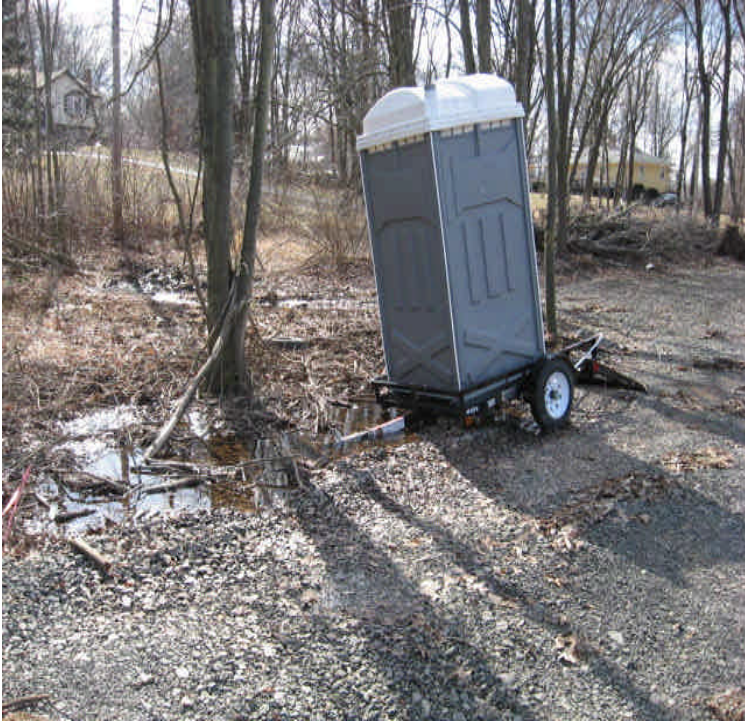
Powers Rd: Sanitary facility was located in standing water, upgradient from a wetland and not tied/secured into the trailer. This should be relocated, over 100 feet from wetlands.

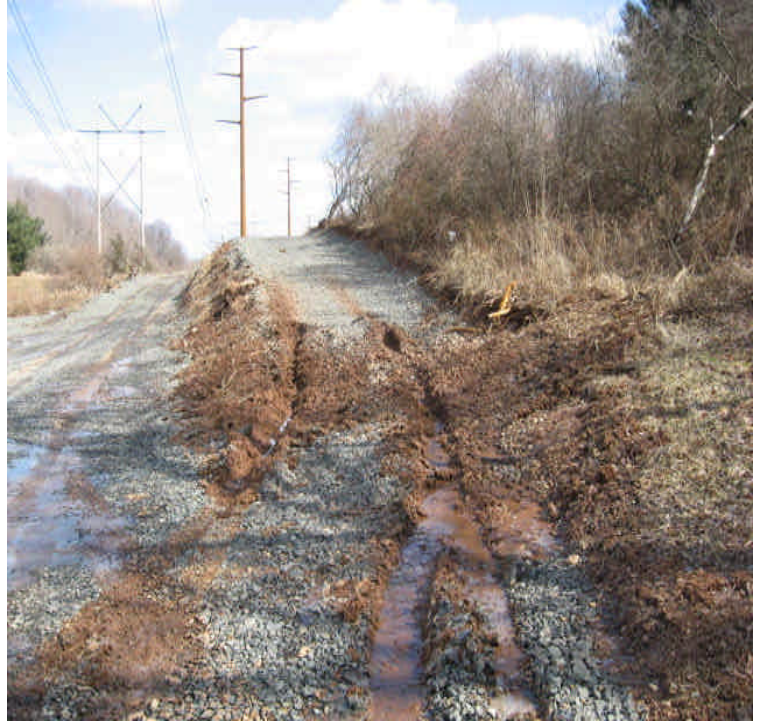
Powers Rd: Rutted tracks were noted at an access road by-pass. Turbid water from the tracks is eventually flowing into the wetlands.

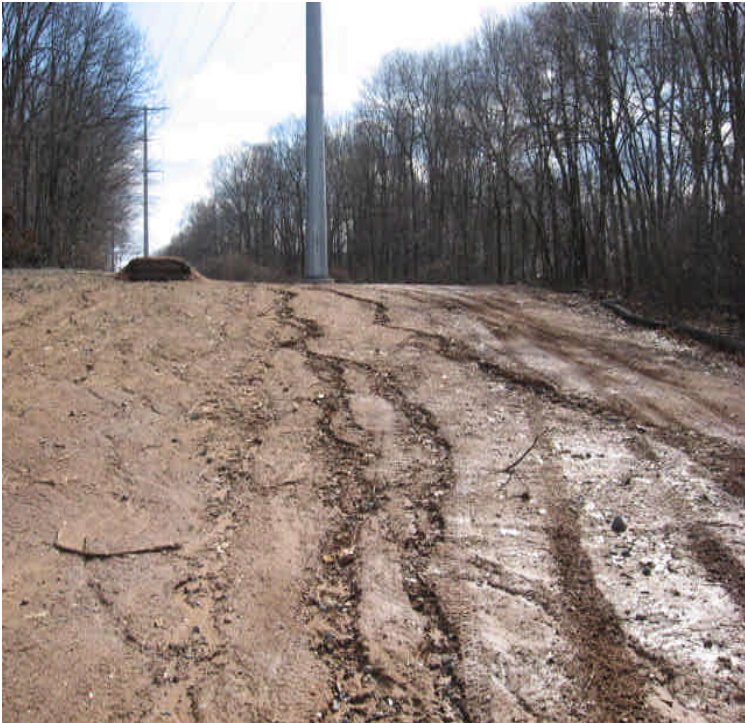
Docker Dr: Eroded channels/gullies from heavy rains and ruts from ATV traffic were noted along a steep slope. Contractors will return soon and attempt to stabilize with a bark mulch but there are large amounts of traffic here.

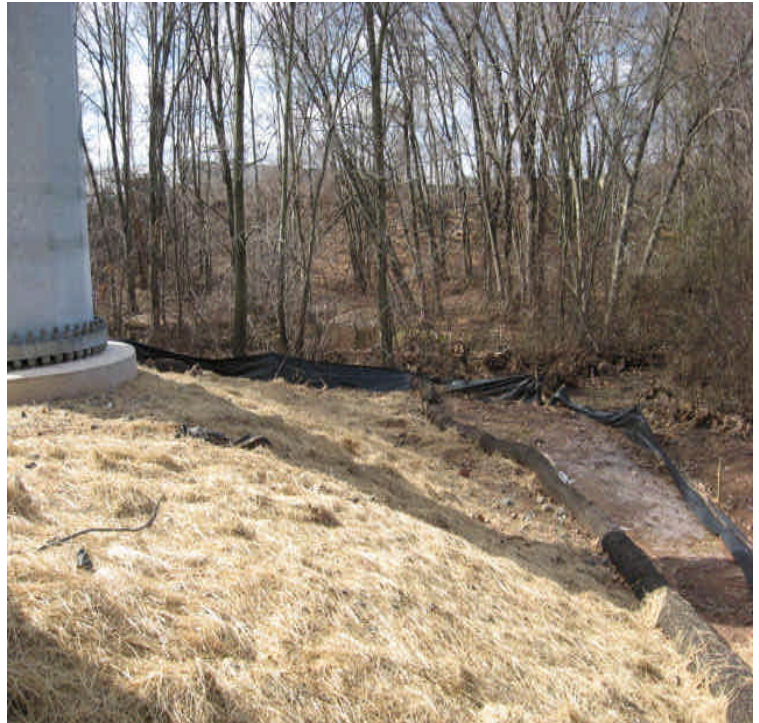
Docker Dr: Additional controls have been installed directly upgradient from wetlands.
