Docket No. 272 – Development and Management Plan Inspection

Segment 2a Inspection

Date: March 24, 2008

Location: Segment 2a – Beseck Switching Station to Cheshire/Hamden Town Line

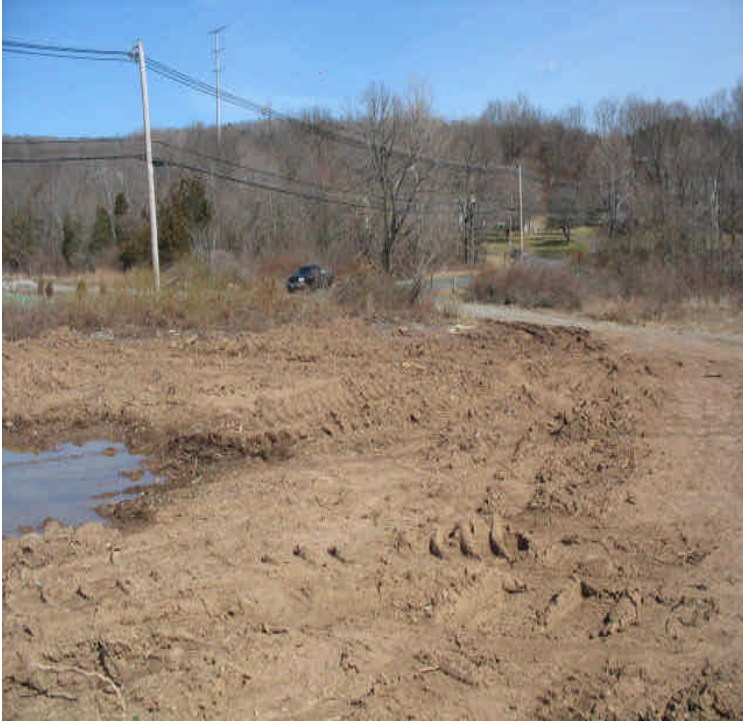
Carpenter Ln: A large, recently exposed area needs stabilization

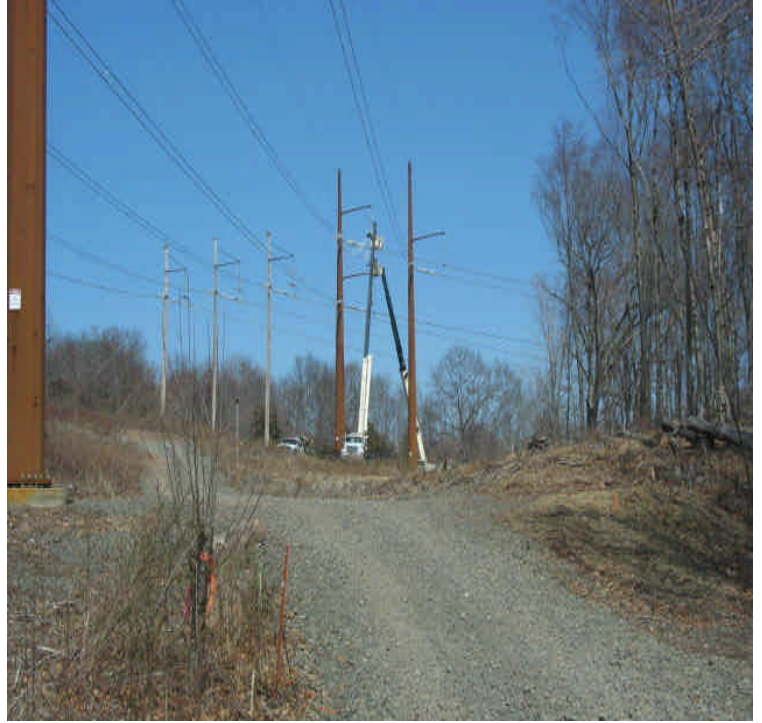
Durham Rd: Line work was underway.

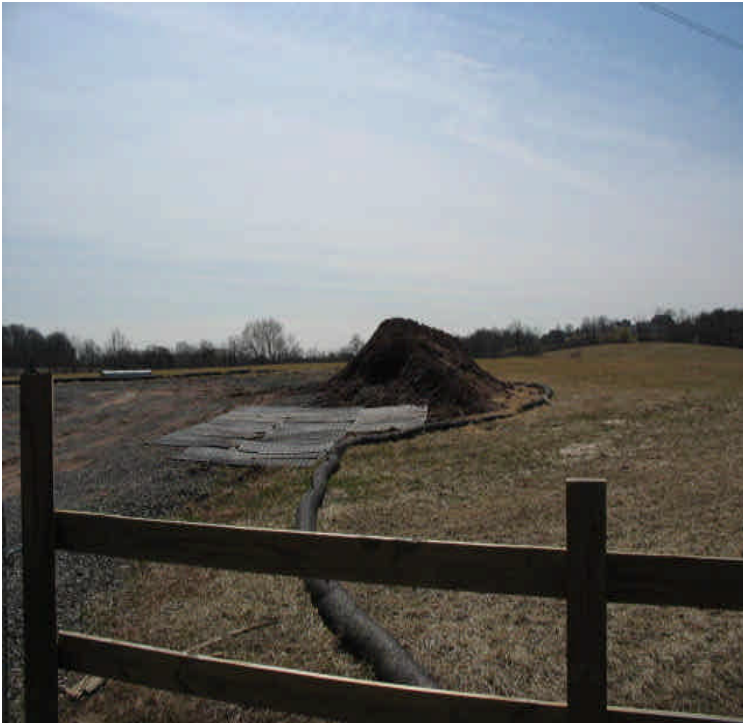
Tamarack Swamp Rd: Stockpile should be removed or stabilized. Controls were present at the base but the soil is not fully contained.

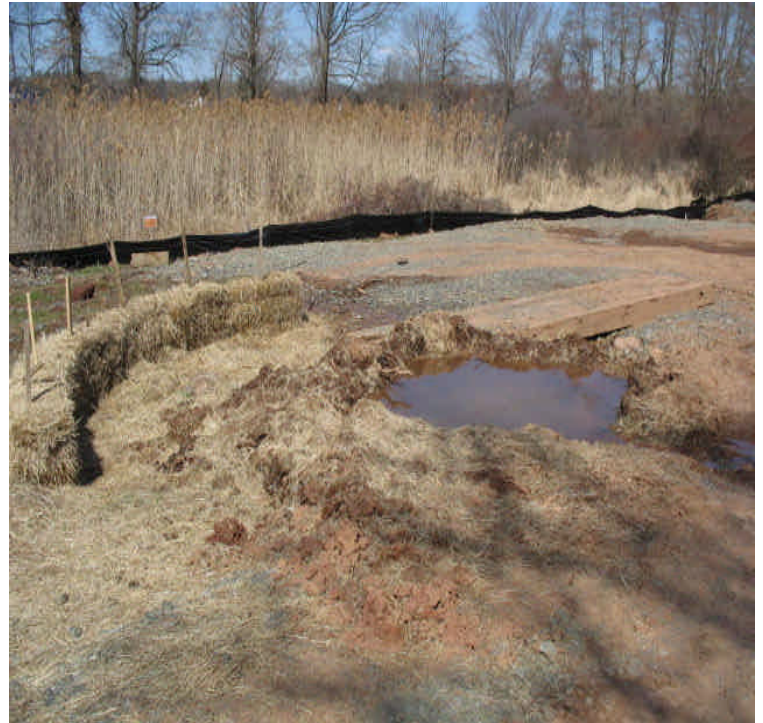
Powers Rd: Haybales and silt fence installed to filter run-off from the saturated, timber mat bypass-crossing.

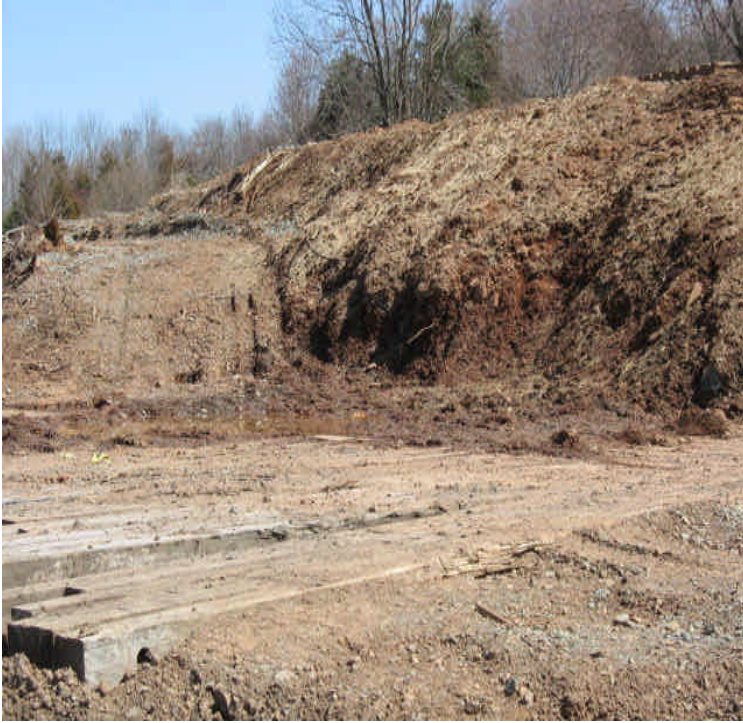
Powers Rd: Timber mat bypass is stable. Additional controls were installed downgradient.

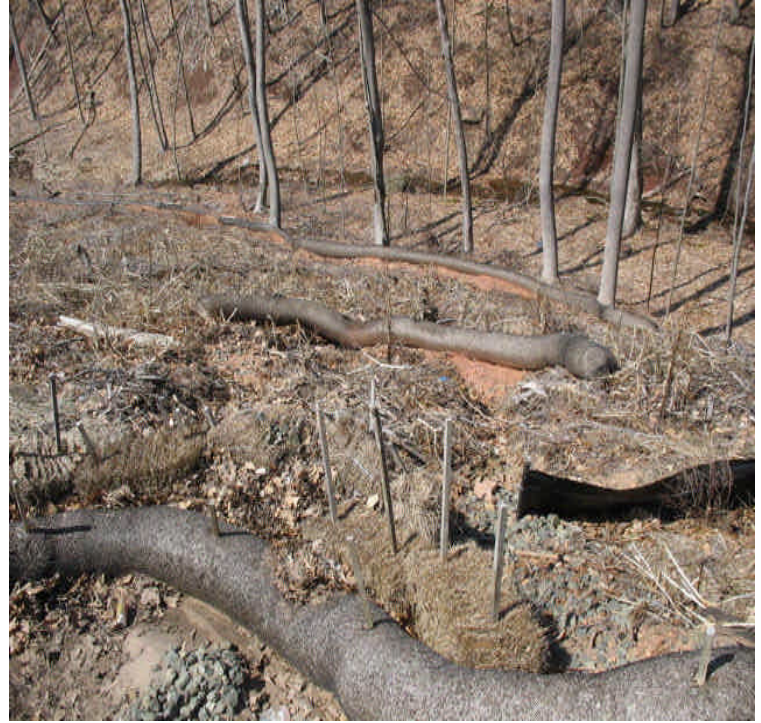
Harrison Rd: Stormwater has eroded soils and undermined controls where the gully had been noted on the slope for several months. Sediment has been pulled back from the controls but a long term solution needs to be evaluated.

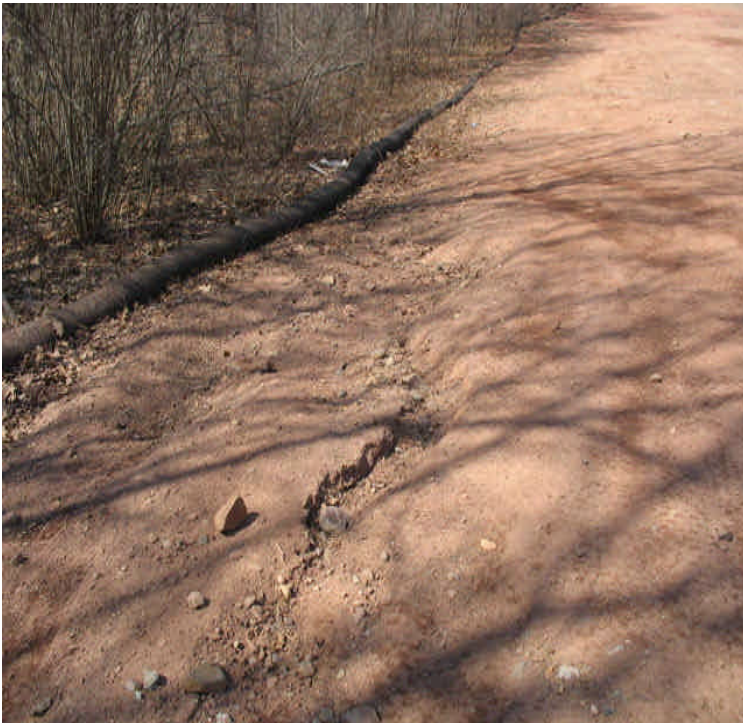
Docker Dr: Eroded rills/gullies had worsened along the slope due to heavy rain. Mulch/seed have washed away. Contractors are scheduled to return here with heavy mulch in an attempt to stabilize the area.

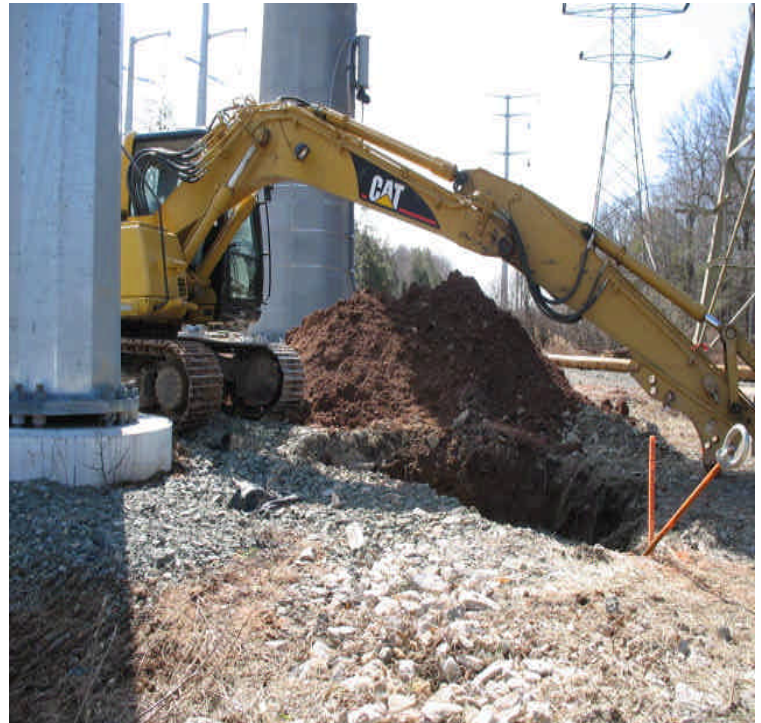
Old Farms Rd: Small stockpile and excavation/trench work noted at Cook Hill Jct. Fill and stabilize as needed upon the completion of work.
