**Docket No. 272 – Development and Management Plan Inspection**

**Segment 2a Inspection**

**Date:** April 1, 2008

**Location:** Segment 2a – Beseck Switching Station to Cheshire/Hamden Town Line

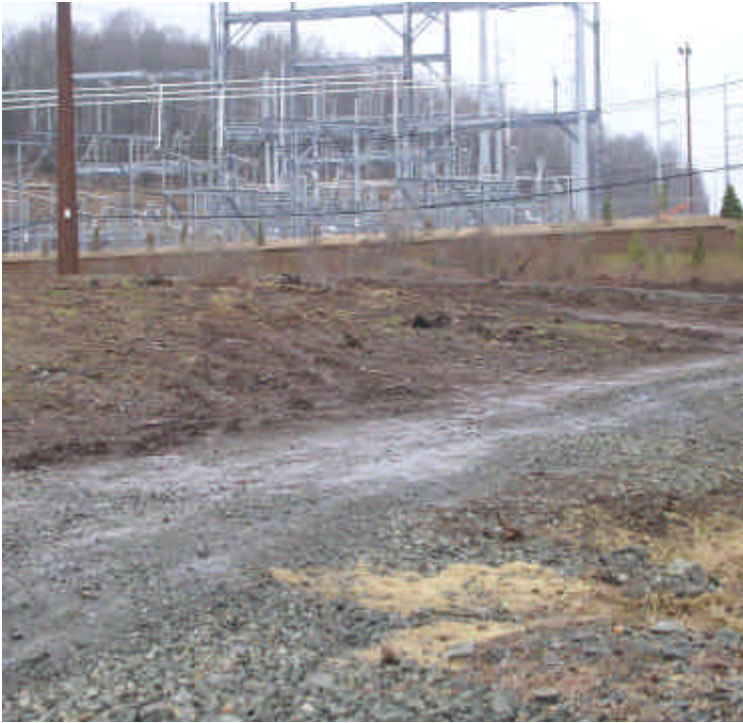
**Carpenter Ln:** A large, recently exposed area needs stabilization. (Beseck SS seen beyond the area, to the north of the roadway).

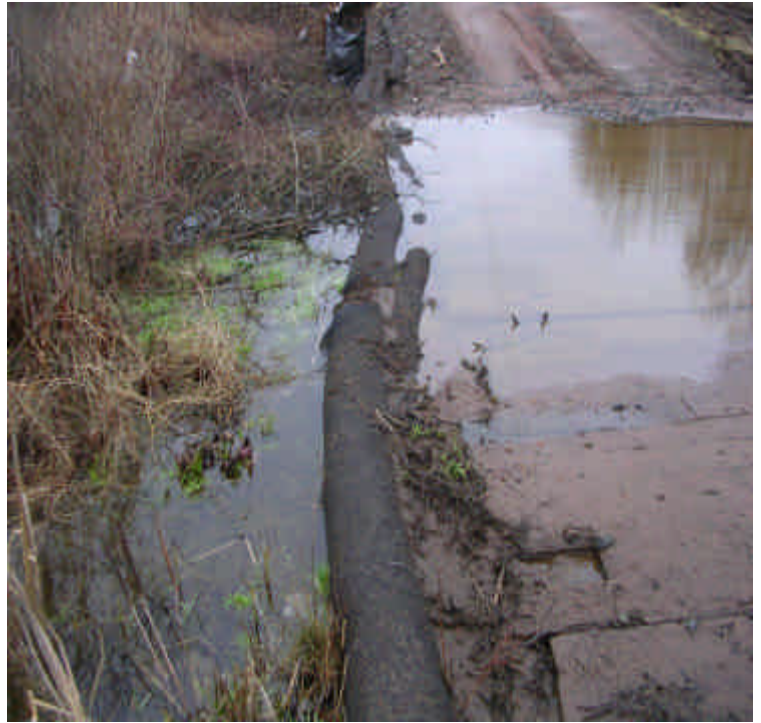
**Durham Rd:** Timber mats remain flooded at the wetland crossing, just before the bridge. Controls are still filtering the flow.

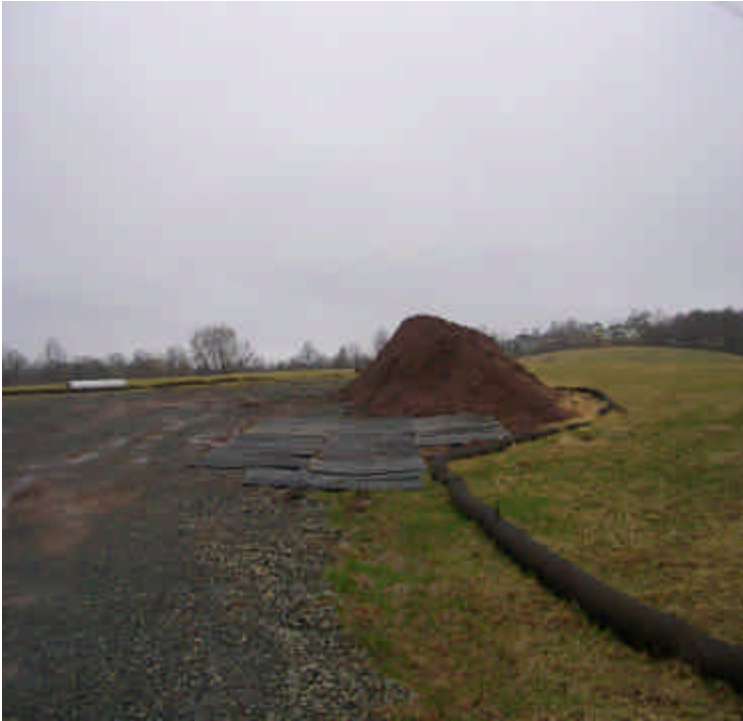
**Tamarack Swamp:** Stockpile should be removed or stabilized. Controls were present at the base but the soil is not fully contained.

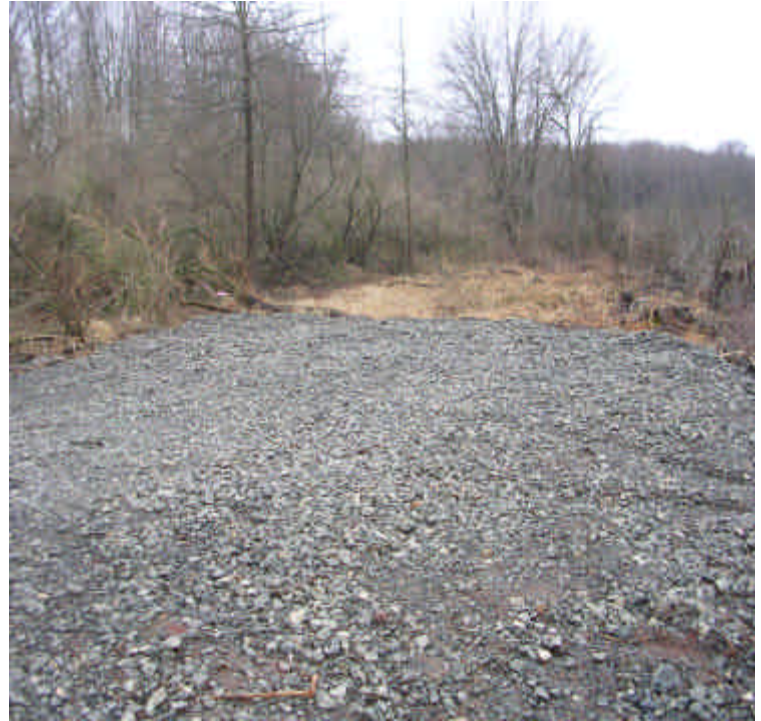
**Tamarack Swamp Rd:** The stone stockpile resulting from snowplowin has been removed and regraded.

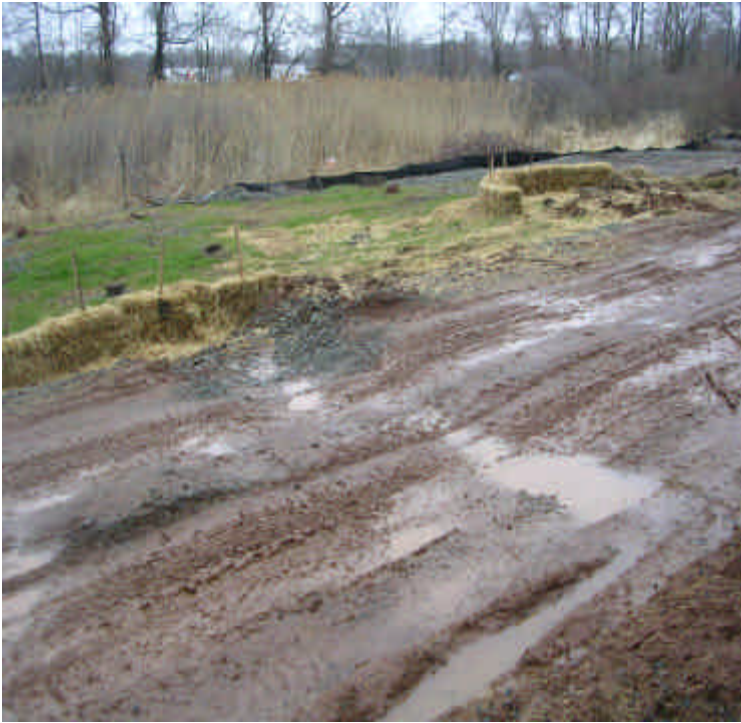
**Powers Rd: Timber mat bypass remains stable. Additional controls were installed and run-off is being filtered.**

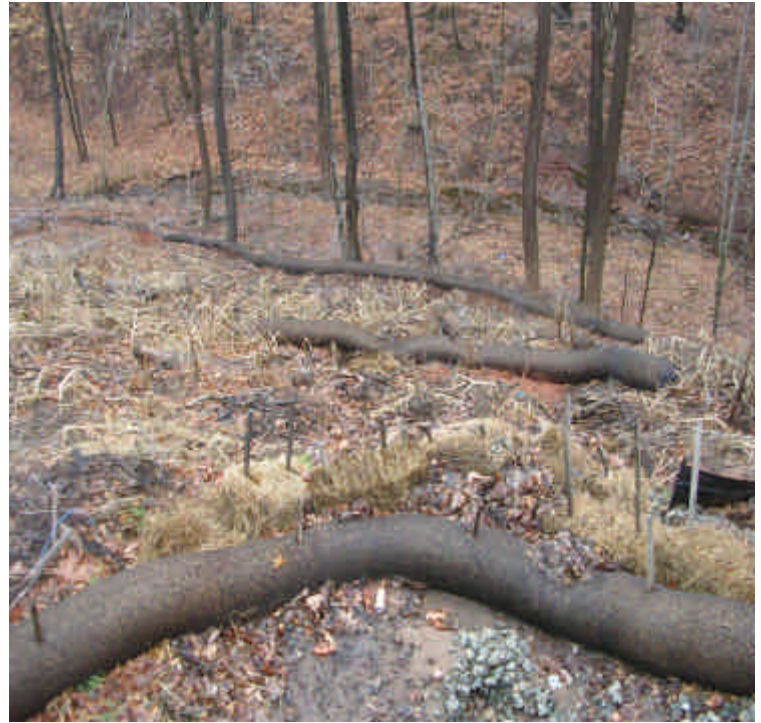
**Harrison Rd: Hay was installed at the undermined areas within the controls. Sediment was pulled away from controls where needed. Work on a long term solution has been approved and will be implemented soon.**

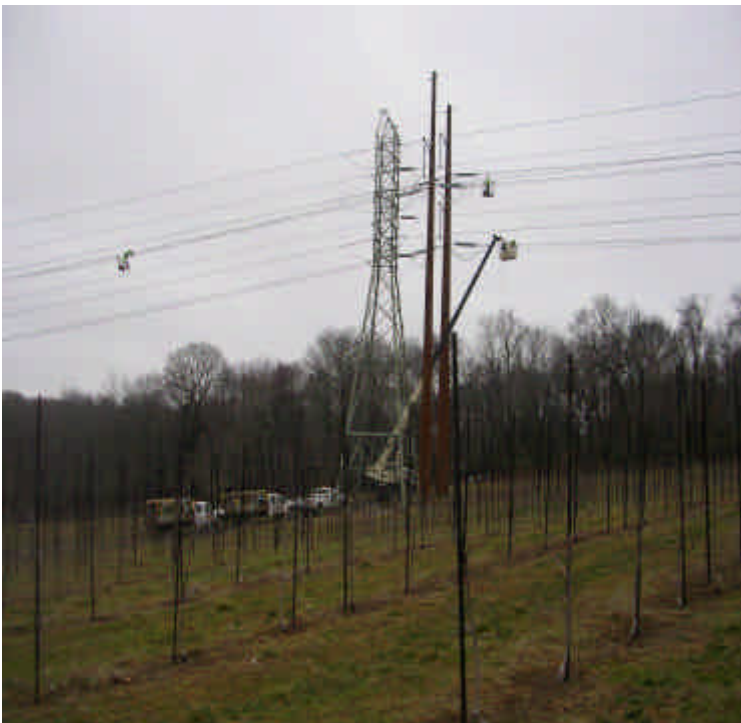
**Blue Hills Orchard: Line work was underway.**

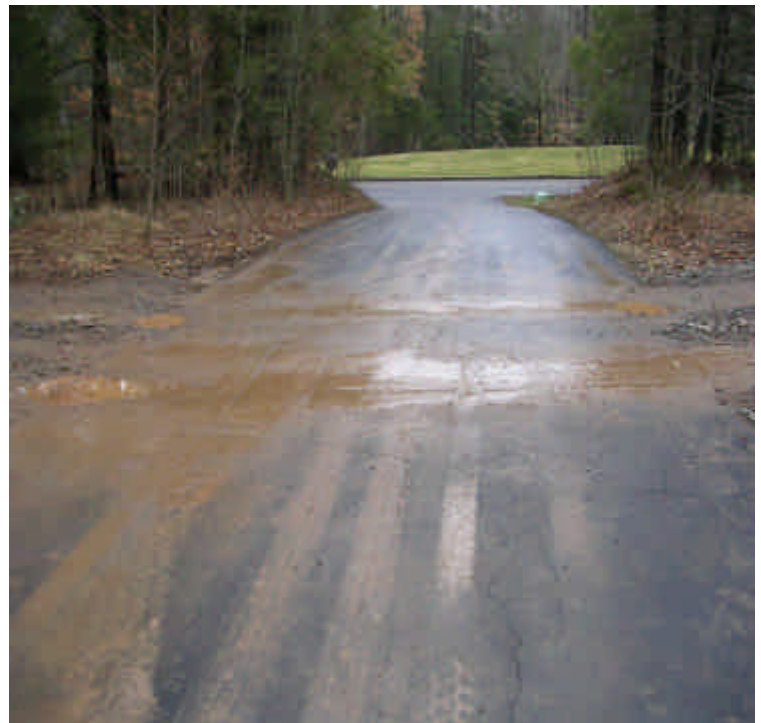
Equipment has tracked sediment onto a private driveway and vehicles have been using this driveway as appose to the existing access driveway. 4/1/08	Add stone to the access road to help control tracking problems and only use the approved access driveway to reduce additional tracking problems. 4/1/08	Needs attention. Private driveway should be swept.
	Ruts were noted in the previously mulched areas along the access road to Cook Hill Jct. (Since 3/11) 4/1/08	Regrade the area and provide additional stabilization. 3/24-4/1/08	Needs attention.
	A private driveway was being used for access at Cook Hill Jct. Sediment tracking was observed. 4/1/08	Install tracking pads on either side of the driveway; sweep sediment from the drive and check for damage. 4/1/08	Needs regular attention

**Old Farms Rd: Private driveway being used by equipment to access a section of ROW near Cook Hill Jct. Driveway should be swept and a tracking pad installed on either side. Monitor for any damage to the driveway**
