**Docket No. 272 – Development and Management Plan Inspection**

**Segment 2a Inspection**

**Date:** April 8, 2008

**Location:** Segment 2a – Beseck Switching Station to Cheshire/Hamden Town Line

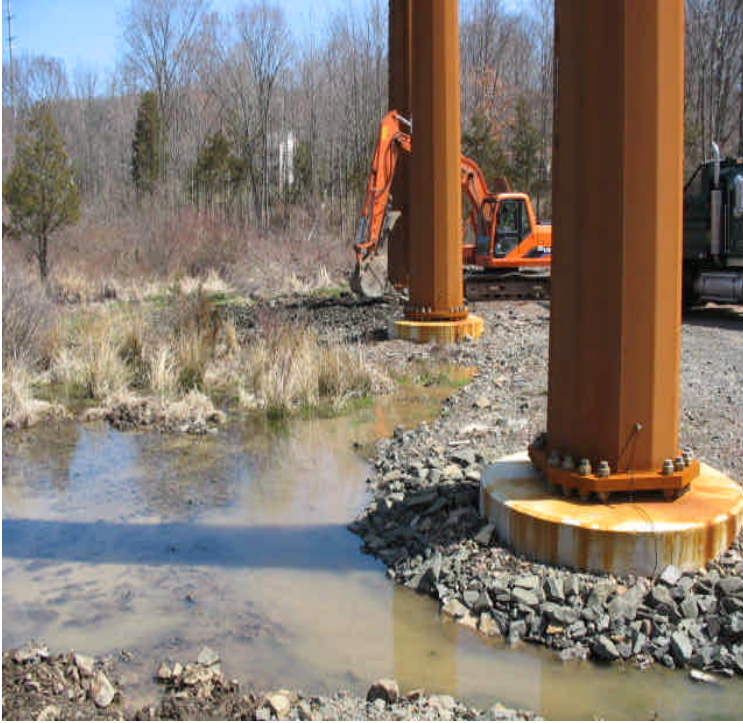
**Carpenter Ln:** Pad/road work was underway within the wetlands which was generating sediment that was entering the water and flowing off-site.

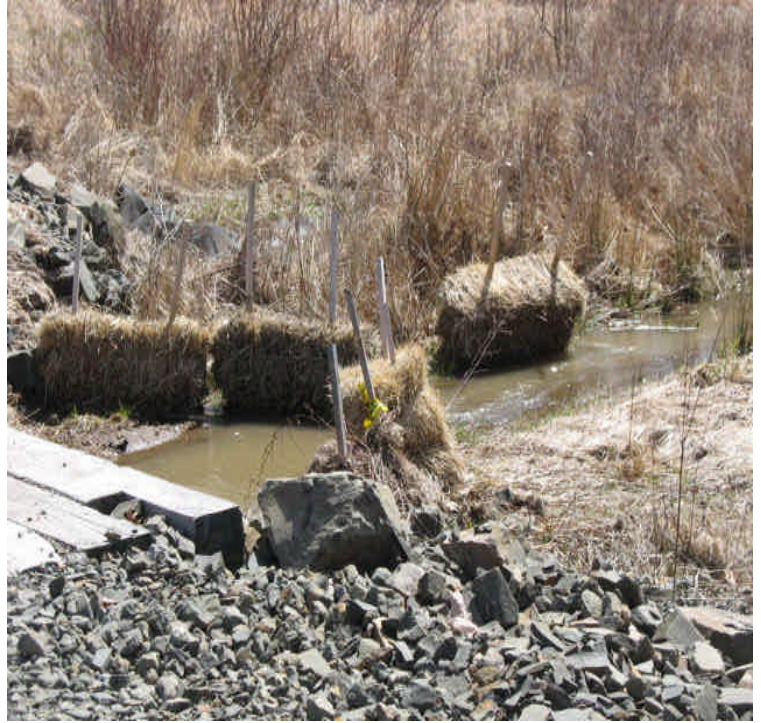
**Carpenter Ln:** The high flow at the outlet will not allow the haybale controls to stay in place. However, the turbid water resulting from the pad work needs to be filtered before it leaves the site. Install appropriate controls ASAP.

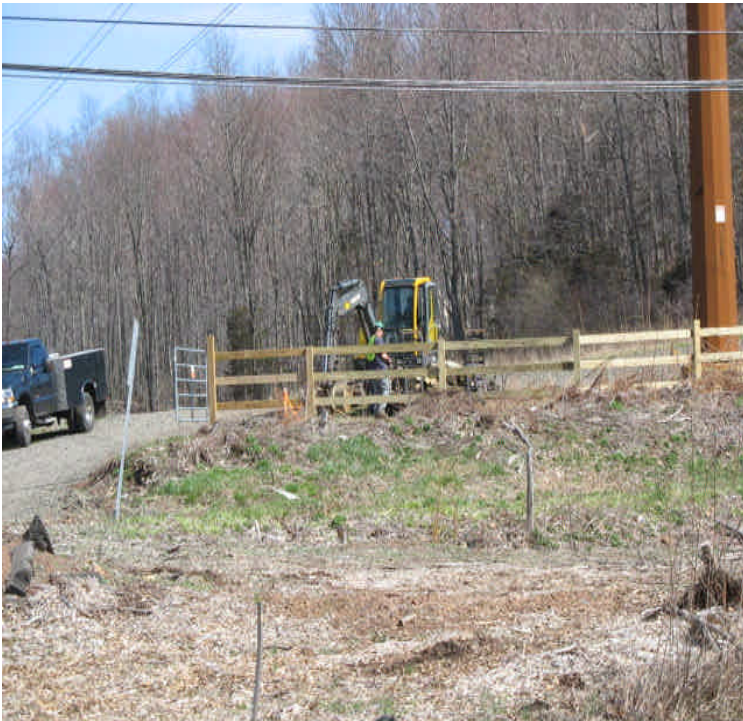
**Durham Rd:** Fence installation was underway north of Durham Rd.

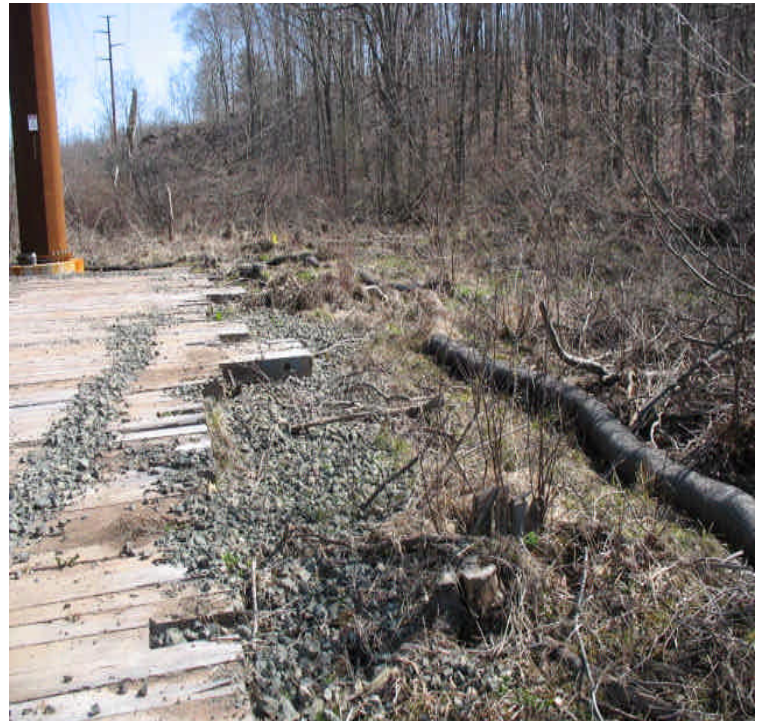
**Liney Hall Ln:** Stone resulting from snow plowing several weeks ago should be removed from wetlands. Final restoration is still needed.

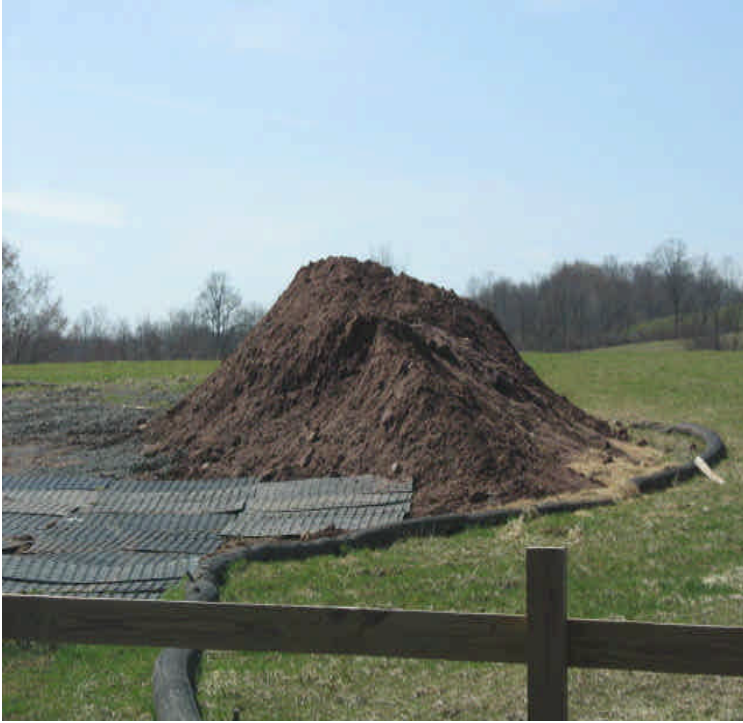
**Tamarack Swamp: Soil stockpile should be removed or stabilized. Controls were present at the base but the soil is not fully contained.**

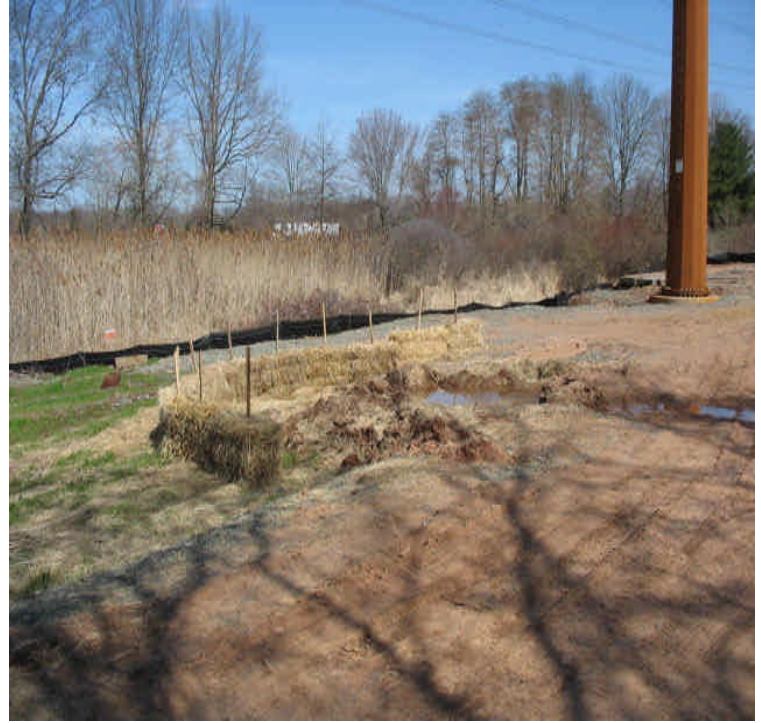
**Powers Rd: Additional controls appear to be filtering all run-off from the bypass access road before it leaves the site.**

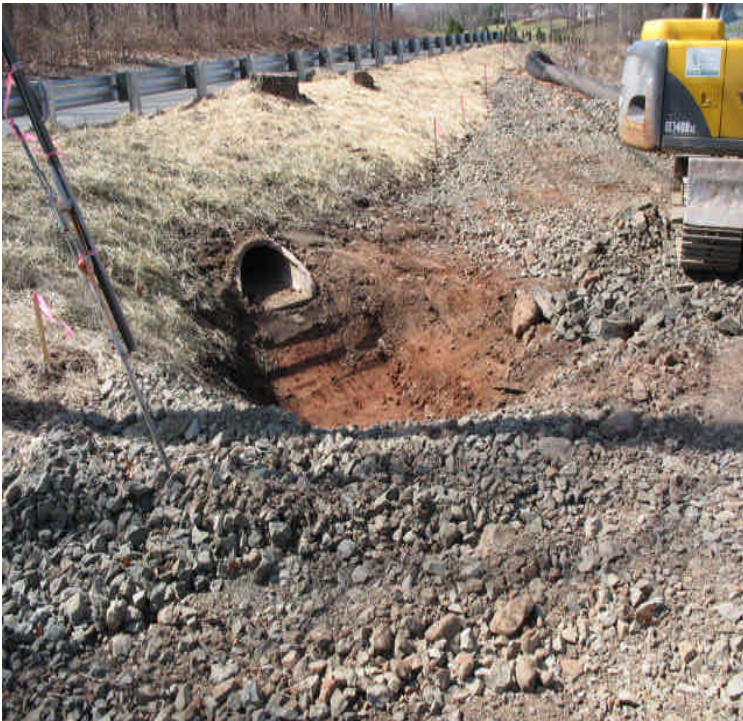
**Harrison Rd: Crews were working on a more permanent solution to filter and slow the stormwater from the roadway that outlets to the ROW. They were building a detention area to allow water to flow over a flat grade prior to heading downslope.**

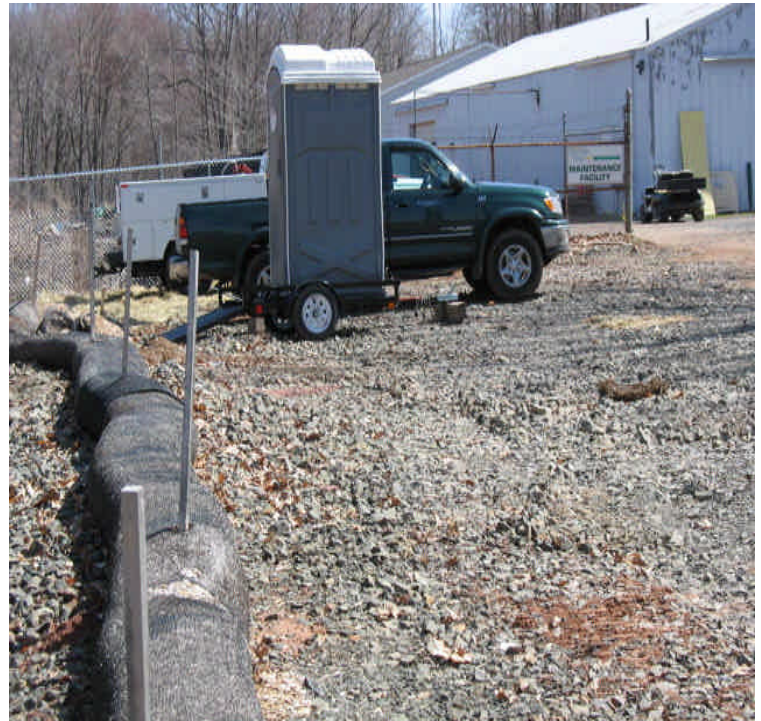
**Harrison Rd: Sanitary facility located above a steep bank to a stream. The resource area appears to be greater than 100 feet away but relocate from the top of slope if feasible, in case of a spill.**
