Docket No. 272 – Development and Management Plan Inspection

Segment 2a Inspection

Date: April 15, 2008

Location: Segment 2a – Beseck Switching Station to Cheshire/Hamden Town Line

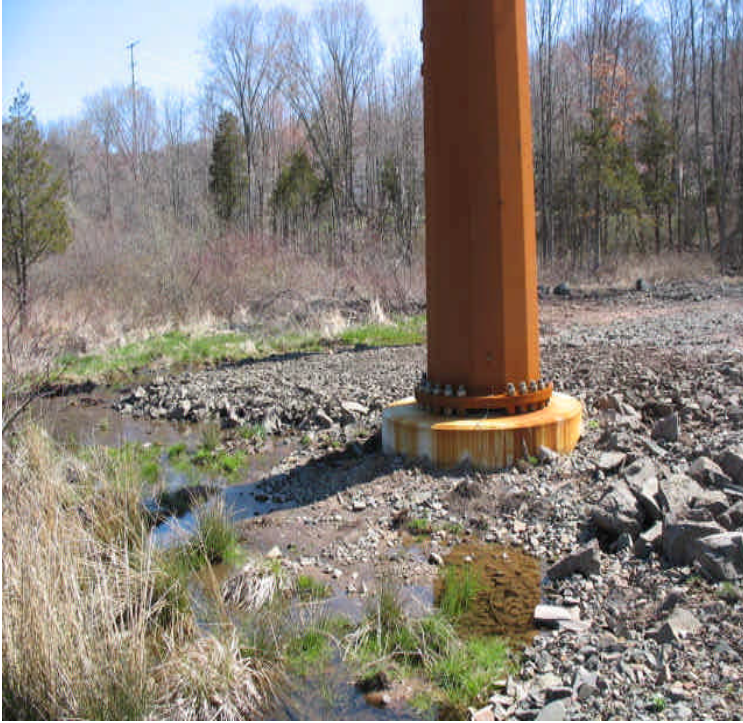
Carpenter Ln: New areas of stone installed were within the wetlands. Crews are reducing the overall wetland impacts by eliminating one of the proposed access roads to the structures but they are working on an access connection between the sets.

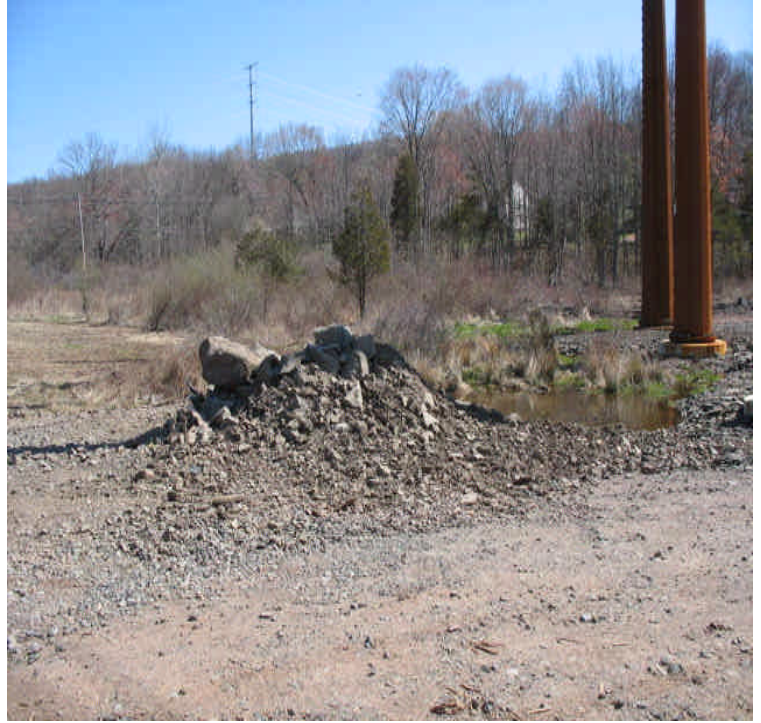
Carpenter Ln: Stone/sediment stockpile from the work was located upgradient from wetlands. Relocate or remove the stockpile greater than 100 feet from wetlands. Also, controls at the outlet did not appear to be repaired following the observation of turbidity in the water last week.

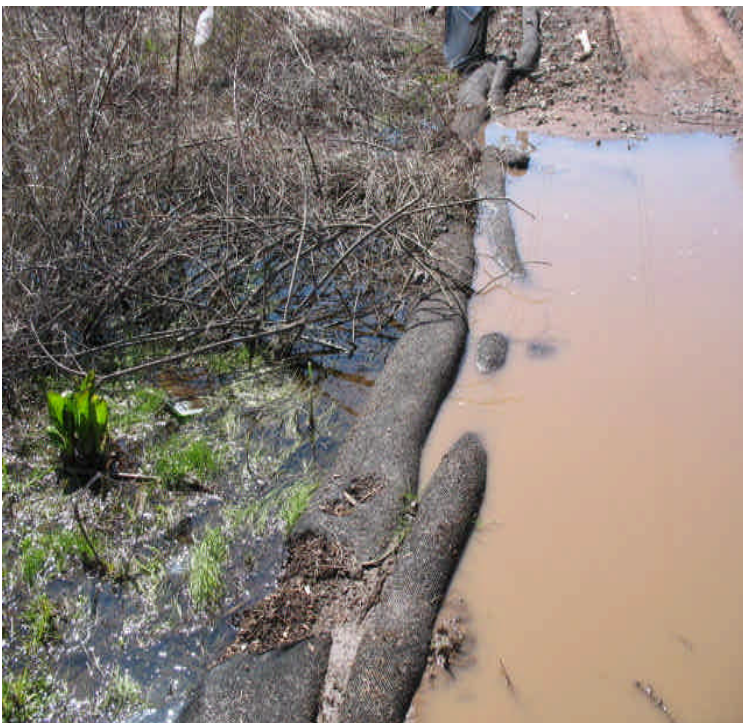
Durham Rd: Turbid water noted at the wetland crossing however sediment is filtering out before entering the wetlands. Continue to monitor carefully.

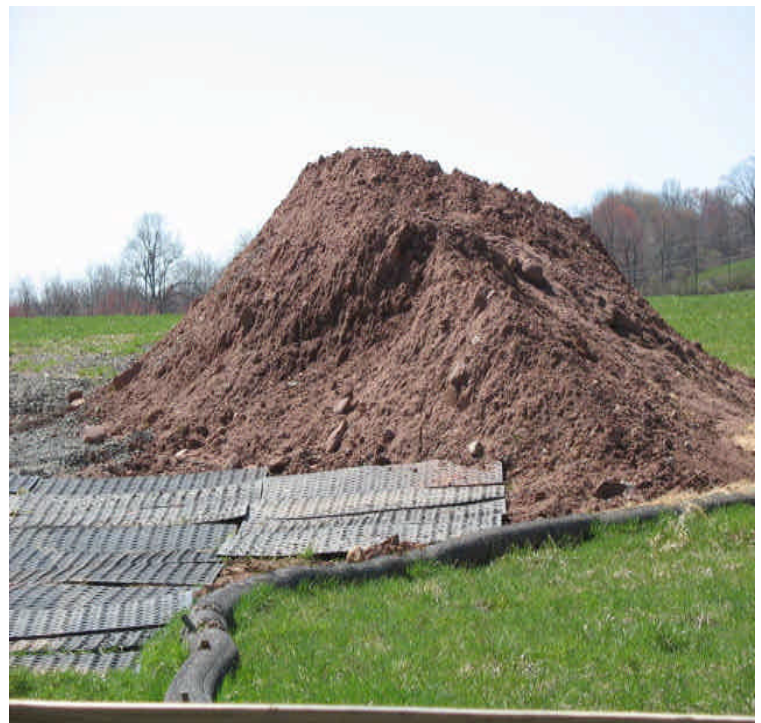
Tamarack Swamp Rd.: Stockpile located east of the roadway is not fully contained with controls. Add controls or stabilize or remove the stockpile.

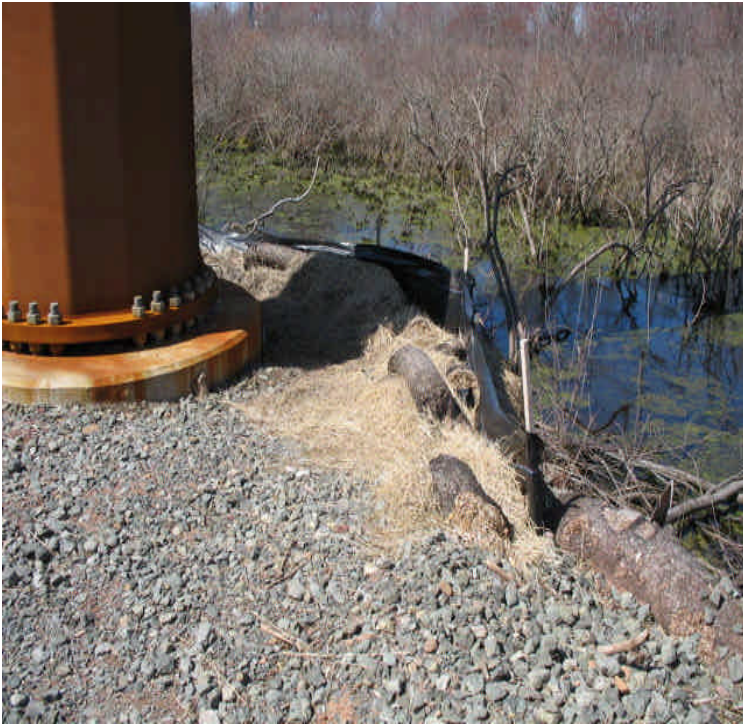
Tamarack Swamp: Controls remain at the edge of the pad to stabilize soils adjacent to the standing water.

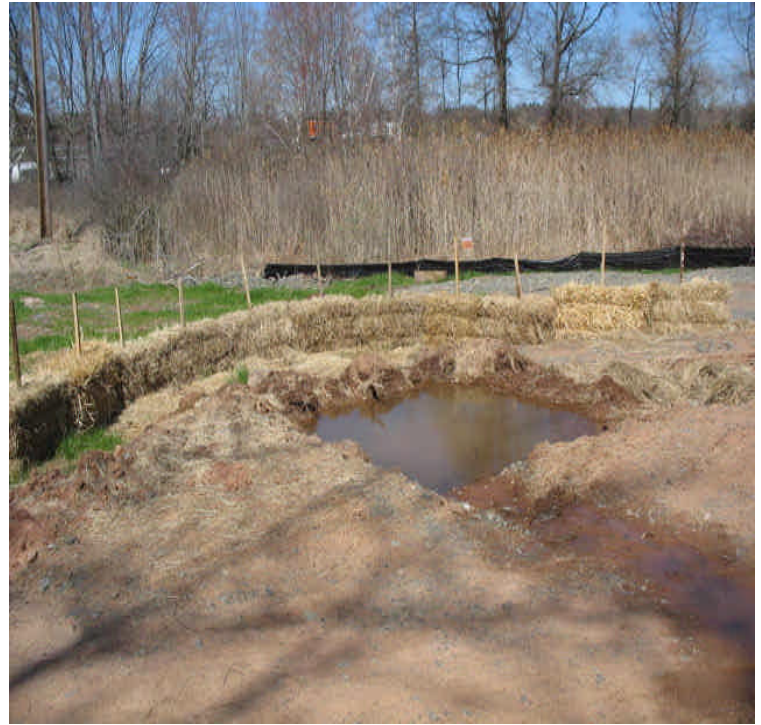
Powers Rd: Additional controls appear to be filtering all run-off from the bypass access road before it leaves the site.

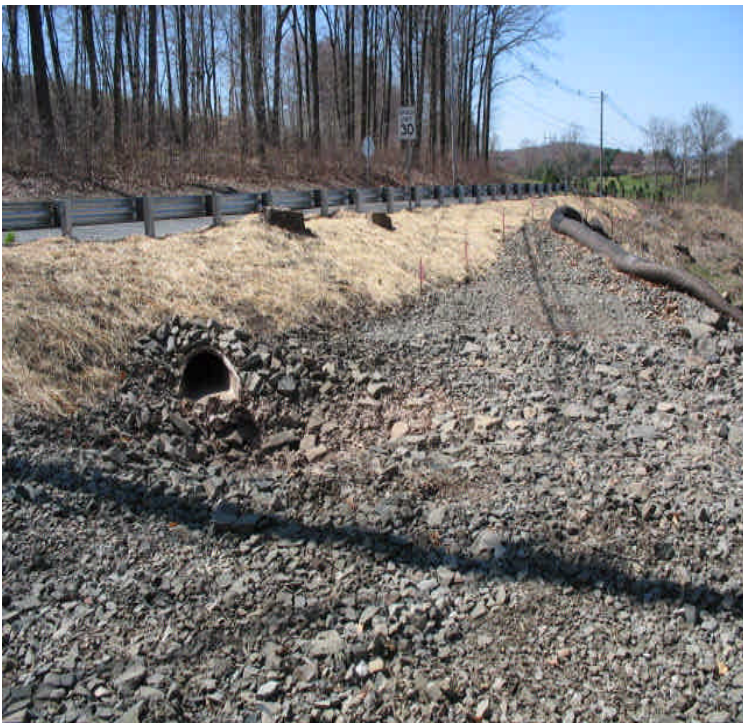
Harrison Rd: Crews installed a more permanent solution to filter and slow the stormwater from the roadway that outlets to the ROW. They were building a detention area/"surge pool" to allow water to flow over a flat grade prior to heading downslope.

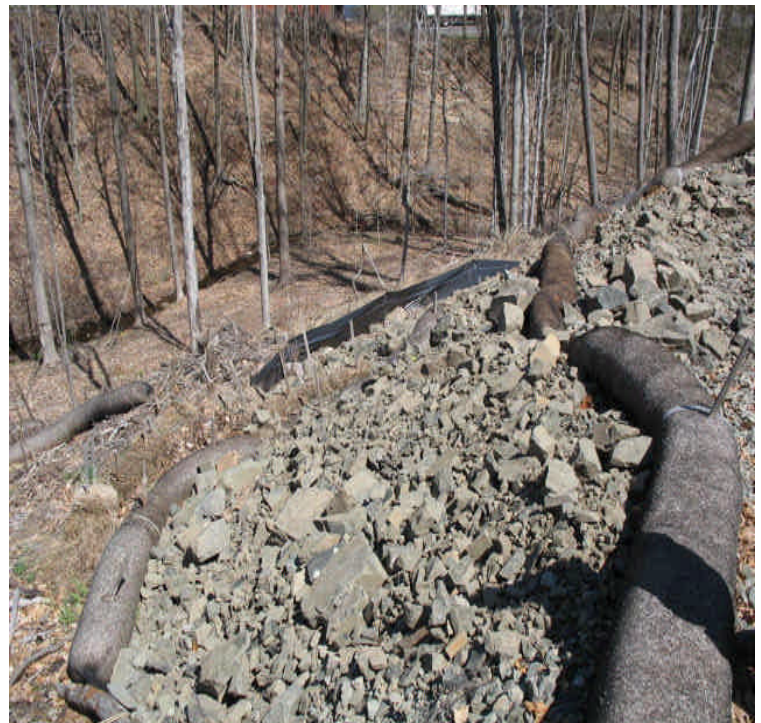
Harrison Rd: The top terrace of the slope below the newly installed detention area has been covered in riprap for stabilization. The pad here will remain, as requested by the golf club, for maintenance crew parking.
