Docket No. 272 – Development and Management Plan Inspection

Segment 2a Inspection

Date: May 6, 2008

Location: Segment 2a – Beseck Switching Station to Cheshire/Hamden Town Line

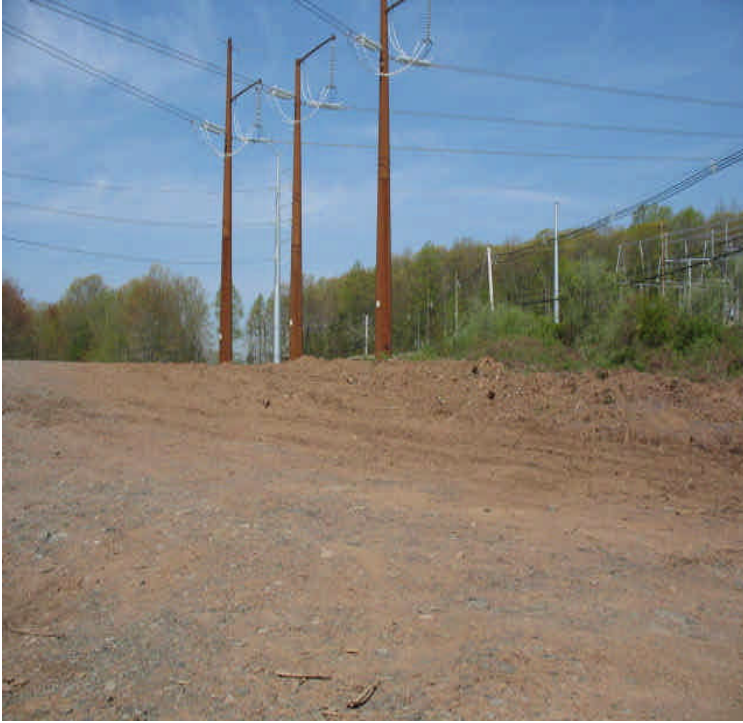
Carpenter Ln: Large area disturbed/exposed during line crew work remains upgradient from wetlands. Final grade and stabilize this area which has remained inactive for several weeks.

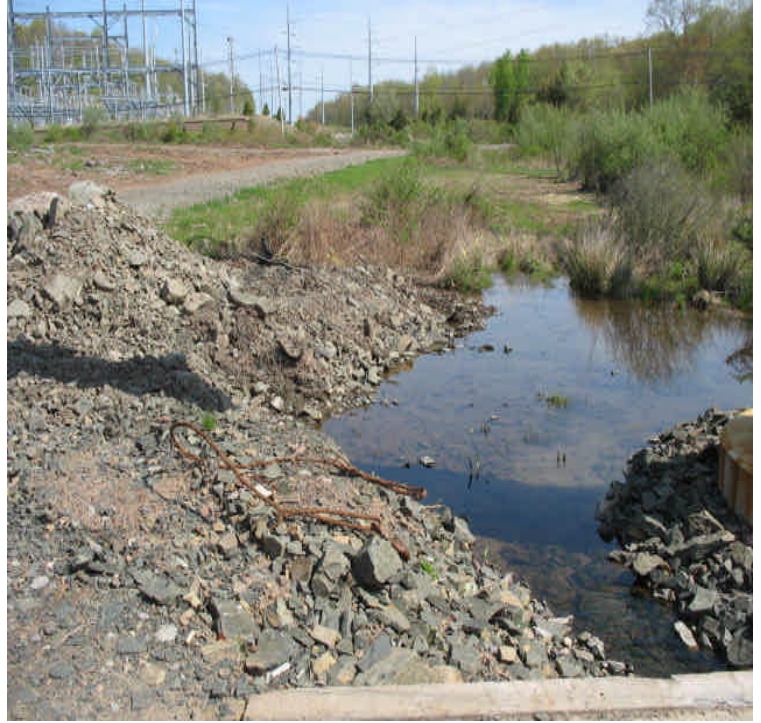
Carpenter Ln: Stone/sediment stockpile from pad work was located in/adjacent to wetlands. Relocate or remove the stockpile greater than 100 feet from wetlands. Also, controls at the outlet should be repaired prior to additional work.

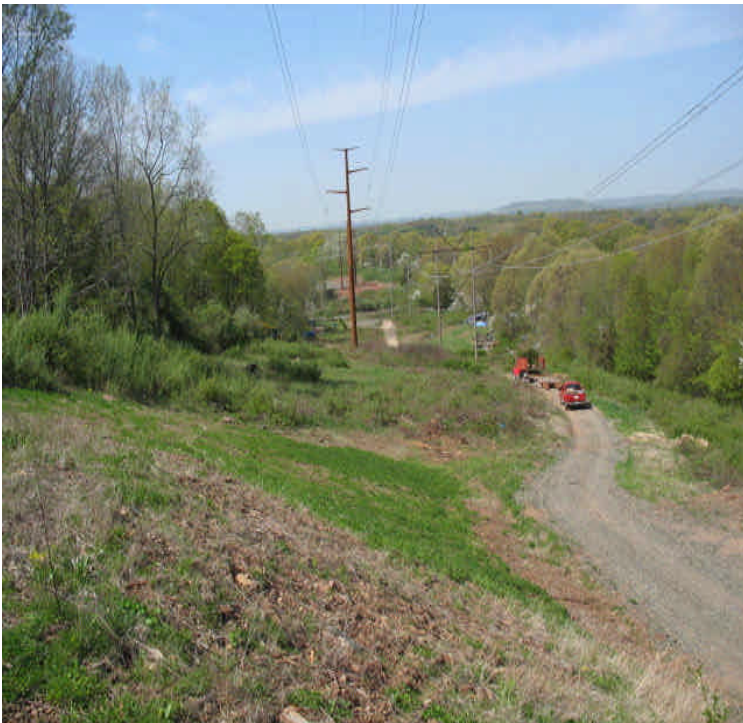
High Hill Rd: Landscapers were planting small shrubs along the edge of the ROW.

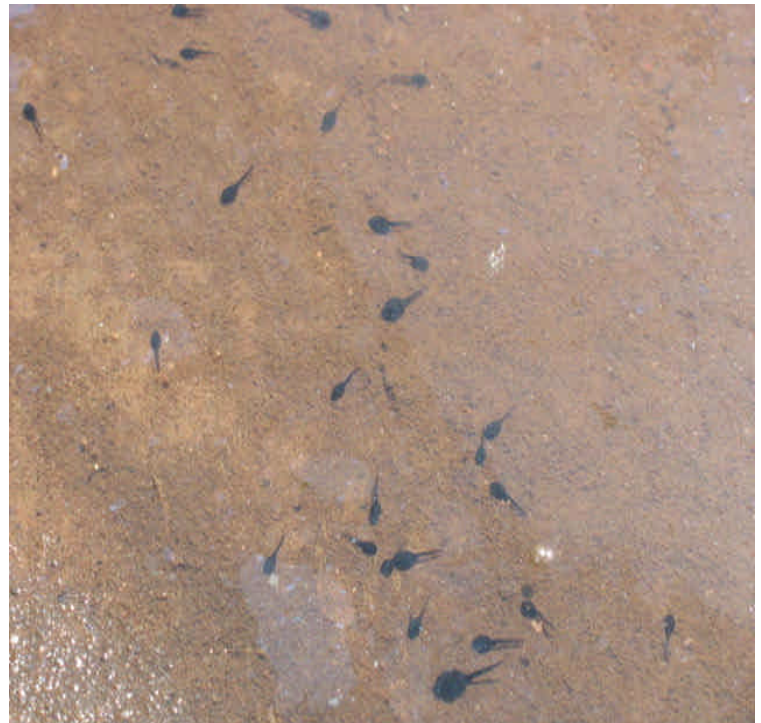
Durham Rd: Tadpoles noted on the timber mats and at the wetland crossing

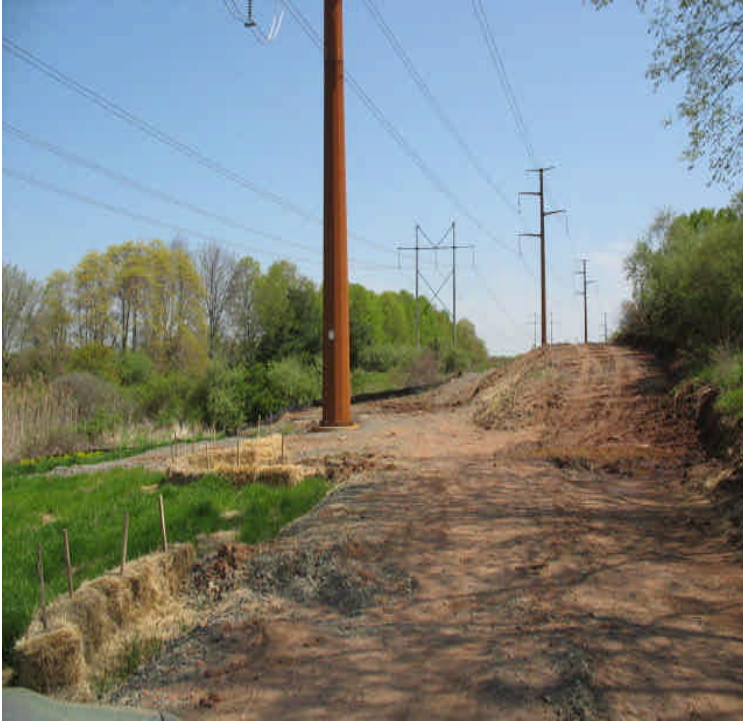
Powers Rd: Timber mat removal complete at the saturated crossing. Controls remain in place at the wetland. Hay/seed applied along the slope. Final reclamation is still proposed at the pad.

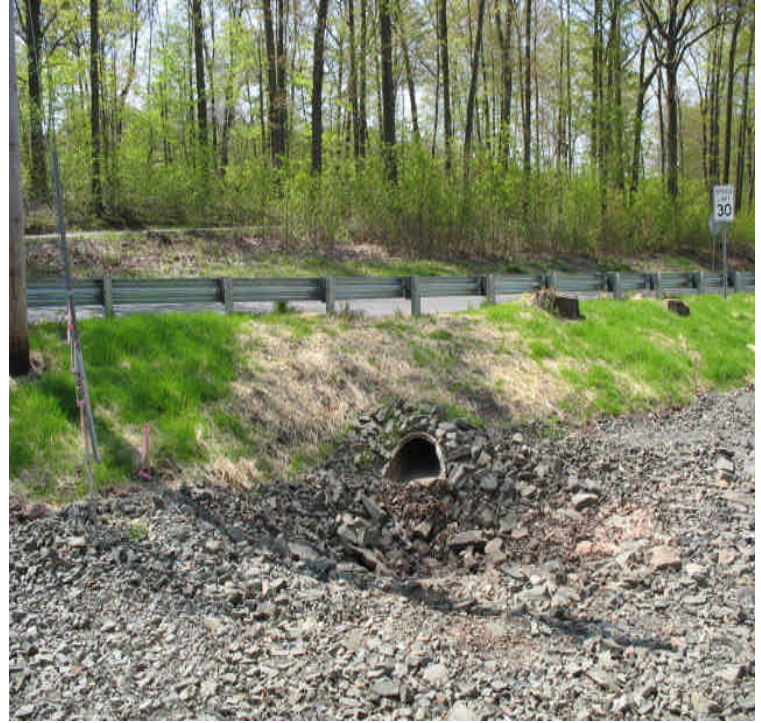
Harrison Rd: View of the recently installed stormwater solution for run-off from the roadway. Stormwater was percolating through the stone during heavy rain without causing erosion. Continue to evaluate

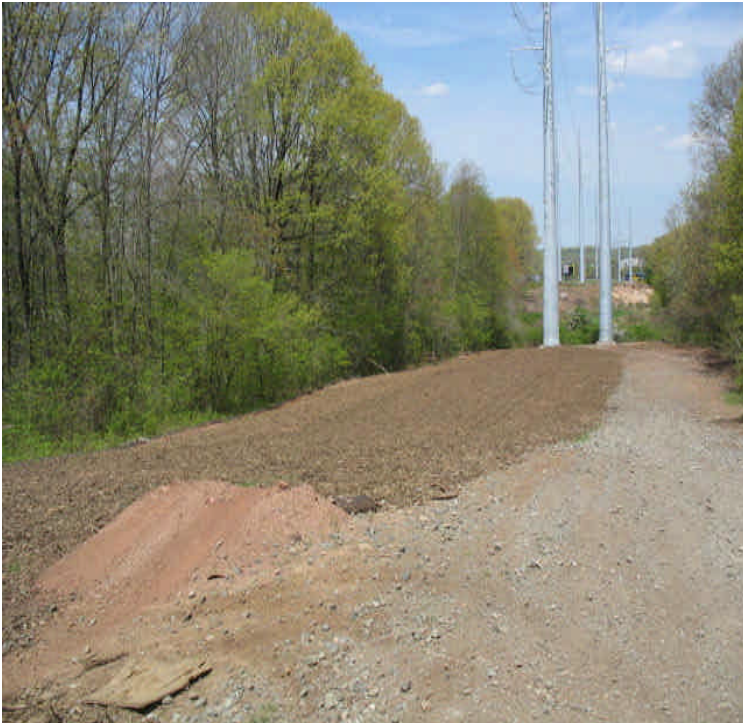
Docker Dr: Heavy mulch was applied over exposed soils for stabilization from stormwater/erosion and ATV traffic.

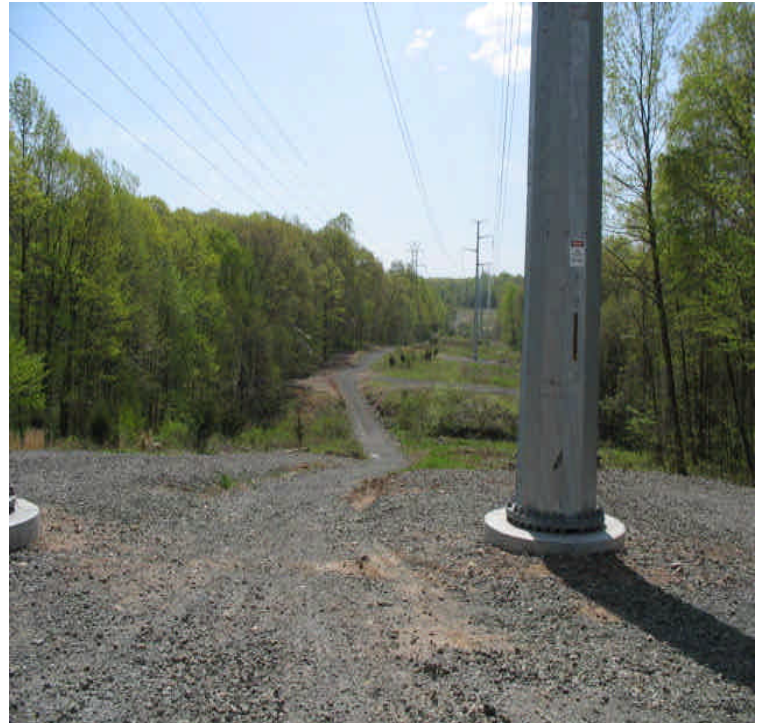
Tuttle Rd: Wetland crossings and water bars look good. Water is clear at the crossings and vegetative growth has returned.
